# Load-Carrying Performance and Hydrostatic Tests of Encapsulated Anchor Systems for Unbonded Post-Tensioning Single-Strands

**Abstract:** ACI 318-14 and 423.7-14 require the use of encapsulation system for an unbonded single-strand tendon for the purpose of corrosion protection and enhanced durability. In this study, load-carrying performance and hydrostatic tests were conducted for a newly developed, unbonded post-tensioning (PT) anchor with encapsulation, following the guidelines put forth in KCI-PS101 and ACI 423.7-14. The static load and fatigue tests as part of this study were used to evaluate the anchorage system behavior under static and cyclic loads, respectively. The hydrostatic test was used to demonstrate that the encapsulation system withstood at least 9.3 kPa of water pressure in a 24 h period according to ACI 423.7-14, and thus has been proven to promote the durability of unbonded PT single-strand tendons. Additionally, the push-in and jacking tests were used to assess the compressive and tensile strengths of the anchor as used in the field. Although these tests were not performed to failure for safety reasons, the anchor endured at least 1.18 and 1.02 times the nom

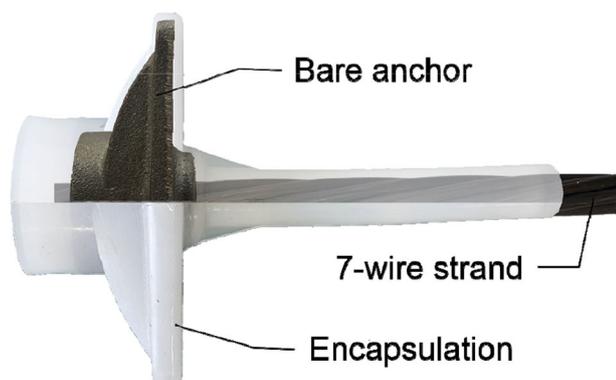
To prevent contact with water/moisture, a bare anchor is coated and covered by coating of LLDPE plastic materials (i.e., encapsulated). Figure 1 shows an encapsulated anchor that has been developed by the authors in Korea, and is being manufactured and supplied for use in several building projects. The sleeve is plastic-molded together with the plastic cover of an anchor as an integrated encapsulation.

Fig. 1 Prototype of developed encapsulated anchor.

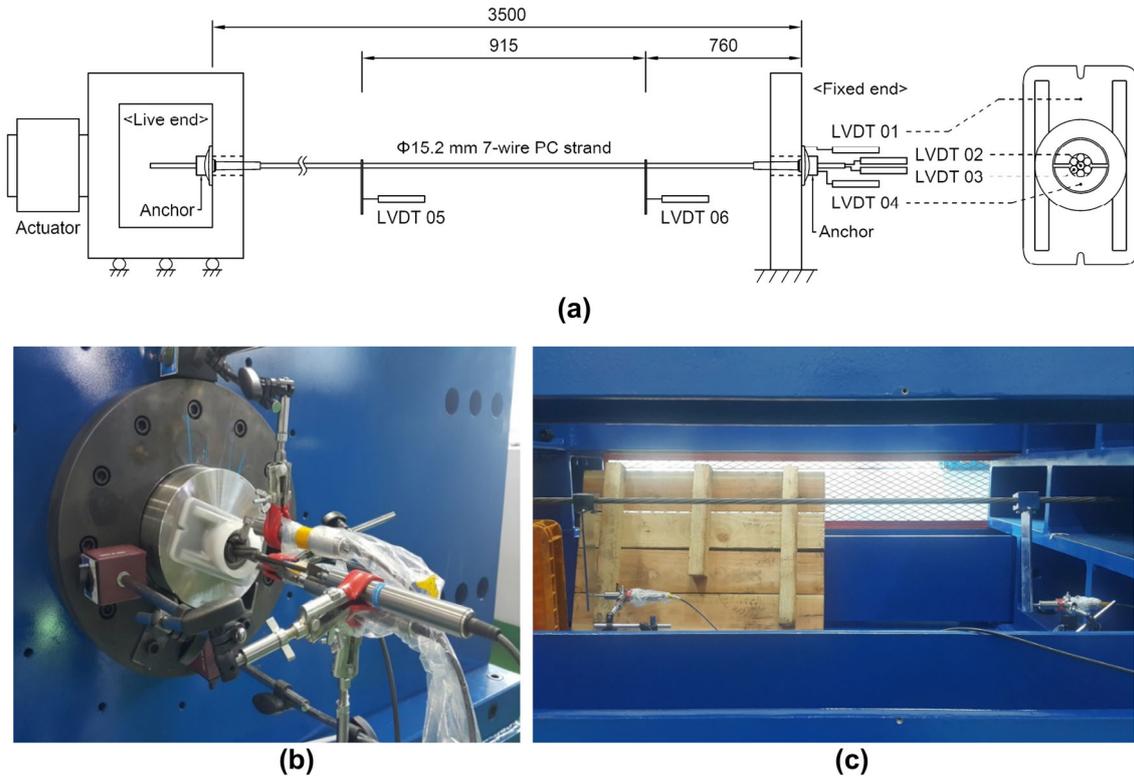
Three specimens (SLT1 ~ 3) were tested. To control both load and displacement, the live-end anchor was set onto a steel frame, which was moved by an actuator, rather than a jacking device (Fig. 2a). LVDT 01 ~ 04 (Fig. 2b) measured the displacement of an anchor plate, core (king) wire, one of the six helical (perimeter) wires, and one set of the wedges. The free length of the strand was 3500 mm. For SLT3, LVDT 05 and LVDT 06 (Fig. 2c) were added to measure the elongation in the middle of the strand, thereby satisfying stipulations in ACI 423.7 (Joint ACI-ASCE Committee 423 2014).

**Fig. 2** Setup of static load test. **a** Section view (unit: mm), **b** fixed end, and **c** middle of free length.

A series of static load tests were carried out to assess the strength of an anchor and evaluate its behavior, as well as that of the wedge, strand, and strand-wedge connection. The test was conducted according to the Korean specification, KCI-PS 101, which is a part of the Appendix of KCI (2010). This is similar to ETAG 013 (EOTA 2002). After pre-jacking at about 10 to 15% of the minimum ultimate tensile strength (MUTS), displacement gauges were installed. Then, tensile loading was increased up to 80% of the MUTS of the strand.

After pre-jacking, displacement measurements confirmed that the load increased at a rate of 100 MPa/min. up to 80% of MUTS. During the first half hour of testing under the 80% of MUTS, the wedge and strand were settled into the anchor and stabilized. For safety, the loading was stopped just before the fracture of the strand. Only the test for SLT3 was carried out until the strand fractured.

curves. This is a new finding that the tensile strain increased more at the jacking end than at the fixed end. See Fig. 2(a) where the measured portion between the LVDT 05 and LVDT 06 was located much closer to the fixed end, and note that the LVDT 05 and LVDT 06 were removed after one hour holding period.

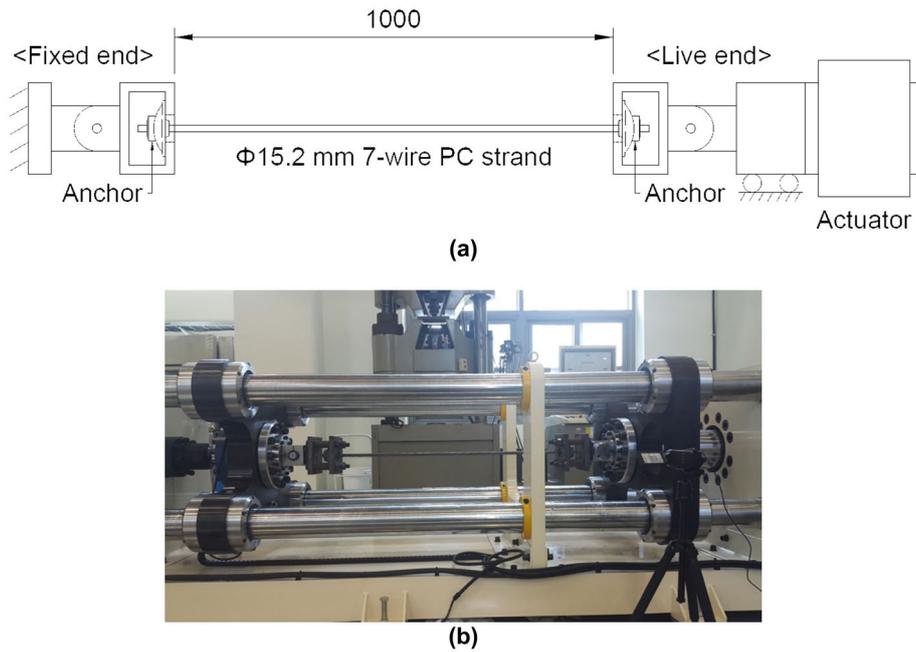
A fatigue test was performed to evaluate the anchorage performance during fatigue or under cyclic loading (Fig. 3). Unlike in bridges, the fatigue in buildings has a negligible effect on a tendon (PTI 2006); nonetheless, fatigue testing is required by KCI-PS101 (KCI 2010) for unbonded tendons. The testing methodology in this study followed in accordance with KCI-PS101. Because it was not easy to develop a jig to hold the plastic-coated anchor, it was tested using bare anchors.

The strand was inserted into the anchor with a wedge, and each anchor was fixed to the steel plates. Both ends were fixed with hinges so that the longitudinal axis was maintained parallel to the ground plane when the strand was elongated. The initial free length of the specimen was 1000 mm. One end was fixed, with repeated loading applied using an actuator at the other end. The repeated loads

**Fig. 3** Setup of fatigue test. **a** Section view (unit: mm) and **b** test setup.

between 160 and 171 kN were applied at 3 Hz for 2,000,000 cycles.

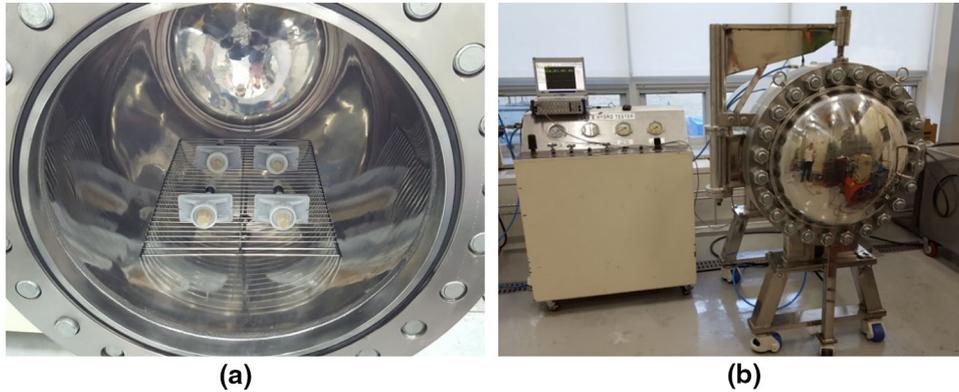
an end cap. The end of the sleeve was sealed with tape as used in the field. A dye was added to the water to examine whether the water entered into the anchor cavity after the experiment. For 24 h, four encapsulated anchor specimens (Fig. 4a) were placed in a hydrostatic pressure chamber (Fig. 4b), with a hydrostatic pressure of over 8.6 kPa.

Fig. 4 a Four specimens inside hydrostatic test chamber and b overview of hydrostatic test chamber.

Hydrostatic tests were performed to affirm watertight efficacy for encapsulation systems. This testing methodology was applied, exactly meeting the specifications of Section 9.3 of ACI 423.7-14. Instead of a wedge, a white tissue was placed inside the anchor cavity, which was covered by

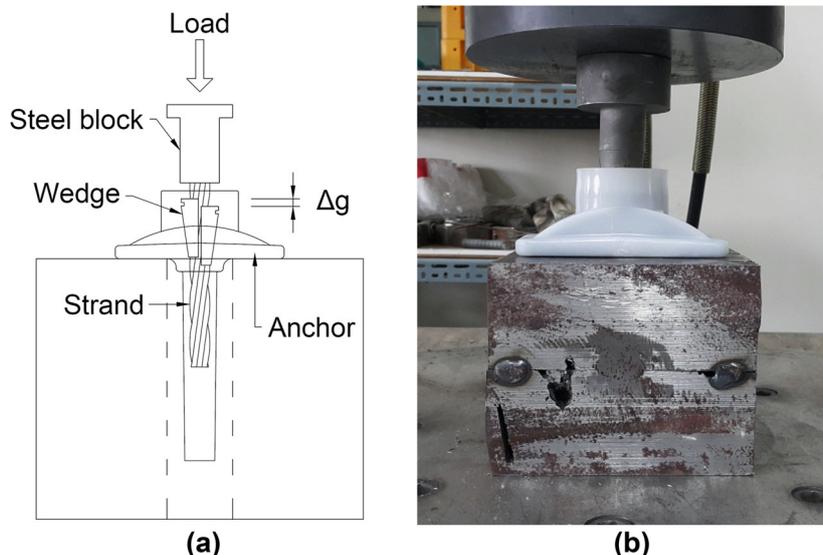
Similar to the wedge plate test specified by Sections 4.1.1 and 4.1.2 of PTI M50.1-98 (PTI 1998), push-in tests were performed to evaluate the strength of an anchor when a two-piece wedge was pushed in, with and without an offset or gap ( $\Delta g$ ) between the two wedge pieces, as shown in Fig. 5. To simulate the actual prestressing force of a tendon, a strand was inserted into an anchor and gripped by a two-piece wedge. Then the load was applied to the strand, not on the wedge. This test can be easily carried out without jacking or pulling, and is suitable for measuring the maximum capacity of an anchor system itself with actual wedge pieces seated in.

A total of six specimens were tested, including one specimen of a non-encapsulated bare anchor. A wooden board was used to support the bare anchor against a steel block, due to its uneven front surface of the bearing plate. Three of the encapsulated anchors were tested with a gap  $\Delta g$  between the two pieces of the wedge, akin to a poor condition that may occur in the actual construction field (Fig. 5a). The test setup is shown in Fig. 5b. The load was applied until the anchor fractured, which was not easy to

Fig. 5 Setup for push-in test. a Section view and b test setup.

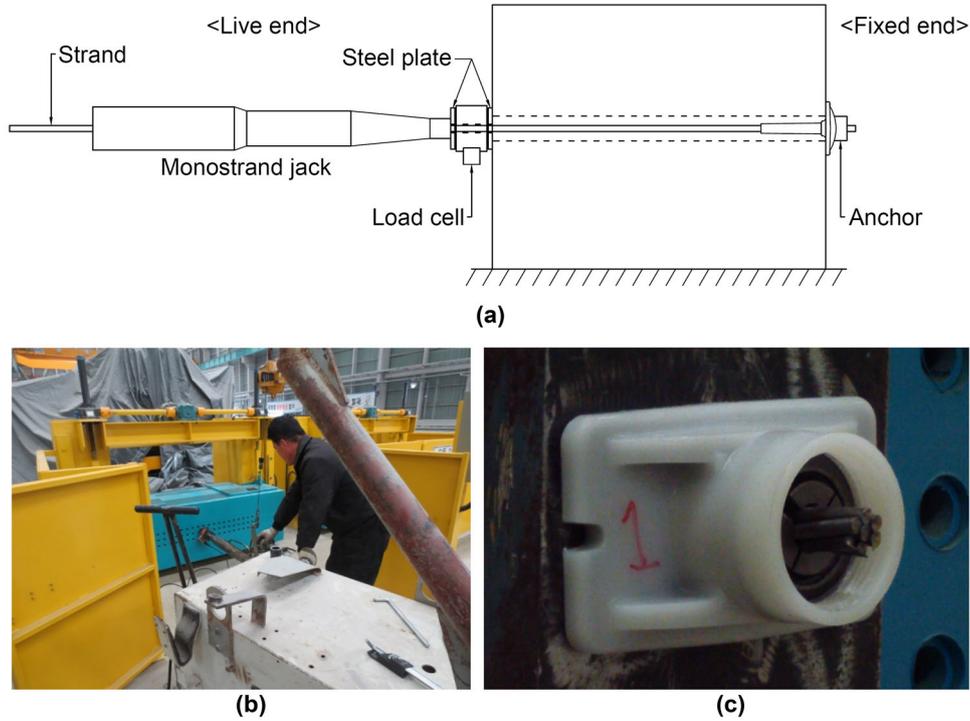
A jacking test is a simple experiment which physically simulates the post-tensioning process. As shown in Fig. 6, an anchor was fixed to a steel block, and the strand was jacked from the other side. The jacking force was measured by a load cell installed between the live-end anchor and the jack. This setup is similar to that used in precast plants.

Fig. 6 Setup of jacking test. a Section view, b jacking process at live end, and c fixed end.

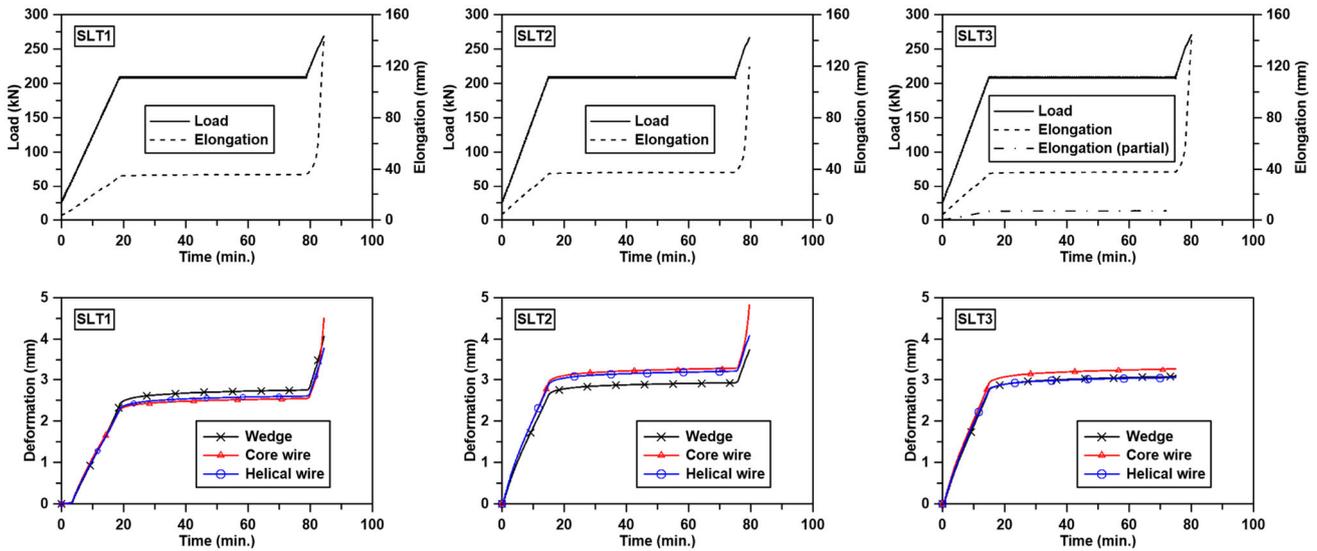
For all specimens, the load of 80% of the MUTS was maintained for 1 h, after which the load was increased up to over 260 kN (Fig. 7). Only the SLT3 specimen was tested up to strand fracture; however, the LVDTs were removed after 1 hour to adhere to equipment safety guidelines. The measured maximum loads (268.5, 266.6 and 270.5 kN) exceeded 100% (260 kN) of the MUTS for all specimens, indicating that the load-carrying capacity has been confirmed.

Fig. 7 Results of static load tests.

The anchor slip displacements (suction) of the wedge, core wire, and helical wire were calibrated by subtracting the displacement of the anchor plate from the total measured value. At 80% of the MUTS, the anchorage slip displacement was only approximately 3 mm, which was maintained with little variation. According to the EOTA document (EOTA 2013), the slip displacement at a fixed end (i.e., wedge draw-in) should be in the range of 3–5 mm. This result demonstrated the stable performance of the tendon assembly.

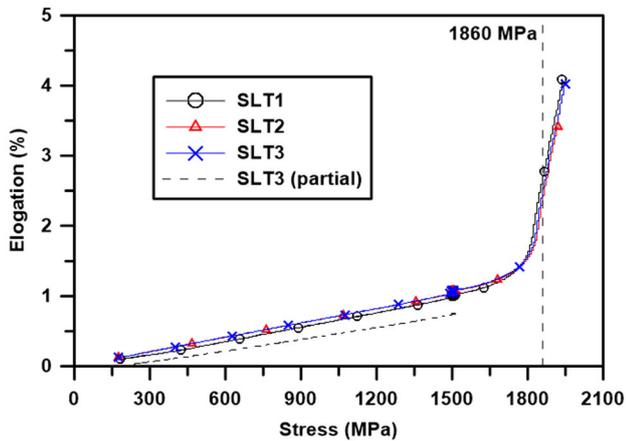
The relationship between the elongation percentage (strain) and stress is plotted in Fig. 8. The elongation percentage was increased rapidly to over 3% beyond 1800 MPa. In the STL3 specimen, fracture occurred at about 4% elongation. The elongation percentage results demonstrate the sufficient ductility of the tested strands prior to failure and satisfactory performance of the tested tendon assemblies. The partial elongation for the STL3 specimen was approximately 75% of the total elongation, as the stress–strain curve in Fig. 8 was located lower than the rest of the

**Fig. 8** Relationship between elongation percentage and stress.

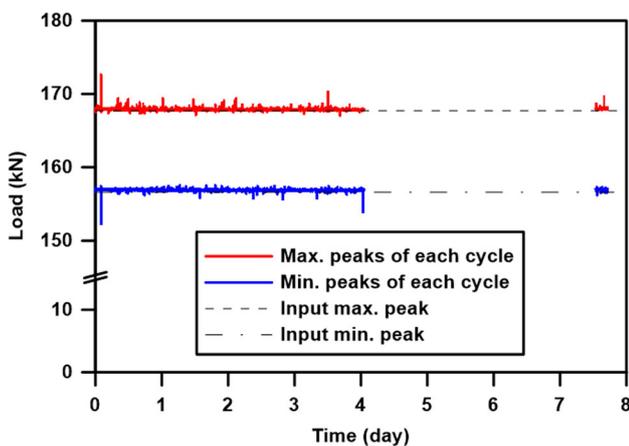
The fatigue load test, also called the high cycle dynamic tensile test, was performed over more than 7 days to generate 2,000,000 loading cycles. The KCI-PS101 specifications, which are the same as those of ETAG 013, were used as a testing protocol. The applied cyclic loads are shown in Fig. 9. Since the actuator was operated by a hydraulic pump, there were slight variations in load amplitude. Despite that, the overall loading range was steadily maintained as specified by KCI-PS101 or ETAG 013 throughout 7 days and beyond. The data from the day four to seven were not obtained due to the equipment's recording storage problem. No cracking of steel was observed in the anchors and wedges after the completion of the test (Fig. 10). No fracture of steel also has occurred, demonstrating the satisfactory fatigue behavior of the tested tendon assemblies. This was based on the third party's visual observation in accordance with KCI-PS101 or ETAG 013. It is noted that the fatigue

**Fig. 9** Results of fatigue test.

test was conducted in an independent commercial testing laboratory. The long-term service life is related to the fatigue behavior. Therefore, the data herein will help increase practical applications of the developed encapsulated anchor system.

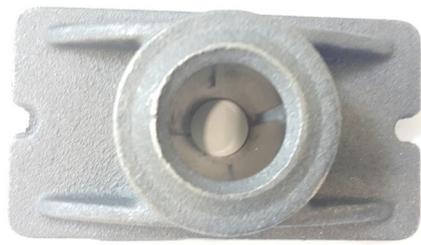
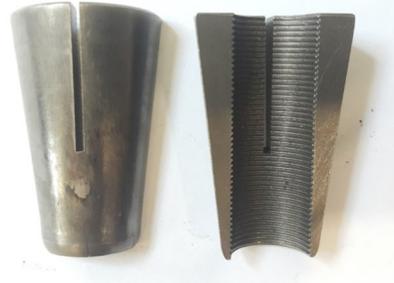
**Fig. 10** Bare anchor and wedge after fatigue testing in accordance with KCI-P101 and ETAG 013. **a** Bare single-strand anchor and **b** two-piece wedge.

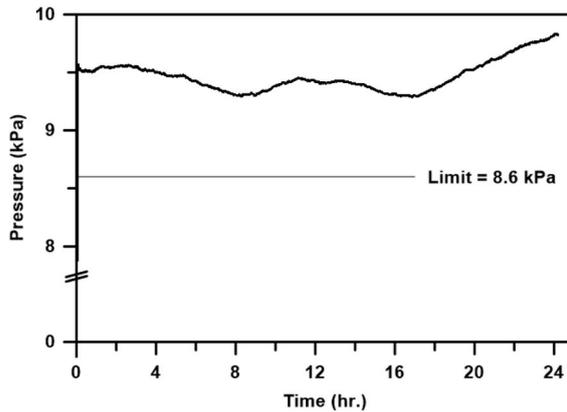
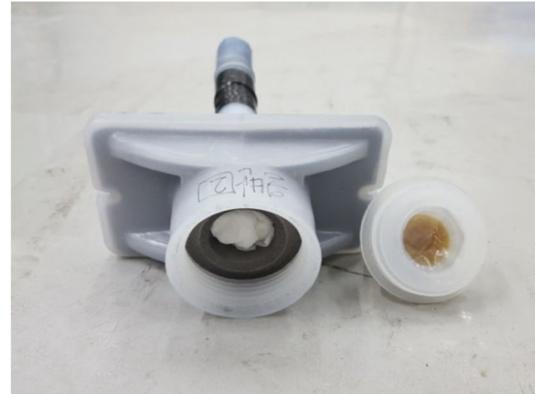
The hydraulic pressure in the equipment was maintained between 9.3 and 9.8 kPa for 24 h, as shown in Fig. 11a, which exceeded the minimum ACI 423-specified pressure of 8.6 kPa. Even though the pressure was attempted to remain constant, there was a modest variation during 24 h. After the hydrostatic test for 24 h, all the moisture on the outside surface of the anchor was removed, and the fastened end cap was opened (unfastened by hand). No paint or water was observed as the white tissues placed inside the cavity were not affected by the paint or internal moisture at all (Fig. 11b). Next, plastic accessories were disassembled, and it was re-confirmed that there was no water intrusion in the anchorage system. Because the use of encapsulated PT systems is now required in the U.S. for all elevated unbonded PT floors and would possibly be required even for slabs-on-ground in the U.S. or for PT construction in Korea soon, the test results in this study will help provide viable options for those in need and promote application of more durable PT systems. Because of the superior watertightness of encapsulation systems and low probability of damaging the coating during transportation, plastic encapsulation is only permitted by ACI 423.7-14 (epoxy coating is no longer permitted).

**Fig. 11** Results of hydrostatic tests. **a** Pressure over time and **b** photo taken after hydrostatic test.

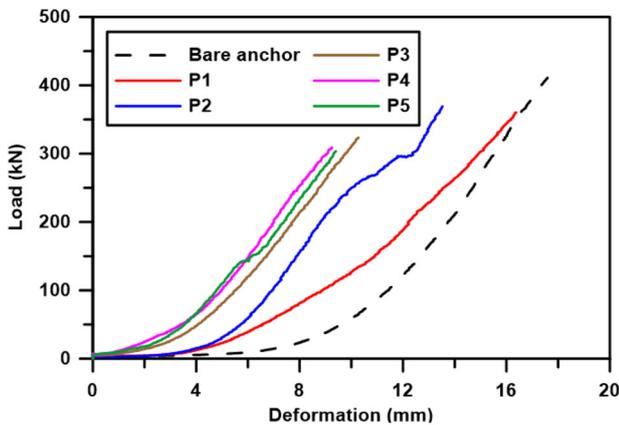
The results of the push-in tests are shown in Fig. 12 and Table 1. Some of the specimens were not pushed towards failure due to safety concerns. Even so, the measured maximum values exceeded the nominal ultimate strength of a strand (260 kN) by far. It was possible because this test had nothing to do with strand performance, as the pushing force was applied up to or almost up to failure of the cast-iron anchor itself. The large slip in the bare anchor was due to the squeeze put on the wooden board. The encapsulated anchors (P1 ~ 5) also exhibited small compressive slips due to the squeezed plastic cover.

**Fig. 12** Results of push-in tests.

Specimens P3, P4, and P5 had staggered wedges, and two pieces of the wedges had an average step height  $\Delta g$  of 7.32 mm. After the test, the intentionally given offset  $\Delta g$  was decreased to an average of 6.28 mm. This reduction of 1.04 mm on average was due to additional slip of one wedge piece while the wedges were set inside the cavity.

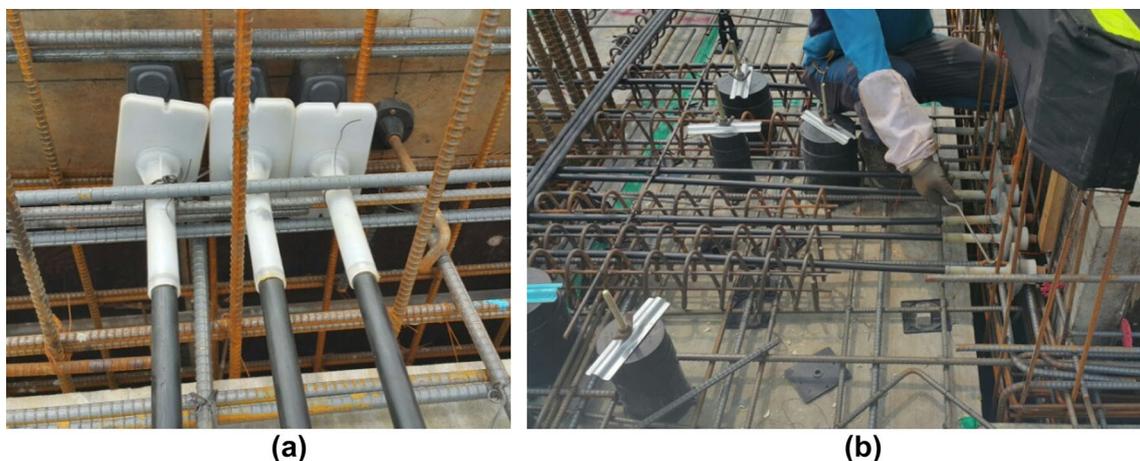
The developed encapsulated post-tensioned anchor systems have been used for several real building projects including residential, office and church buildings in Korea, which have been recently completed or currently under construction. Figure 13 shows an actual building project,

**Fig. 13** Applications of developed encapsulated anchor systems. **a** Stressing end anchors and **b** fixed end anchors.

where the developed systems were applied for the first time in Korea. To the authors' knowledge, the developed bare anchor was also the first Korean anchor for a single-strand tendon, as other anchors were either imported products or under other countries' license. Not to mention that it is the first Korean encapsulated system. The ACI 423.7-14 requirement for the use of encapsulated anchor systems is not yet required in Korea or by Korean Building Code (Architectural Institute of Korea 2016). However, because there is a growing demand to improve the durability and sustainability of PT structures with unbonded single-strand tendons, such corrosion-protective encapsulated anchor systems would be much needed in the near future in the region of East Asia.
