# Evaluation of the Depth of Deteriorations in Concrete Bridge Decks with Asphalt Overlays Using Air-Coupled GPR: A Case Study from a Pilot Bridge on Korean Expressway

The surveyed pilot bridge (‘J’ bridge) in this study is a pre-stressed concrete box girder (PSCB) bridge completed in 1998. The bridge has two traffic lanes with 150 m extension and 12.6 m width (Table 1, Fig. 2). The penetrating waterproof materials were sprayed on top of the bridge deck concrete. This was then covered with two layers of asphalt concrete.

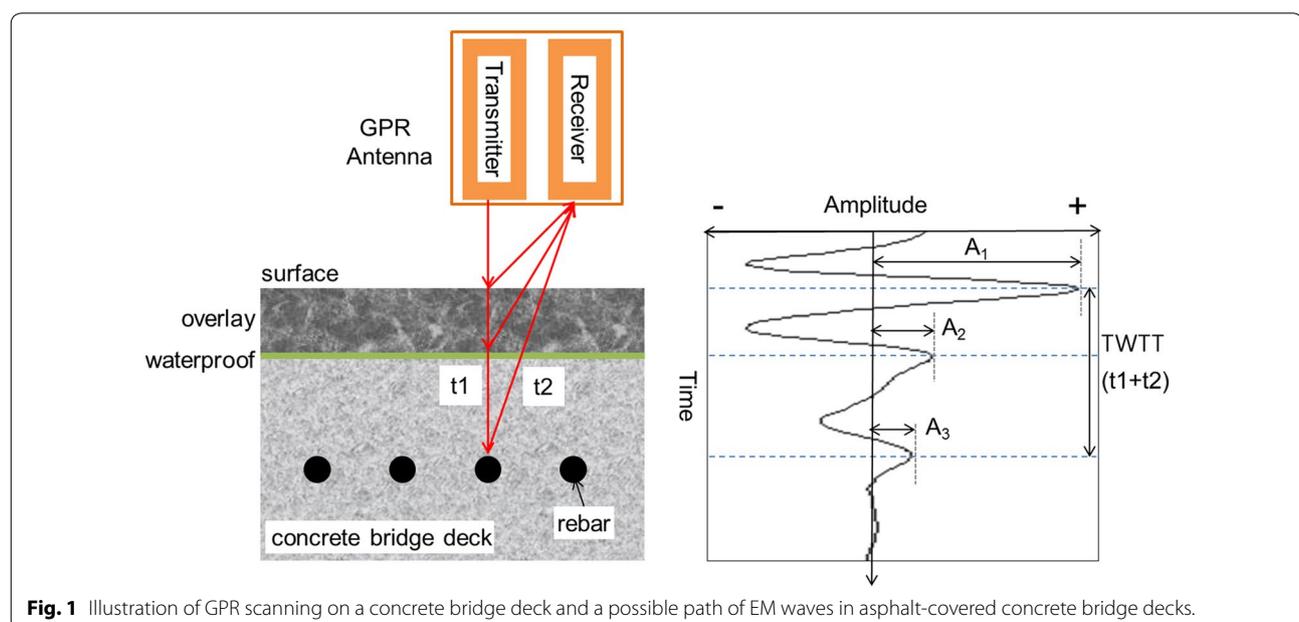
operation of the GPR system, a transmission antenna is installed perpendicular to the road surface where an electromagnetic (EM) wave is emitted via underground. Figure 1 illustrates the possible path of the radar wave emitted from the GPR antenna. Some of the energy of the EM wave is transmitted through the layers of asphalt and deck concrete while the remaining EM waves are reflected from the boundary at different permittivity. The reflected EM wave is detected by the receiving antenna of the GPR system and stored for data analysis. The analysis of the reflected EM wave allows the detection of underground cavities, rebar location, and layer thickness (Morey 1998). ASTM D 6087-08 (2008) is the standard test procedure that would provide information on the condition of the asphalt-covered concrete bridge decks by the energy attenuation method. The method is based on the principle that the area of deteriorated concrete with greater chloride concentration and water content would exhibit higher energy attenuation than the sound area. Many researchers have verified that the in situ testing method is effective in assessing the condition of concrete bridge decks (Maser and Bernhardt 2000; Cardimona et al. 2000; Maser 1990). Previous studies have investigated the process of enhancing the accuracy of the reflected EM wave attenuation method (Dinh et al. 2016; Hasan and Yazdani 2014; Tarussov et al. 2013; Barnes et al. 2008). Moreover, several researches have demonstrated the feasibility of GPR as an in situ NDE method to evaluate the depth of chloride-induced deterioration of concrete in bridge decks (Varnavina et al. 2015). In that research, a relationship between GPR

where  $T$  is the two-way travel time of an EM wave in a material (TWTT;  $t_1 + t_2$ , see Fig. 1);  $t_1$  is the travel time of an incident EM wave from a transmitter to a rebar; and  $t_2$  is the travel time of a reflected EM wave from a rebar to a receiver. It is necessary to obtain the reliable relative permittivity of the material in order to accurately assess the condition of the targets embedded in the media.

where  $A_p$  refers to the reflection amplitude from a steel sheet plate, and  $A_2$  and  $A_3$  refer to the peak amplitudes of reflected EM waves from the A/C interface and the top surface of rebar, respectively (see Fig. 1). In addition, it is essential to adjust the effect of concrete cover of actual rebars on the GPR attenuation for a more reliable estimation of  $\delta_{cover\_conductive}$ . In this study, the concrete cover effect was determined based on the recommendations of previous researches (Dinh et al. 2016; Romero et al. 2015; Barnes et al. 2008), and will be discussed further in Sect. 4.2.

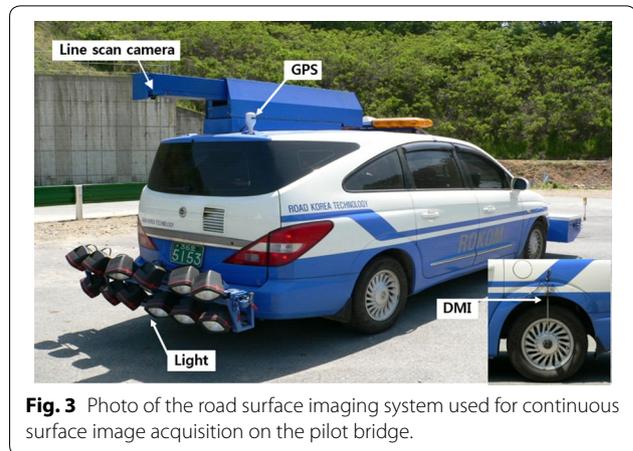
A road surface imaging equipment was used to perform a visual inspection on the surface of asphalt overlays (Fig. 3). This device includes a combination of multiple sensors: a line scan high-resolution camera at the rear top of the vehicle for the surface image acquisition, a GPS system, and a distance measuring instrument (DMI) for automated location measurements. This equipment

was driven at an average speed of 80 km/h to collect the images of the road surface of all lanes that includes the shoulders. The location and areal extension of deteriorations from various sources were calculated by using an image-processing computer program.

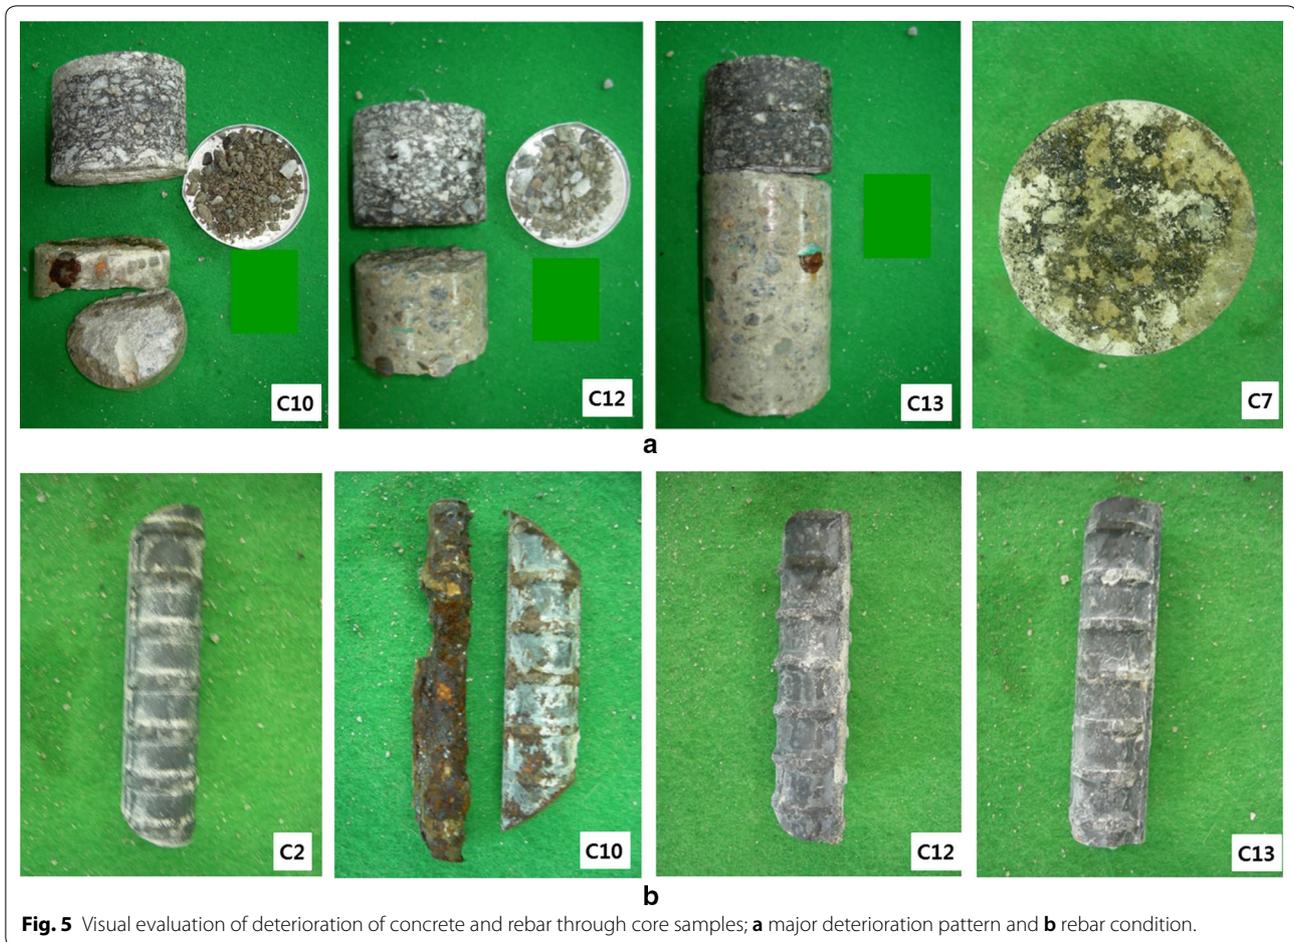
**Fig. 5** Visual evaluation of deterioration of concrete and rebar through core samples; **a** major deterioration pattern and **b** rebar condition.

Table 3 summarizes the survey results from the detailed visual inspection of the 13 core samples. It was observed that most of the waterproofing layer was either deteriorated, vanished, or was completely lost in most concrete cores. The deteriorated depth of concrete was in the range of 1 to 82 mm. The common types of concrete deterioration were observed to be the decomposition of concrete constituents due to freeze–thaw action on top of the concrete (9 core samples) and delamination in concrete (3 core samples). Based on the survey results of 4 core samples with rebars, the clear covers of rebars were measured between 53 and 73 mm (Fig. 5b). In this study, corrosion of rebars was not observed unless the deterioration depth of concrete exceeded the clear cover of the rebars. Therefore, the concrete deterioration of the pilot bridge in this study was mainly attributed to the freeze–thaw action, with a deterioration mechanism as follows: the rainwater and deicing salt penetrated first the area of the damaged overlay, and then penetrated the concrete further through the weak points with poor waterproofing (Rhee et al. 2018). Subsequently, the freeze–thaw action could enhance the porosity and microcracks through weakening and/or softening the microstructure and through decomposition of the concrete components.

It was observed that the rebar in the C10 lost about 40% of the section due to corrosion activities (see Fig. 5). However, the rebar in the C3 did not show any evidence of corrosion. This phenomenon also supports the chloride-induced deterioration (corrosion of rebars) occurrence after the concrete deterioration due to freeze–thaw action in the pilot bridge.

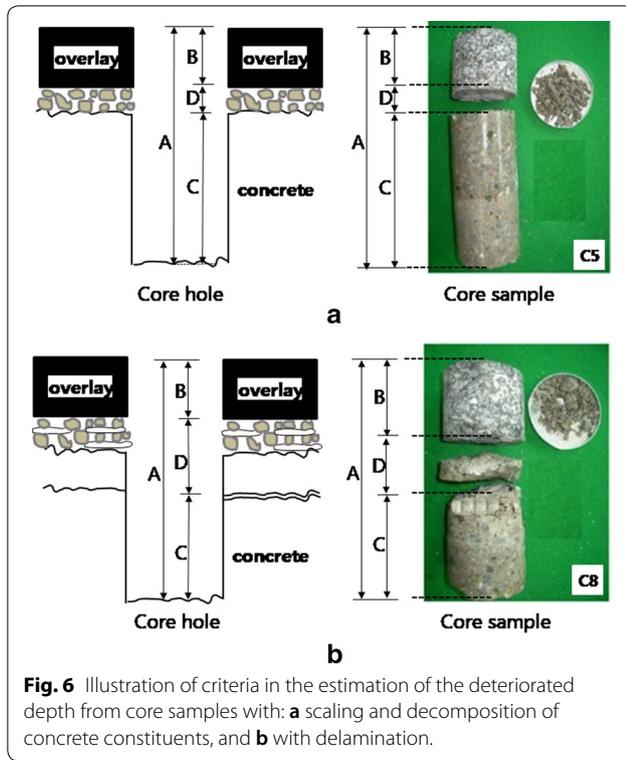
**Fig. 6** Illustration of criteria in the estimation of the deteriorated depth from core samples with: **a** scaling and decomposition of concrete constituents, and **b** with delamination.

deteriorated depth of concrete,  $d_{damage}$ , which is denoted as ‘D’ in Fig. 6, is calculated as follows,

$$d_{damage} = A - B - C \tag{8}$$

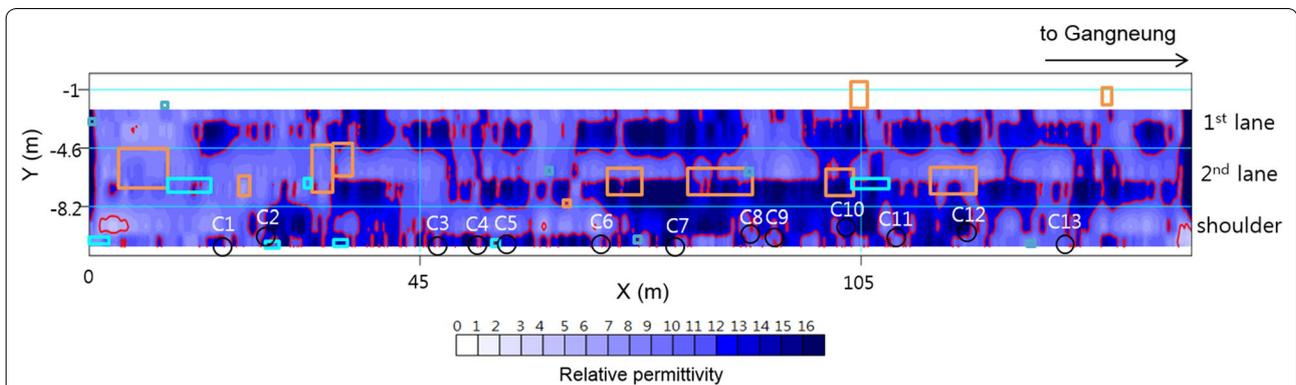
and the top surface of concrete bridge deck (A/C interface). The average relative permittivity was determined to be 11.7 with a standard deviation of 2.7, which surpasses the relative permittivity of sound concrete that is within the range of 5 to 10 (ASTM D6432 2011). Overall, the high value of relative permittivity is mainly attributed to the presence of water at A/C interface caused by damages in asphalt concrete layers, poor waterproofing, and material deterioration. Areas with high relative permittivity value were determined to occur around the wheel paths, which coincide with the intensive surface-breaking cracks (Fig. 4). Furthermore, large values of relative permittivity were observed around  $X=70-120$  m on the 2nd traffic lane, which corresponds to the location of pavement patches. Results indicate that the deterioration in bridge decks could still occur even after repair due to the presence of weak points. In addition, the area around the barrier on the shoulder has a high relative permittivity due to the penetration of rainwater.

**Fig. 10** Condition map based on the relative permittivity of concrete measured by air-coupled GPR system on the pilot bridge: red lines indicates the relative permittivity values of 6 and 12. For a comparison, various types of damages on the surface in Fig. 5 are shown in the figure (○: core, —: surface-breaking cracks, □: efflorescence, □: patching and □: pothole).

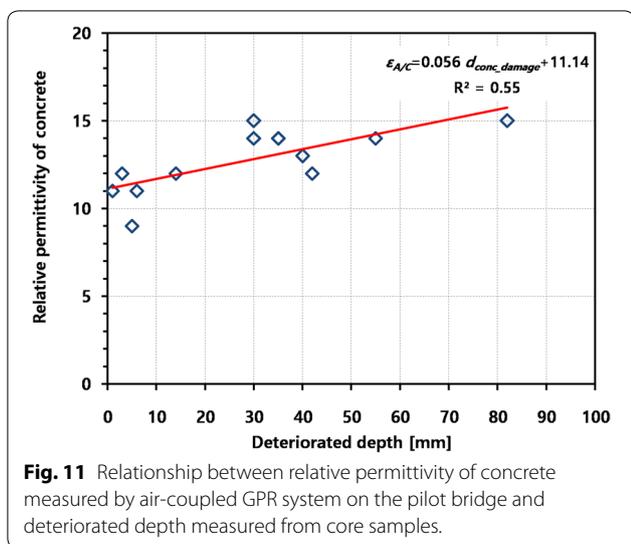
Figure 11 shows the variation of the relative permittivity measured near A/C interface ( $\epsilon_{A/C}$ ) where the deteriorated depth of concrete bridge deck was measured from core samples ( $d_{conc\_damage}$ ). The relationship between  $\epsilon_{A/C}$  and  $d_{conc\_damage}$  is established by a linear regression analysis that is given in Eq. (9):

$$\epsilon_{A/C} = 0.056 d_{conc\_damage} + 11.14 \tag{9}$$

Based on the survey, the present work proposes that the relative permittivity should not be less than 11 to avoid failure of the waterproof layer, which may lead to surface deterioration of the concrete. The relationship illustrated in Eq. (9) was derived from the observation of the pilot bridge under wet condition where the A/C interface and concrete bridge deck contain a sufficient quantity of water. The GPR survey performed under various time and weather condition (Rhee and Choi 2017) may result in different distribution of relative permittivity, which may affect the relationship between  $\epsilon_{A/C}$  and  $d_{conc\_damage}$ . Thus, it is necessary to better understand the variation of relative permittivity, which depends on the absorptive capacity and water content of various concrete bridge decks in Korea expressway networks.

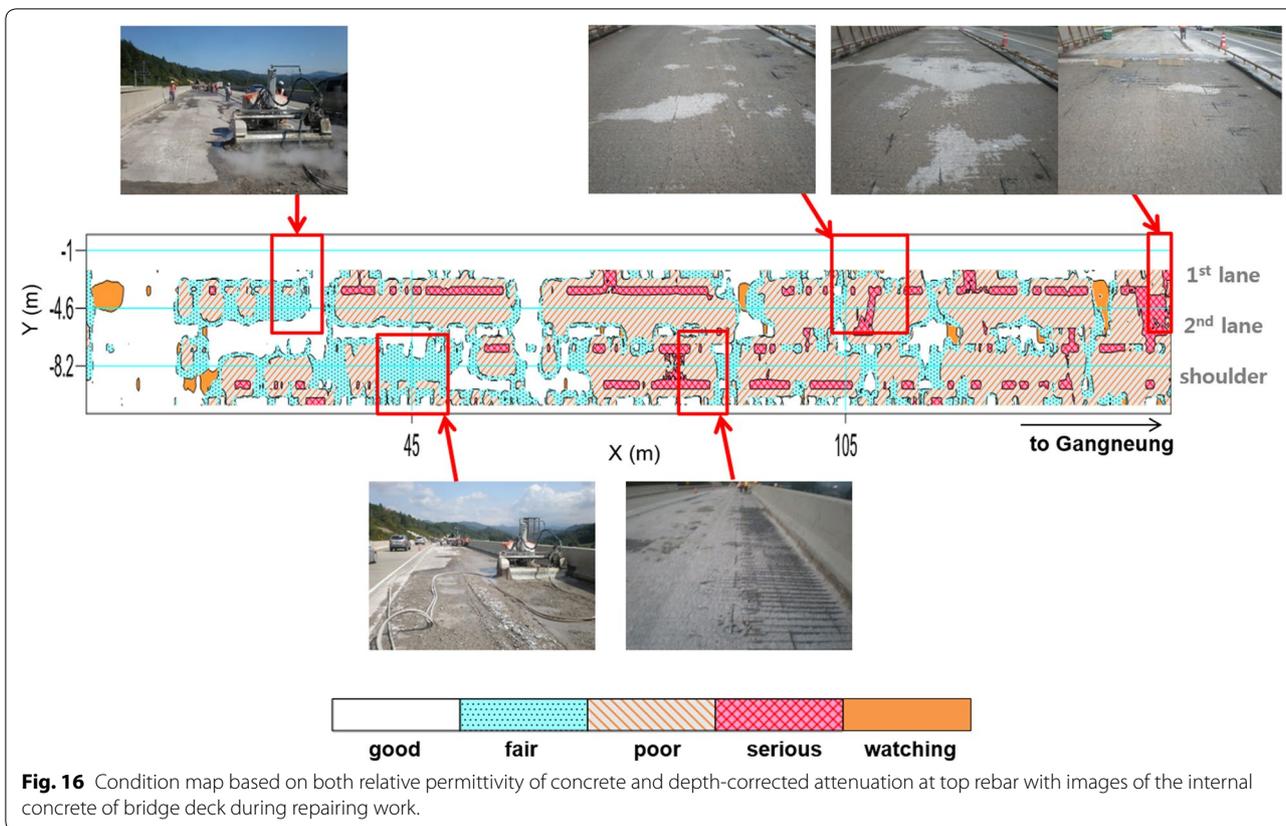
**Fig. 16** Condition map based on both relative permittivity of concrete and depth-corrected attenuation at top rebar with images of the internal concrete of bridge deck during repairing work.

Figure 16 shows the condition map of deterioration prediction in consideration of both relative permittivity of concrete and depth-corrected attenuation at top rebar. The images of the internal concrete of the

bridge deck investigated during the repairing work are in line with the five categories of deterioration listed in Table 6. Examining this in conjunction with the previous pilot bridge deck survey result (Fig. 4), ‘Fair’ area of poor waterproofing was observed. This area is located around the barrier on the shoulder, where the gathered rainwater was due to the overlay damages (cracking, patching, etc.) and lateral slope. This has led into a ‘Poor’ stage, at which the early deterioration of concrete started due to the accumulation of chloride ion in concrete. Afterwards, if the deterioration of concrete

worsens to reach the location of the rebar, this would then be a ‘Serious’ stage in which the possibility of corrosion of the rebar is high. The ‘Serious’ area was observed at wheel path, around the barrier, and around the end of the bridge.
