Use of Higher-Harmonic and Intermodulation Generation of Ultrasonic Waves to Detecting Cracks due to Steel Corrosion in Reinforced Cement Mortar

Abstract

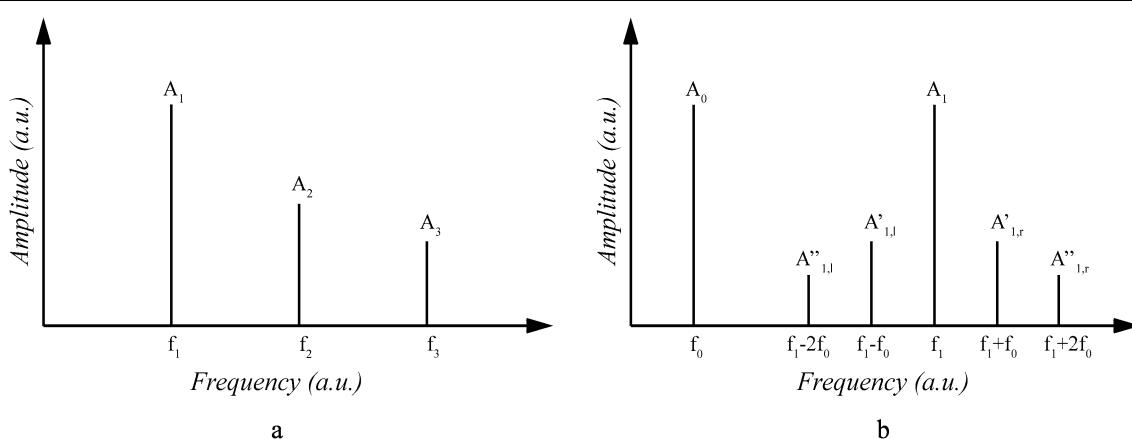
Fig. 1 Frequency spectrum: **a** harmonic distortion (HD); **b** intermodulation distortion (IMD).

Figure 1 shows graphically the concepts of harmonic distortion (HD) and intermodulation distortion (IMD) (Price and Goble 1993). HD takes place when a system is excited by a signal of frequency f_1 . In this case, higher order frequencies appear at the output ($f_2 = 2f_1$, $f_3 = 3f_1$, and so on), being this phenomenon termed as higher order harmonics generation (Fig. 1a).

IMD occurs at frequencies that are the sum and/or the difference of integer multiples of the fundamental frequencies. If a non-linear system is excited by two signals (f_1 and f_0), the non-linearity give rise to additional output components at $(f_1 + f_0)$ and $(f_1 - f_0)$ known as the first-order intermodulation products. At the same time, the second-order products will mix with the original signals

giving components of frequencies ($f_1 + 2f_0$), ($f_1 - 2f_0$), and so on (see Fig. 1b).

where $A'_{1,b}$, $A'_{1,r}$, $A''_{1,l}$ and $A''_{1,r}$ are the amplitudes of the subsequent left and right sidebands, respectively, and A_1 is the amplitude of the high-frequency acoustic wave; see Fig. 1. The intensity of the modulation ratio can be correlated with damage size. In many studies, the parameter R has been used as the damage index (Van den Abeele et al. 2000; Friswell and Penny 2002; Muller et al. 2005; Aymerich and Staszewski 2010).

In this work it is proposed the use of a new parameter for putting in evidence the micro-damage through the intermodulation non-linear features. The new index, termed as $DIFA$ (difference of amplitudes), Eq. (2), is based on the difference between the amplitude of the fundamental frequency and the sum of the amplitudes of all the first-order and second-order intermodulation products; see Fig. 1:

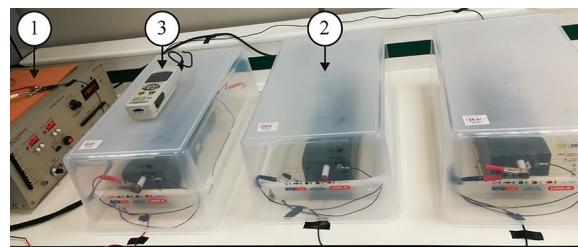
Fig. 3 Setup of the accelerated corrosion test. 1: potentiostat–galvanostat. 2: mortar specimen under test (the specimen is located on a tray with a plastic cover to keep a practically constant relative humidity environment, see text in Sect. 2.2). 3: relative humidity measurement device.

The accelerated corrosion tests were conducted using a potentiostat–galvanostat (Model 362, EG&G Instruments, Princeton NJ, USA). A constant anodic current density of $40 \mu\text{A}/\text{cm}^2$ was applied between the steel rebar (anode) and an external galvanized steel grid (cathode) placed in the bottom of the specimens. To keep an appropriate electrical conductivity throughout the cement mortar, the samples were partially submerged (5 mm height) in a recipient filled with tap water, and a polypropylene sponge was put between the mortar specimen and the steel grid (Climent et al. 2006). The duration of the accelerated corrosion tests was different for each one of the tested specimens, see Sect. 3.1. Given that the galvanostat provided a constant current density, it was possible to corrode three specimens simultaneously by connecting them in series. The tests were performed under nearly controlled climatic conditions, with a relative humidity of $84\% \pm 4\%$ and a temperature of $23 \pm 1^\circ\text{C}$, to minimize the influence of additional factors on the measurements, i.e., to avoid uncontrolled drying of the reinforced mortar specimens (Payan et al. 2010). Figure 3 shows an image of the accelerated corrosion test.

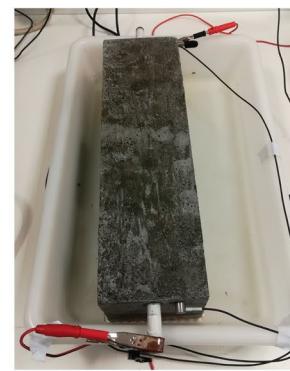
Fig. 2 **a** Dimensions of the reinforced cement mortar specimens. **b** Photo of one of the specimens before starting the corrosion test.

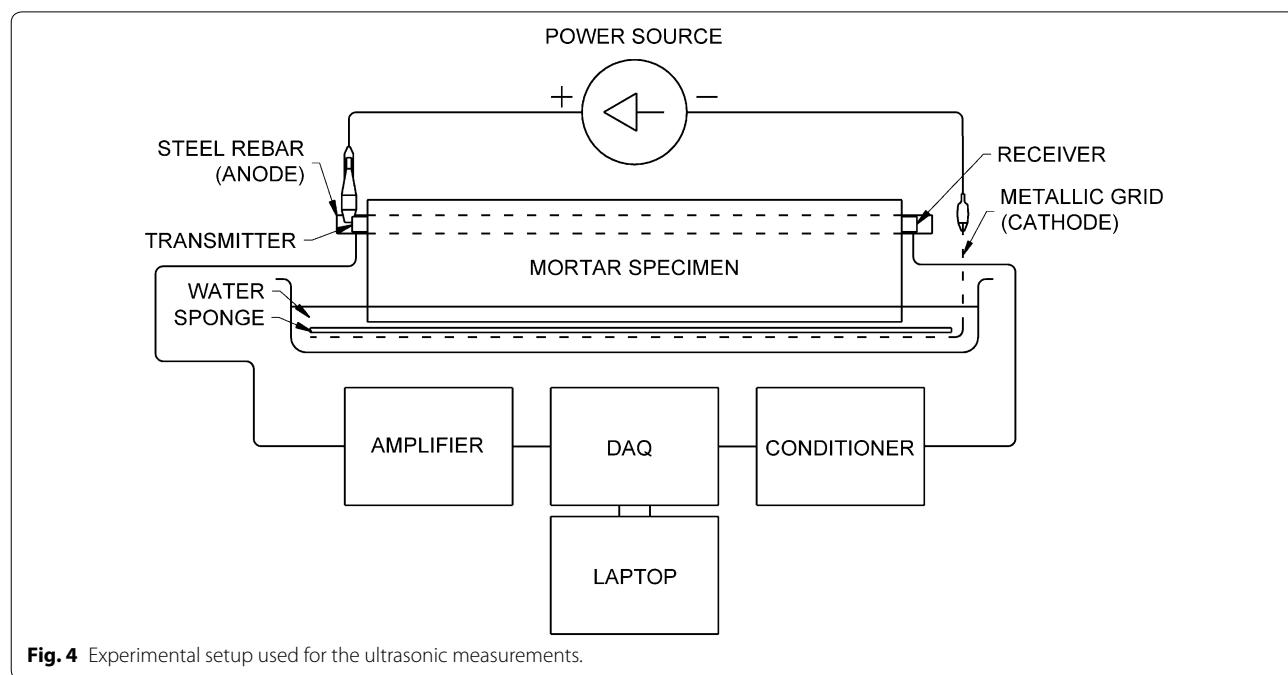
Fig. 4 Experimental setup used for the ultrasonic measurements.

amplified using a signal conditioner 2693-A (Brüel & Kjaer, Naerum, Denmark) and then sent to the acquisition platform. For the IMD experiments, the emitter transducer was supplied with two tones at the same time ($f_1=30$ kHz, $f_0=2$ kHz).

IDK09 transducers (Dakel 2019) with isolated contact membrane (Al_2O_3 pure ceramic) and piezoelectric ceramic active element PbZrTiO_3 (PZT)—modified ceramic class 200—were used for both the emitter and receiver elements. This kind of PZT material is suitable for active (exciter) and passive (sensor) applications, and it is recommended for wide-band no-resonance uses due to their low mechanical quality factor ($Q_m < 100$). Both transducers were glued permanently (at the beginning of the NLU measurement series) to the reinforced cement mortar specimens using a quick setting Cyanoacrylate glue as the coupling agent. In this way it is thought that any possible defect or air void in the coupling interface has affected equally to all the NLU measurements. Taking into account that in this work the interpretation of the NLU data is always done on a comparative basis (no absolute value is considered), it is believed that the influence of the coupling between sample and transducers is negligible. Previous works (Antonaci et al. 2013) have also shown that that the effects due to small differences in coupling turned out to be negligible compared to the effects induced by corrosion of steel embedded in concrete. The NLU measurements were conducted on a “direct transmission” mode (Antonaci et al. 2013). Figure 5 shows a layout of the reinforced cement mortar

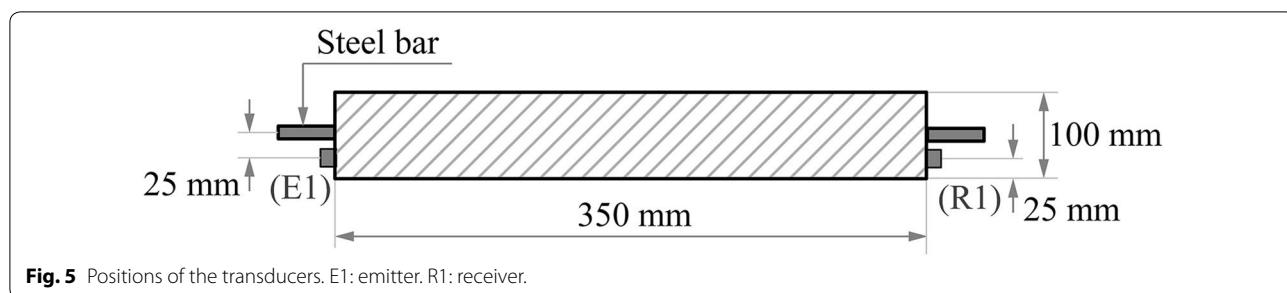
Fig. 5 Positions of the transducers. E1: emitter. R1: receiver.

specimen with the positions of the ultrasonic transducers and the steel bar under test.

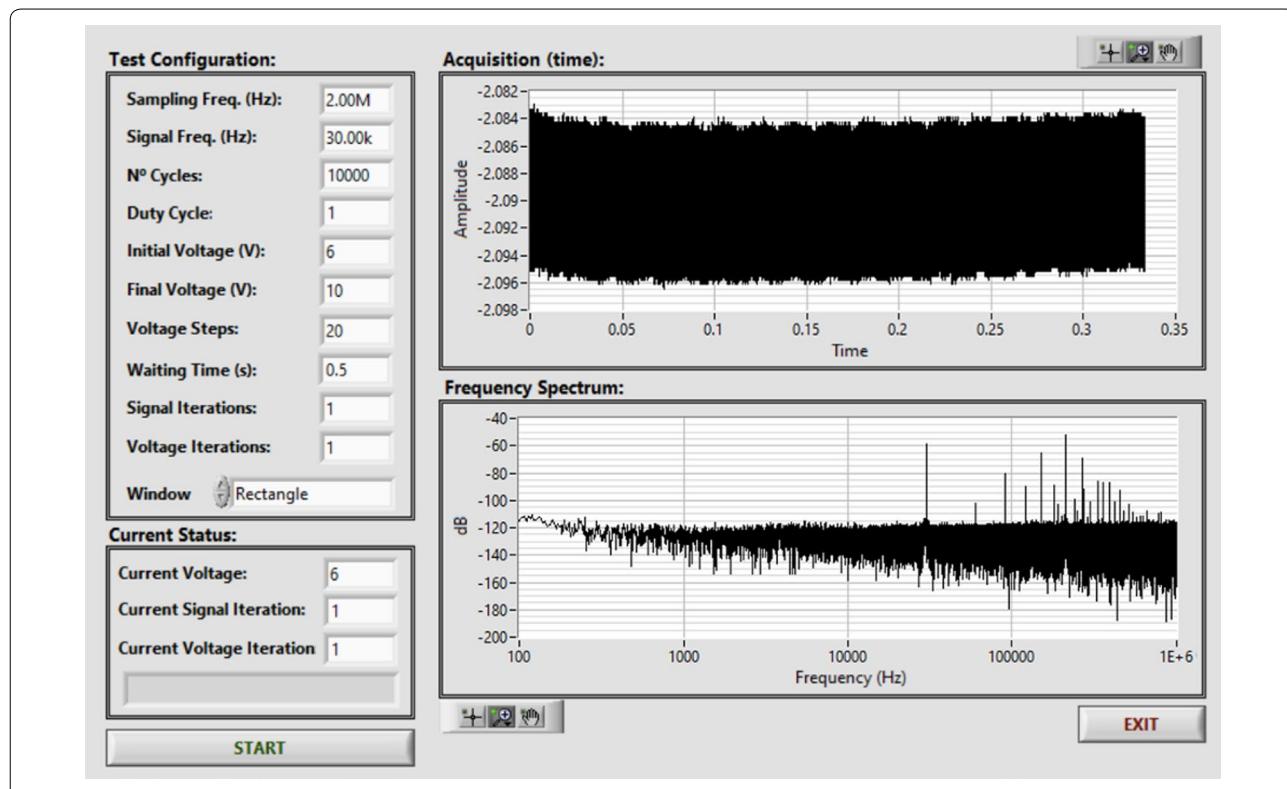
Fig. 6 Emission and signal acquisition application front panel.

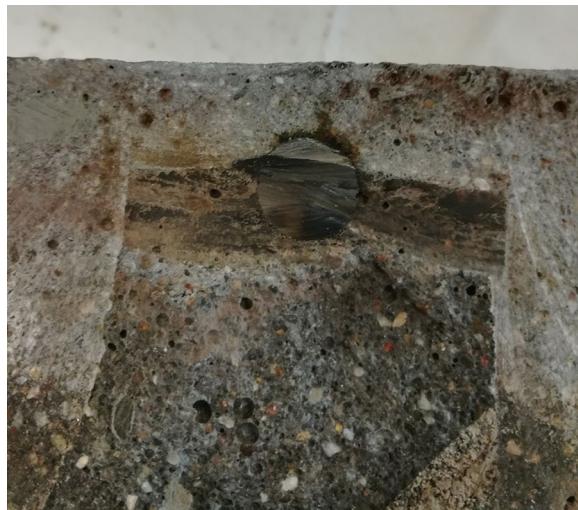
Fig. 7 Photo taken after cutting specimen number 10, at the end of its corrosion test. Steel corrosion products have concentrated on top of the steel rebar and are filling the open crack produced by corrosion.

The first micro-crack in sample 11 was detected on the eighth day (7 days of current passing). Then, the specimen was disconnected from the power supply. A day later, a visible crack appeared in sample 10, and 2 days later it appeared in sample 9 (see Table 2). The test of sample 10 was stopped at the 15th day, and after disconnecting the current the specimen was cut in order to inspect the fissure and the corrosion products path; see Fig. 7. On that 15th day the maximum crack width on the upper surface of sample 10 reached the value of 70 μm . Finally, the test of sample 9 was concluded after 31 days of testing, when the surface of the specimen showed a crack with a maximum value of 320 μm width. Figure 7 shows clearly the accumulation of steel corrosion products at the steel–mortar interface, especially on top of the

bar, and the partial filling of the open crack produced by the corrosion process.

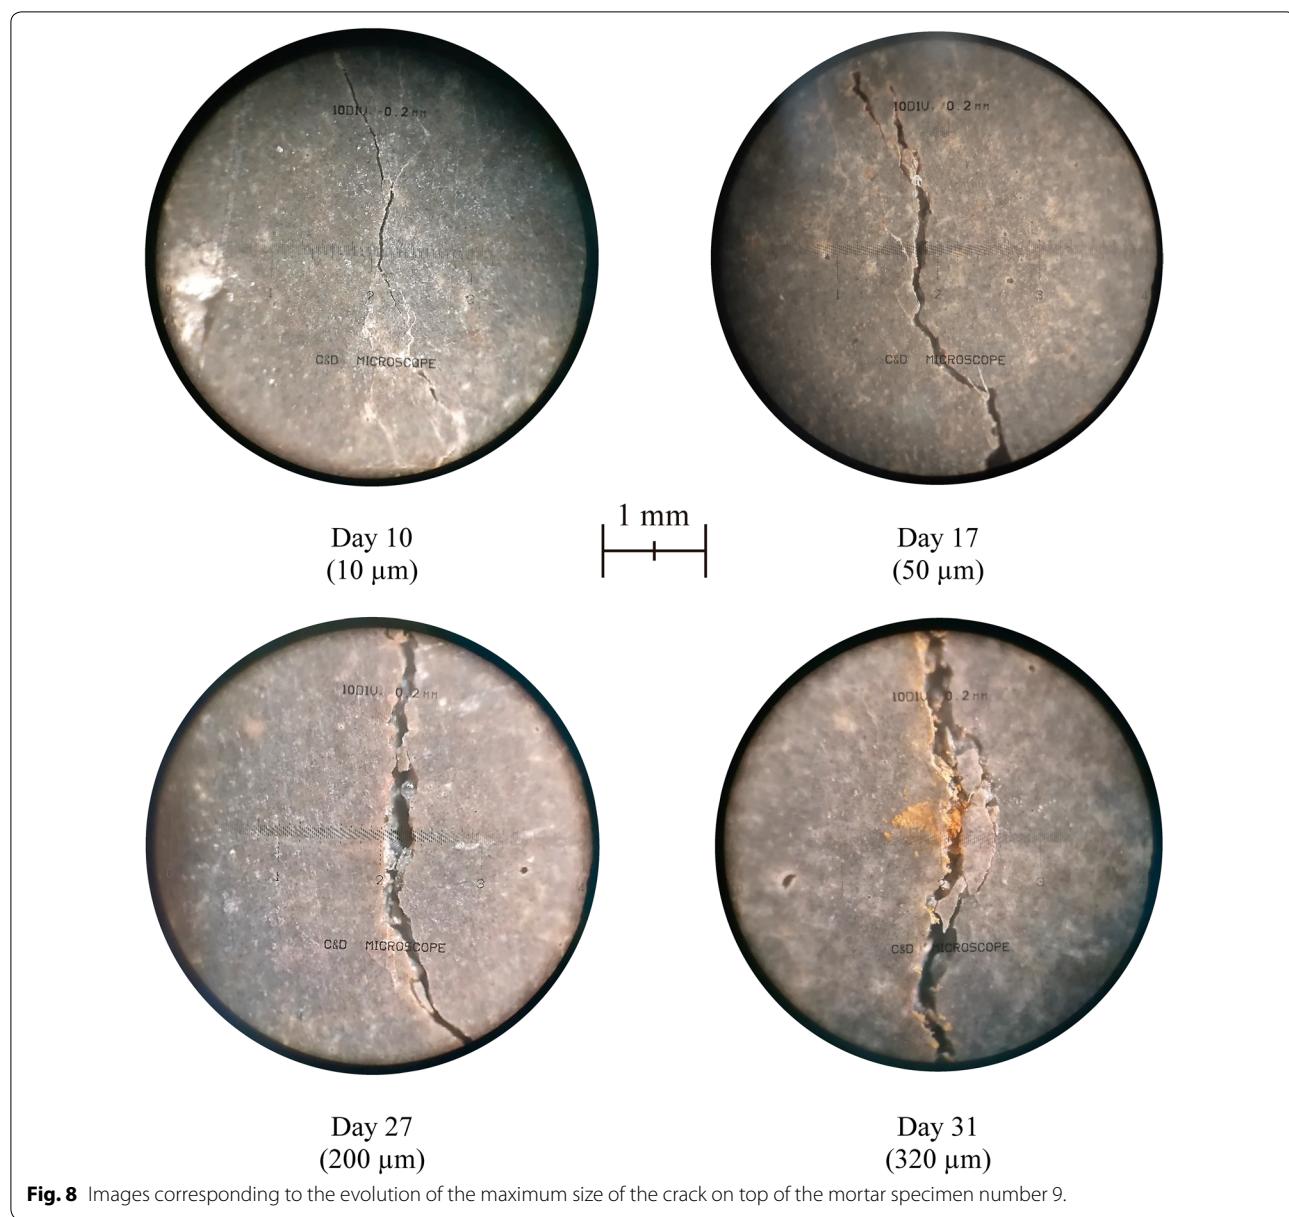
Fig. 8 Images corresponding to the evolution of the maximum size of the crack on top of the mortar specimen number 9.

Figure 8 shows a series of images corresponding to the evolution of the fissure appeared on top of the mortar specimen number 9. The figure also includes the measured values of the crack width.

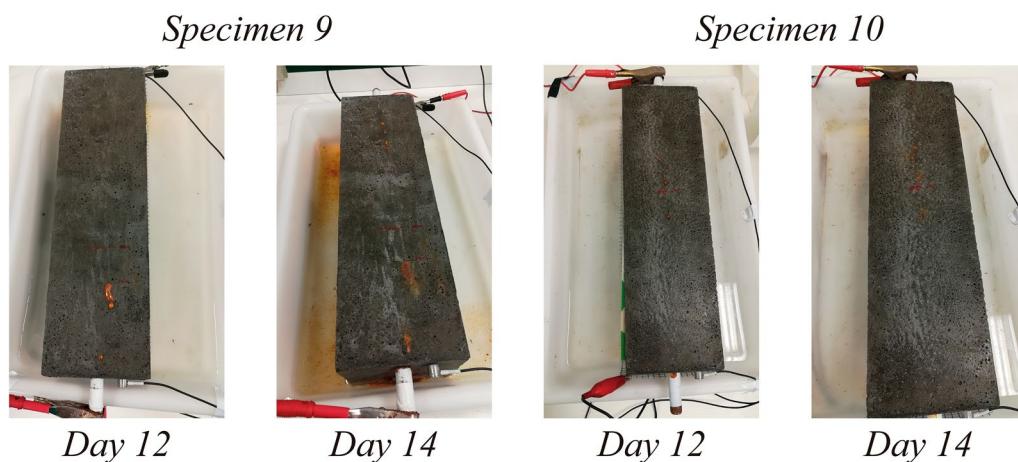
Fig. 9 Photos of specimens number 9 and 10 showing a difference of the intensity of the leaching out of steel corrosion products through the open cracks.

Another remarkable observation regarding the accelerated corrosion tests is that after the appearance of the open crack on top of the mortar specimens, a reddish viscous liquid, containing also solid steel corrosion products, leached out through the cracks; see Fig. 9. The pH of this liquid was 3, because of the hydrolysis reaction caused by the iron ions in solution (Andrade et al. 1993; Climent et al. 2019). This implies that a net mass transport process is taking place through the mortar specimens. It is known that transport phenomena through porous media, for instance ion diffusion, are greatly enhanced in case of exposure to a humid environment (Climent et al. 1998). Furthermore, a convective transport process can take place due to liquid wick action through concrete (Aldred et al. 2004), in the case of experimental conditions like those in this work: contact with liquid water at the lower part of the mortar specimen and exposure of the rest of surfaces to an atmosphere of relative humidity lower than 100%. The net transport of water from the bottom of the specimen to the upper surfaces drags the steel corrosion products first filling the cracks and finally making them appear at the openings of the cracks on the top surface; see Figs. 7, 9. However, it was observed that the leaching phenomenon was of different intensity for the various specimens under test. Figure 9 clearly shows that the leaching appeared earlier and with a much higher intensity for specimen number 9 than for specimen number 10. See the upper surfaces of both specimens at the 12th and 14th days of testing, and the much higher accumulation of reddish iron corrosion products in the plastic tray supporting specimen 9. The most likely explanation for this different intensity of the leaching of corrosion products is a possible difference in the compaction of the reinforced cement mortar specimens. It must be recalled that the compaction was done manually, see Sect. 2.1. It is possible that if the steel–mortar interface was less compact and more imperfect in some case (specimen 9), the dragging of corrosion species formed at the steel surface may have been more efficient, thus leading to a quicker filling of the cracks and to a more intense leaching out of corrosion products.

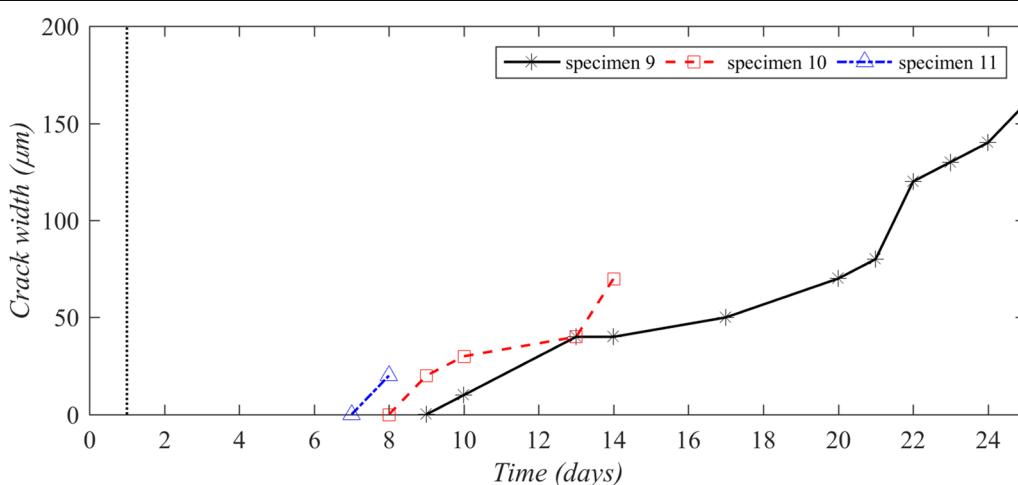
Fig. 10 Crack width evolution measured for the three specimens.

Figure 10 depicts the evolution of the crack width for the mortar specimens, as a function of time. The cracking of concrete due to stresses caused by corrosion of embedded steel has been classically described as consisting of a short period during which no crack is visible; the generation step, followed by an approximately linear

of increased non-linear features associated with these changes of slope in Fig. 10.

parameters were clearly higher than the tenfold threshold in the period between the 7th and the 10th days of measurements. Looking at Fig. 10, it is appreciable that this period correspond to the few days around the moment of first observation of the surface crack on top of specimen 10 (9th day). However, after the 10th day the relative values of Bn and Bpn returned to the region below the tenfold threshold, except for a single measurement obtained on the 13th day. Finally, the results corresponding to specimen 9 (black star points in Fig. 12) show a different behavior: the relative values of Bn and Bpn did not exceed the threshold during the days around the first observation of a crack on top of specimen 9 (10th day). Instead, the parameters reached values much higher than the tenfold threshold during the period between the 15th and 21st days. It should be noted from Fig. 10 that these days preceded a clear change of slope in the evolution of the surface crack width growth, observed between the 21st and 22nd days for specimen 9. Hence, it is highly probable that all the observed strong increases of the values of the relative values of Bn and Bpn exceeding the arbitrary threshold, may be correlated with damage of the material related to the corrosion process: creation of a new open crack or creation of new void space by considerable enlargement of the width of an existing crack (Shah and Ribakov 2009b; Climent et al. 2019). Another observation appreciable from Fig. 12 is that the parameter Bpn (related to the third harmonic) seems to be comparatively more sensible than the parameter Bn

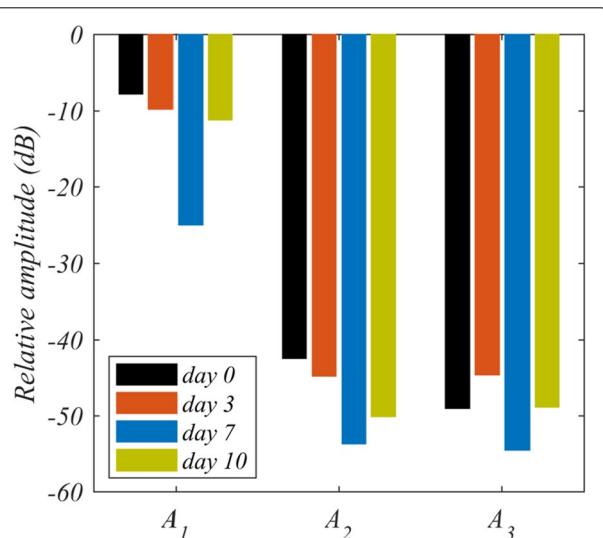
Fig. 11 Relative amplitude evolution of the main components of the frequency spectrum of the received signal for specimen 10 (transducer emitter excited with 180 V). A_1 : relative amplitude of the fundamental frequency ($f_1=30$ kHz). A_2 and A_3 : relative amplitudes of the second and third harmonics, respectively, ($f_2=60$ kHz and $f_3=90$ kHz).

Figure 11 shows the results derived from the analysis of the frequency spectra of the received signals corresponding to specimen 10. The results correspond to the day 0 (before the onset of the corrosion test), and the days 3, 7 and 10. The relative amplitude of the components of each frequency spectrum was always calculated taking the reference amplitude (A_{ref}) as equal to 1 V. Hence, the relative value of any amplitude (A) depicted in Fig. 11 has been calculated according to the following expression:

the first visible crack due to steel corrosion was detected on the surface of specimen 10 at the ninth day (Fig. 10 and Table 2). Regarding the evolutions of the relative amplitudes in Fig. 11, it is appreciable that on the third day small differences were found in comparison with the day 0 (before the onset of the corrosion test): the fundamental amplitude decreased slightly, and the harmonics' amplitudes also showed small differences with their amplitudes at the day 0. However, on the 7th day, 2 days before the visible appearance of the micro-crack at the surface of the mortar specimen, a strong decrease of the fundamental amplitude (about 20 dB) was observed together with comparatively lower (about 10 dB) reductions of the amplitudes of the harmonics. These differences can be clearly ascribed to harmonic distortion phenomena. Three days later (10th day) the relative values of the amplitudes returned to values close to those found on the 3rd day. The observations on the 7th day are compatible with a strong increase of the non-linear elastic features: previous publications have clearly shown that the effects of a non-linear elastic feature on the amplitude of the fundamental frequency component of the signal are much stronger than those on the second- and third-order harmonic components (Scaleraudi et al. 2008). It is reasonable to interpret that on the 7th day, few days before the observation of the first visible surface fissure, the micro-cracks were actively developing at the cement mortar cover region over the corroding steel rebar. This observation points out to the possibility that the NLU measurements may provide an early warning of the cracking due to steel corrosion.

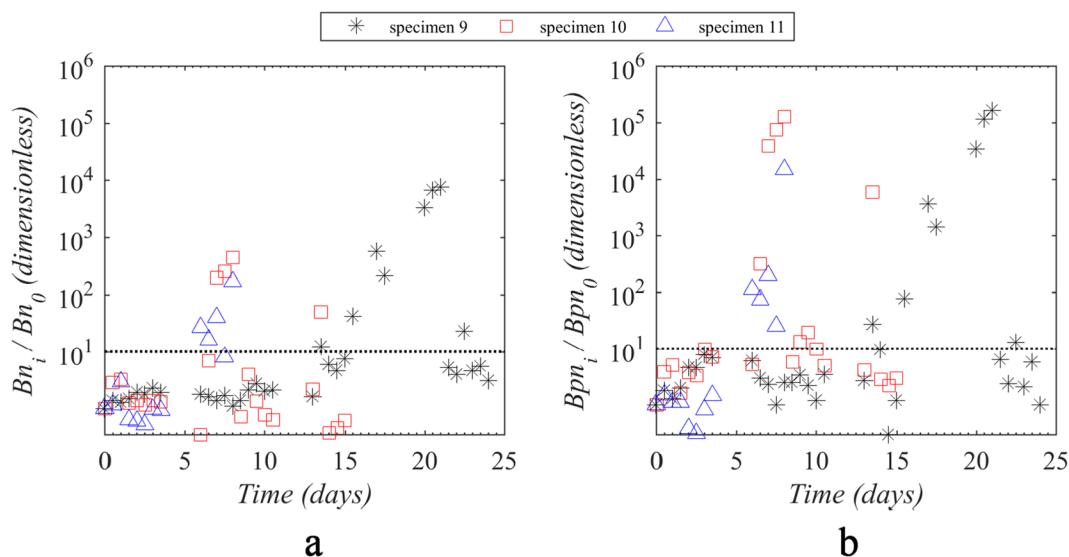
Fig. 12 Evolution of the parameters Bn and Bpn , normalized to their initial values ($t=0$), during the tests of the three reinforced cement mortar specimens (transducer emitter excited with 180 V). The dotted horizontal line represents the arbitrary threshold considered as indicative of a critical increase of the non-linear elastic features, see text for details.

Figure 12 shows the variations of the relative values of the parameters B_n and B_{pn} during the tests of the three reinforced mortar specimens. Any value in the figure is normalized to its corresponding value at ($t=0$). It must be recalled that the values of these B_n and B_{pn} parameters are proportional to those of the rigorously defined non-linearity parameters; see Sect. 2.4. Previously it was proposed a tenfold increase relative to the initial values of these parameters, as the arbitrary threshold for considering a critical increase of the non-linear elastic features, which in turn would be indicative of the presence of significant defects or damage in the material medium (Climent et al. 2019). This threshold is indicated as dotted horizontal lines in the plots of Fig. 12. Regarding the results corresponding to specimen 11 (blue triangle points in Fig. 12), the relative parameters exceeded clearly the arbitrary threshold for the measurements taken during the interval between the 6th and the 8th day when a visible crack was first observed at the upper surface of specimen 11; see Table 2 and Fig. 10. As for the results of specimen 10 (red square points in Fig. 12), the relative

(related to the second harmonic) for detecting the non-linear features associated with damage due to embedded steel corrosion in cement mortar.

Two issues remain unsolved in the preceding paragraphs. The first is the different behavior observed for specimen 9 in Figs. 12, 14, during the days 6th to 10th: the values of the relative parameters Bn and Bpn corresponding to this specimen did not exceed the tenfold threshold, and its values of the parameter DIFA did not drop to values close to 0. The second question is related with the ubiquitous observation that after the critical events of the cracking process, put in evidence by strong

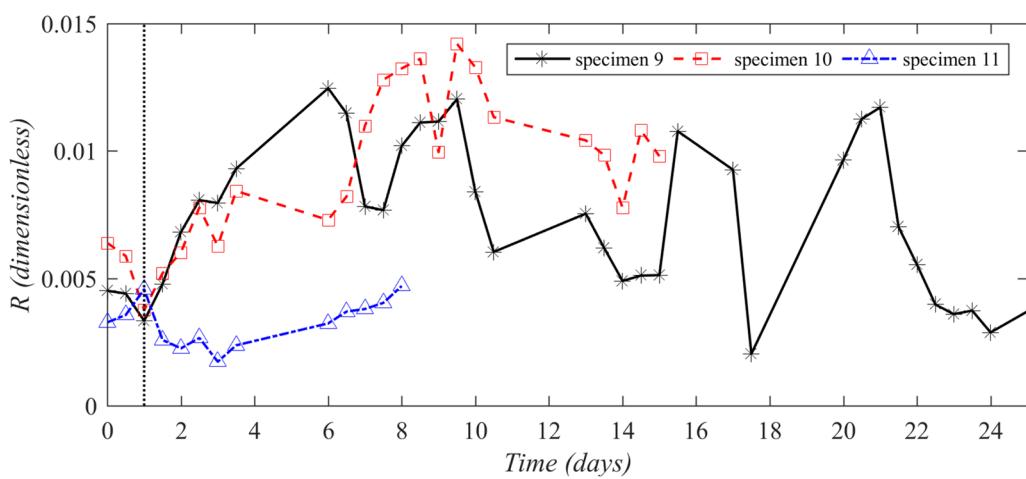
Fig. 13 Evolutions of the values of parameter R with time. The emitter transducer was supplied with two tones at the same time ($f_1 = 30$ kHz, $f_0 = 2$ kHz), and excited with 180 V. The vertical line ($t = 1$ day) indicates the onset of the accelerated corrosion test.

As for the experiments of intermodulation, Fig. 13, Fig. 14 depict the evolutions with time of the values of parameters R and $DIFA$, respectively. The parameters are defined in Sect. 2.4, Eq. (1) and Eq. (2), respectively. Regarding the intensity modulation ratio, Fig. 13 shows rather clear progressive increases of the values of R during the critical time periods related with the cracking due to corrosion: for specimens 9 and 10, R started to increase just after the onset of the accelerated corrosion test, from days 1st to 9th, i.e., during the period when the micro-cracks are thought to be developing before coalescing into an open crack, which was visible on the upper surface at the 10th and 9th days for specimens 9 and 10, respectively (Table 2 and Fig. 10). The results of specimen 11 were less clear in this sense. Furthermore, another maintained progressive increase of R is observed for specimen 9 during the days 17th to 21st in parallel with the observation of high values of the relative Bpn parameter of specimen 9 in Fig. 12. It should be noted also that after these periods of progressive increase of R , its values decrease to lower values, making Fig. 13 to look like a saw-teeth graph. It seems that the IMD phenomena might be present long before the first observation of cracking, although some uncertainty remains regarding some results showing small increases of R (specimen 11).

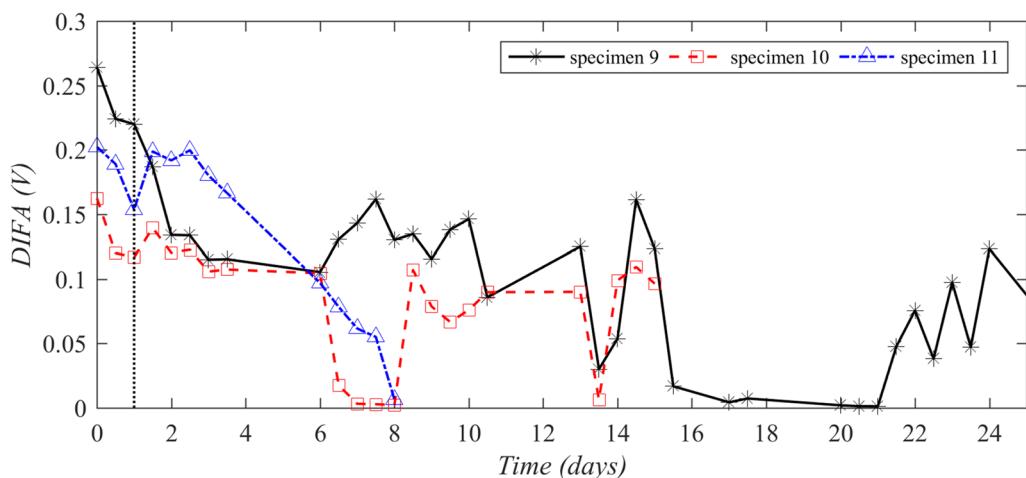
Fig. 14 Evolutions of values of the parameter DIFA with time. The vertical line ($t = 1$ day) indicates the onset of the accelerated corrosion test.

Figure 14 shows the variations of the parameter $DIFA$ as a function of time for the tests of the reinforced mortar

specimens. It is appreciable that after the onset of current passing slight decreases of the parameter were observed for the three specimens. However, the most relevant variations were recorded between the days 6th and 8th for the specimens 10 and 11, and between the days 15th to 21st for specimen 9. During these latter periods the parameter DIFA dropped rather abruptly to very low values, close to 0, thus indicating a strong non-linear elastic response. This feature is not so evident when analyzing the evolutions of the dimensionless relative parameter R with time (Fig. 13). An excellent correlation may be noted between the periods of very low values of DIFA (Fig. 14), and those of high values of the relative parameters Bn and Bpn exceeding the arbitrarily chosen threshold (Fig. 12).

Again, it is noticeable in Fig. 14 that after the periods of very low values, the parameter DIFA returns to intermediate values (about 0.1 V in these experiments) typical of the situation previous to the critical events of the cracking process.
