Experimental Study on Existing RC Circular Members Under Unequal Lateral Impact Train Collision

Abstract

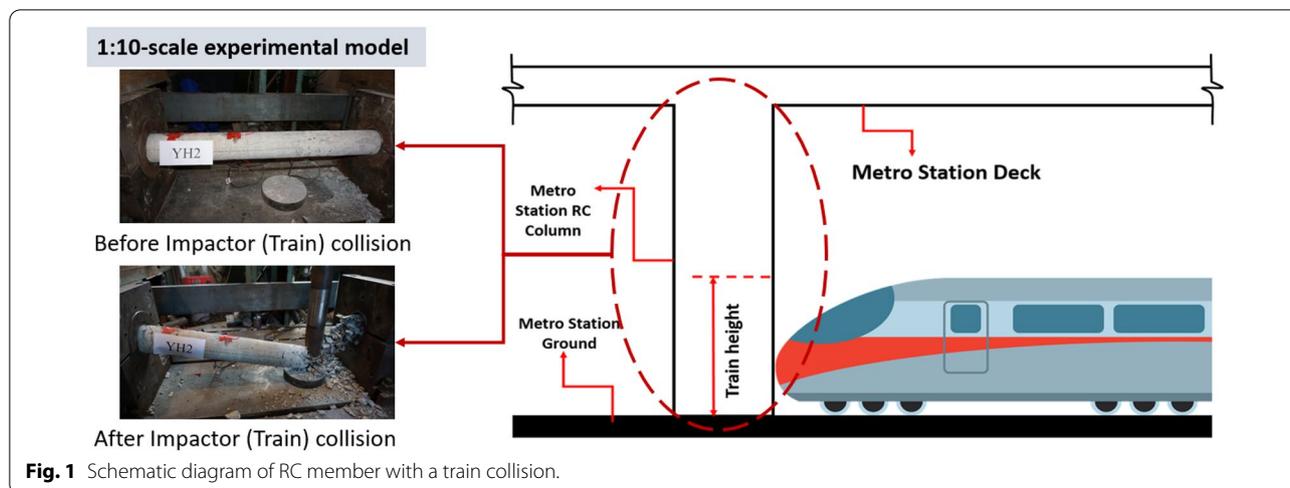
Fig. 1 Schematic diagram of RC member with a train collision.

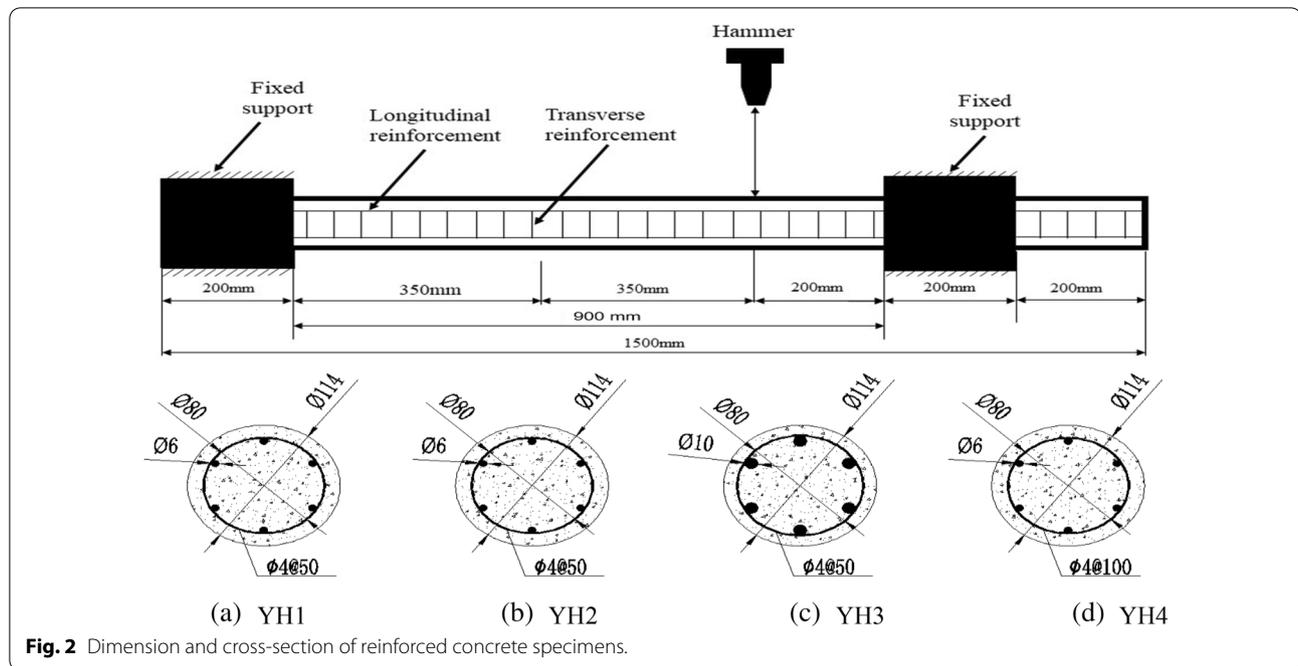
Fig. 2 Dimension and cross-section of reinforced concrete specimens.

The specimen's cross-sectional diameter is 114 mm, and each test specimen has 6 HRB235 steel bars evenly distributed along the specimen's ring direction, as illustrated in Fig. 2. The stirrup has a 4 mm diameter. A smooth steel bar is used instead of a hot-rolled ribbed steel bar since finding one with a diameter of 4 mm is difficult. The thickness of the concrete cover is 12 mm. Table 1 lists the dimensions and reinforcing details of the specimens. The reference specimen YH2 is utilized, and only one parameter differs from YH2 compared to the other specimens. The impact energy shown in Table 1 includes frictional energy loss, computed using energy conservation principles. Referring to the effect of the bonding strength influence, the term bond commonly refers to the adhesion between concrete and steel, which resist the slipping of steel bar from the concrete (Alharbi et al., 2021). This bond is responsible for transferring stresses from steel to concrete, thereby providing composite action of steel and concrete in RC members. The structural behavior of reinforced concrete elements requires the interaction between steel reinforcement and concrete. Impact forces in the area of separating cracks and bending cracks are carried by the reinforcement and transferred into concrete by bond action.

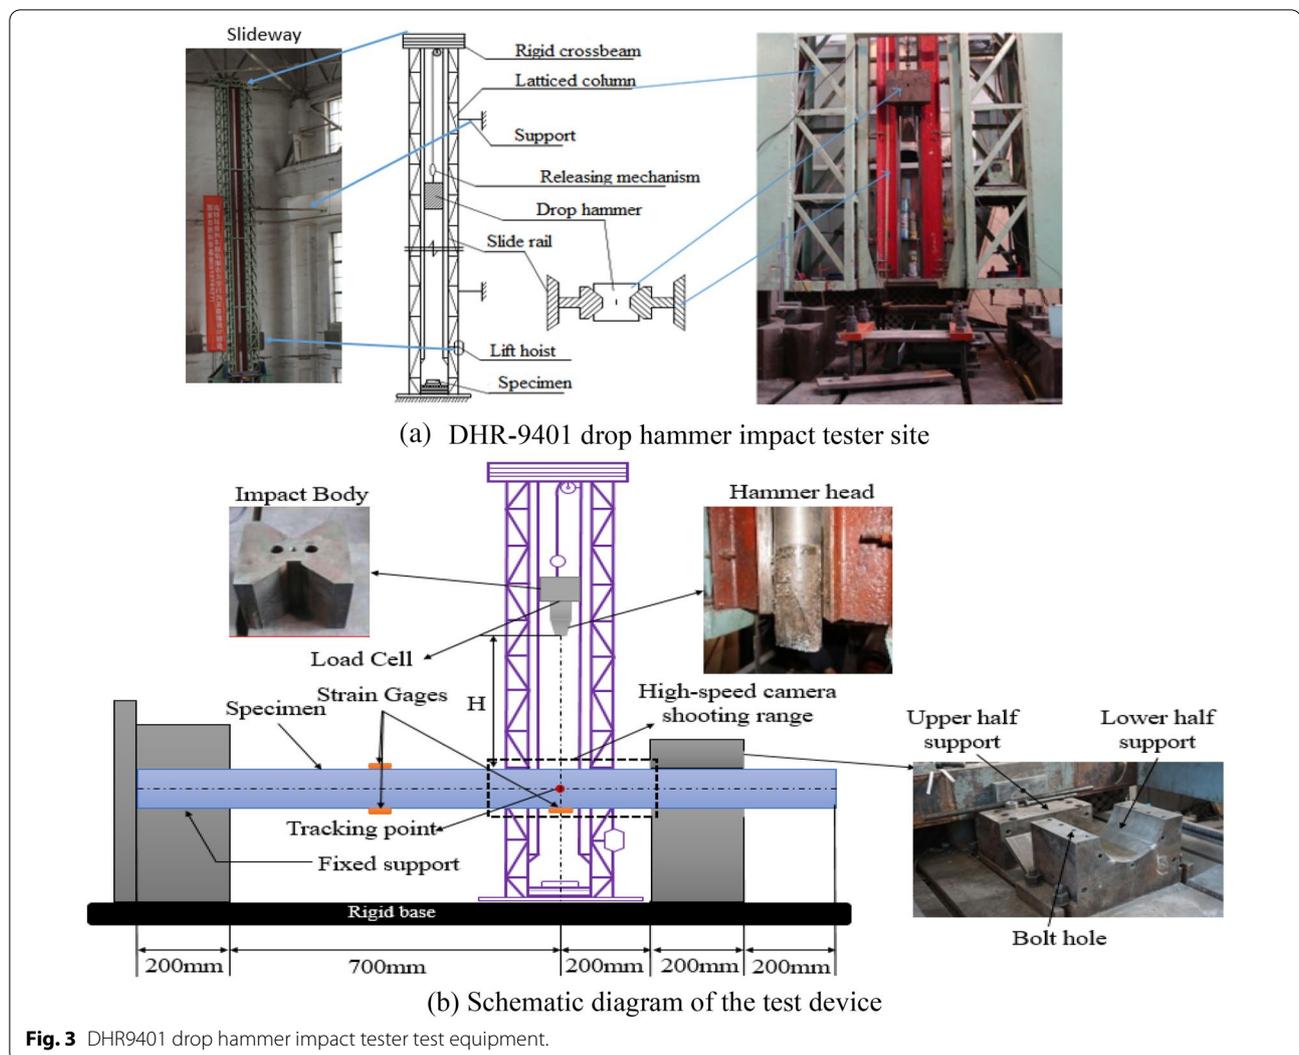
This impact test was completed on the DHR9401 drop hammer impact-testing machine, as shown in Fig. 3.

The height of the DHR9401 drop hammer slideway is 13.47 m, the effective drop distance is 12.60 m, and the corresponding impact velocity can reach a maximum of 15.7 m/s, which can meet the requirements of low-speed impact-testing in a wide range. According to energy conservation, the impact height was chosen as 2.0 m; thus, the impact velocity was calculated as 6.26 m/s. The test frame is a portal frame composed of two vertical lattice steel columns and rigid beams. The frame is connected to the surrounding buildings through multiple supports and has good overall rigidity. The inner side of the rigid frame column is provided with a steel rail slide. The slide has a surface roughness of 0.8 after grinding. The drop hammer with a "V" groove adopts a sliding fit with the track. The error of the track along the entire height direction is only (2 mm). The body falls smoothly, the impact velocity of the drop hammer is very repeatable, and the error is within 2% compared with the calculation as shown in Fig. 3a. The drop weight is lifted by a small hoist driven by

As shown in Fig. 3b of the device, the mass of the striker weights can be adjusted arbitrarily within the

range of (2~270 kg) and matched with the corresponding height to meet the impact energy requirements. The impact body is composed of a drop hammer and an impact head. The drop hammer is made of (45# forged steel); the impact head comprises large-strength chromium 15 (64HRC). Conspicuously, the striker weights (impact body, load cell, and impact head) weighed 270 kg. The test's drop mass and height were chosen based on a locomotive's mass (64 t) and train speed (80 km/h) while passing stations. The test was 1:10 scale, the impact energy was estimated to be (15.8 kJ). The shape of the impact head is a rectangular parallelepiped face, and the size is 80 mm × 30 mm × 80 mm. The contact surface size is 30 mm × 80 mm. The total weight of the striker in this test is 270 kg. A load cells sensor is placed between the impact head and the drop hammer to measure the impact force. The test specimen support is made of (Q235) steel. The support is

divided into upper and lower parts (Fig. 3b), and there is a bolts connection between the upper and lower parts. The bolts provide pre-tightening force for the two parts of the support, effectively improving the friction between the support and the test specimen. To a certain extent, it can restrain the component from moving in the axial direction. Fig. 3a shows the assembly diagram of each component of the impact test site.

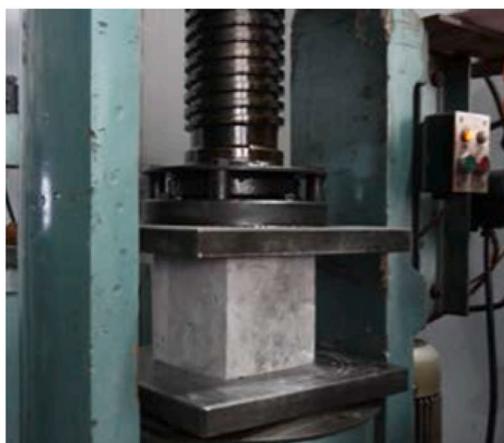
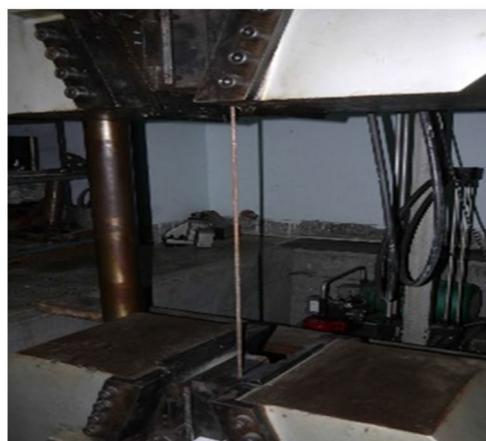
(a) Cube uniaxial compression test

(b) Steel bar tensile test

Fig. 4 Concrete and steel bar material test.

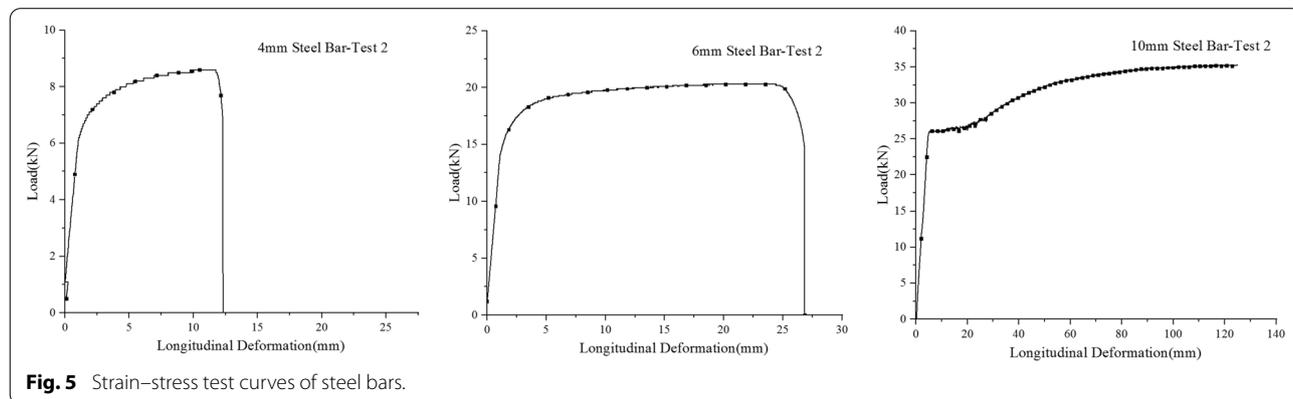
Fig. 5 Strain–stress test curves of steel bars.

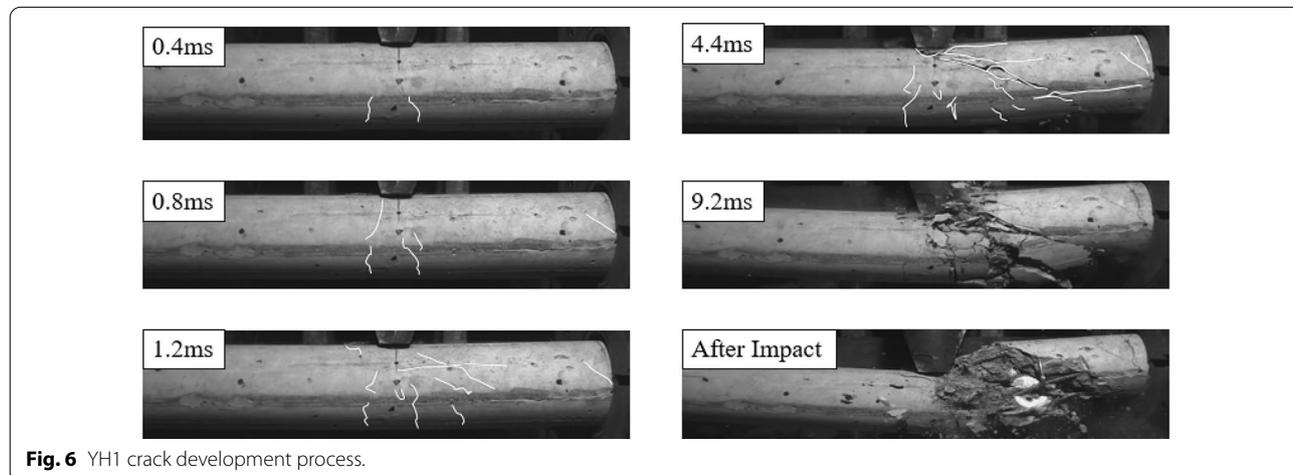
Fig. 6 YH1 crack development process.

at 0.4 ms, and it appeared on the bottom right of the impact point. After a short vertical extension, the tendency is to expand toward the impact point.

A 36.5° main diagonal crack appeared in the shear span to the right of the impact point, and new vertical cracks started to emerge near the specimen's bottom. The concrete at the impact location was still undamaged. This resulted in a 36.5° failure surface on the right side of the impact point, indicating that the specimen was fractured. By 9.2 ms, a web of vertical and oblique cracks had developed between the impact point and the failure surface, concrete fragments had splattered, and steel bars had been revealed. After the impact, the concrete shattered into a powder, the steel bars bent but did not break, holding the fractured concrete together, and the stirrups remained intact. Overall, the specimen is severely damaged, but only between the impact point and the damaged surface.

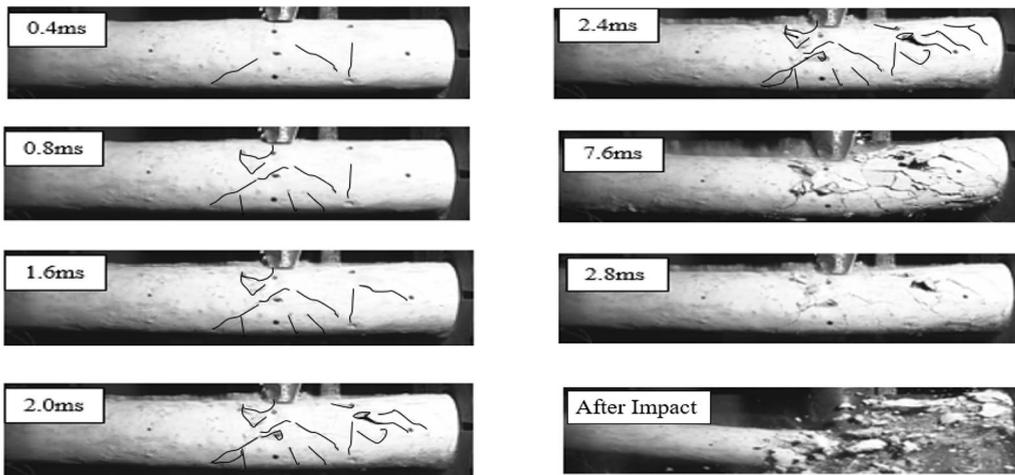
Fig. 7 YH2 crack development process.

Fig. 7 shows the YH2 crack development under impact velocity 6.26 m/s and impact mass 270 kg. At (0.4 ms) after the impact head contacts the specimen, two symmetrical diagonal cracks emerge at the impact point. Vertical cracks extend from the top and bottom of the specimen on the left side of the impact point to the middle of the specimen. Near the impact point, many vertical cracks emerged at (0.8 ms). The concrete was substantially maintained at this time. Aside from the impact point, three parallel 51° diagonal cracks occurred on the support at 1.6 ms. The oblique cracks in the shear span initially extended at 51° from the specimen middle to the top and bottom. Two diagonal cracks are distributed on its right side; one starts from the middle of the specimen and faces the support, the bottom extends, and the other extends to the top of the specimen at the center axis of the right end support. The concrete cover between the impact body and the specimen has peeled off. At 2.0 ms, a 51° diagonal shear crack appeared. The crack extended up to the impact point and down to the right end support in 0.4 ms. The initial crack altered as it approached the top and bottom of the specimen. At 2.4 ms, the extension direction develops horizontally, forming a surface thoroughly. At 2.8 ms, new vertical cracks emerged at the region's bottom between the impact point and the right end support. In addition, the two diagonal cracks in contact with the support extended to inside the support. At this stage, intertwined cracks split concrete into desired shapes, and many through cracks cause concrete near the support to be divided into blocks. Some of the smaller concrete blocks collapsed. Until 7.6 ms, the concrete splattered, and the right support's steel bars were visible. Since the concrete failed, the impact energy was transferred to the steel bars, which started to pull the inner part of the right support to the left. So, after the collision,

the specimen's concrete is severely damaged and crushed, and the support's fixed part is pushed out for a distance.

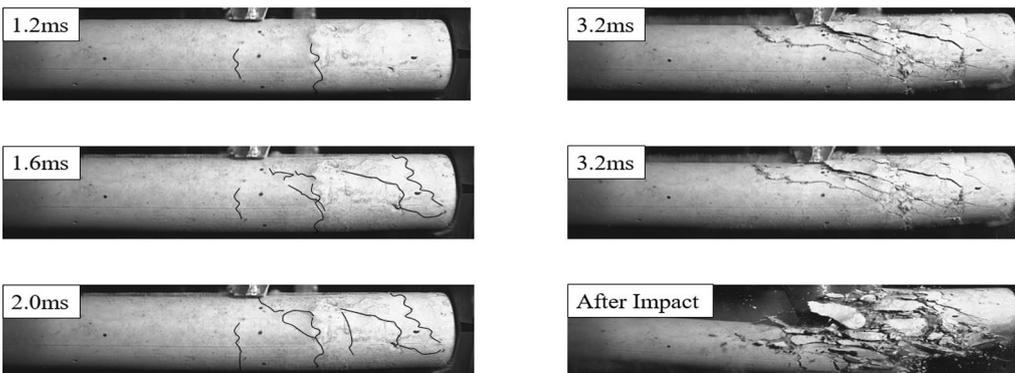
Fig. 8 YH3 crack development process.

Fig. 8 shows the crack development of YH3 at 6.26 m/s and 270 kg. At 0.4 ms, a vertical crack emerges just below the impact point, reaching the cross-3/5 section's height. A 56° oblique crack developed on the right side of the impact point, towards the impact point and the specimen's bottom. It was discovered at 0.8 ms that a 35° diagonal crack had developed in the shear span, between the impact point and the bottom of the right end support. There were two oblique cracks from the bottom of the right end support to the impact point at 27.5° and 56.5°, and a vertical fracture on the top right end support. At 1.2 ms, a 38° oblique major crack developed from the center to the impact point to the bottom of the specimen. However, the primary oblique crack penetrates at 1.6 ms.

On the support's bottom, the 27.5° oblique crack enters the 35° oblique crack next to it, and the top end continues to expand toward the impact point. The vertical cracks developed are neither extending nor widening. At 2.0 ms, as the shear span was increased, additional minor diagonal fractures emerged near the bearing on the right. Three through surfaces develop in 3.2 ms. At 3.6 ms, when the concrete between the through cracks splits into blocks, it loses strength. The steel bars bear the weight of the specimen and the impact body, causing the longitudinal bars to pull and drag the right end support to the left. The concrete from the right side to the failure surface collapsed, but the steel bars held firm. The specimen is severely damaged between the impact point and the damaged surface.

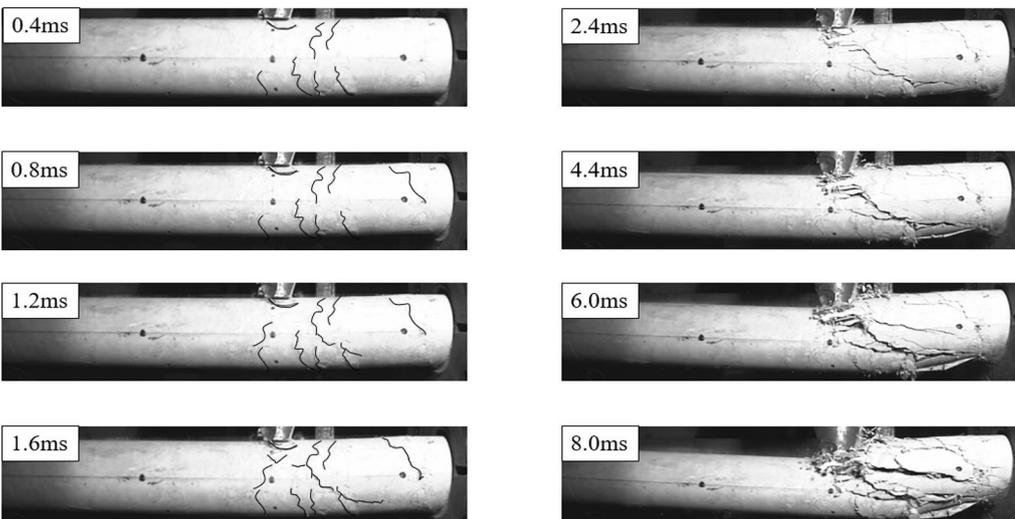
Fig. 9 YH4 crack development process.

Fig. 9 depicts YH4 crack growth at 6.26 m/s and 270 kg. At 0.4 ms, the concrete cover layer is crushed at the impact point; many vertical cracks develop between the supports on the right side of the impact point. An up-and-down 60° major oblique crack appeared at 0.8 ms, at the shear span right of the impact point. The specimen's top and the central axis were both reached by a 56° oblique crack. In the 1.2 ms period, the right side vertical cracks on the impact point gradually merged, and the remaining vertical cracks on the impact point continued to extend to the impact point; the 60° main oblique crack's upper and lower ends changed development trends, with the lower end first extending in the direction of a 36° angle, and then both upper and lower ends developing horizontally, continuing to rise.

At 1.6 ms, the top end of the main oblique crack enters the compression crack, and the main diagonal crack penetrates. After 2.4 ms, the failure surface expanded, and the specimen's bottom concrete was split longitudinally. For the right side of the impact point, only steel bars supported the concrete. After 2.4 ms, the failure surface continued to widen, and the concrete at the bottom of the specimen was

turn in the axial direction. The concrete had lost its bearing capacity for the right side of the impact point and was only borne by steel bars. A 26.5° oblique fracture occurred between the impact point and the right end support at 4.4 ms. At 6.0 ms, all oblique cracks are penetrated, and their lower ends reach the right end support and extend within. The concrete between the impact point and the right end support was shattered at 8.0 ms. The steel bar pushes the right end support out a distance, crushing the concrete between the impact point and the support and seriously cracking the pushed-out concrete in the support.

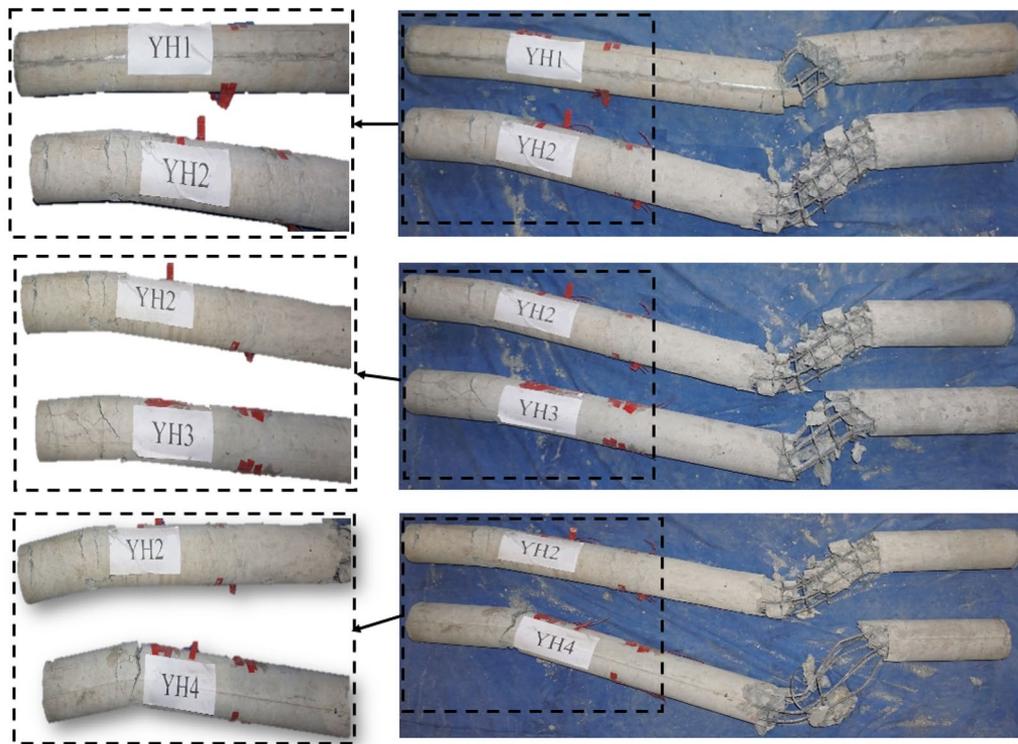
Fig. 11 Compares the failure modes of YH1, YH3, and YH4 with the control specimen YH2.

Fig. 11 shows comparison of failure mode for the specimens YH1, YH3, and YH4 with the control specimen YH2 as follows:

Aside from the impact height, YH1’s impact height is half that of YH2, and all other variables are the same. It has less vertical cracks, and its width is smaller than YH2, and the bottom of the left end of YH2 has been compressed, and the steel protective layer is partly peeled off. YH1 lacks this effect; just the impact point is visible. YH2 deflects more than YH1 in the left portion. Both specimens’ failure surfaces are produced to the right of the impact point. YH1’s failure surface extends to the impact point and shear span. Unlike YH1, YH2’s failure surface has been extended into the proximal support. Therefore, the right part of the damaged surface of YH1 stays reasonably undamaged, but the concrete of YH2 crashes from the impact point to the right end of the support area. The right end support’s inner fixed part is damaged. Two rings of stirrups are visible on YH1, and all stirrups from the YH2 impact point to the support are exposed. That seems to be, the impact height increases, as does the damage range. So, as impact height increases, the primary oblique crack bottom moves to the right. Having more vertical cracks causes greater damage locally and a wider impact range.

The reinforcement ratio of YH3 is 2.76 times that of YH2, and all other criteria are the same. Vertical crack YH2 extends to the center axis of the left end support, whereas the length of YH3 vertical crack is 1/3 of member height. The vertical crack stops growing downwards when it reaches 30 mm in length. YH2 has a higher deflection than YH3 in the left part of the impact point. Both specimens’ failure surfaces are to the right of the impact point. After the YH3

had been impacted, the cross-sections were complete, with upper and lower ends in the shear span. YH3's tensile length of longitudinal reinforcement is shorter than YH2's, and only three stirrup loops are visible. It illustrates that when the longitudinal reinforcement ratio increases, the local range damage decreases.

YH4 has half the hooping rate of YH2, and the other criteria are the same. This crack is wider and continues straight to the bottom longitudinal bar at the left end of the support. As a result of the compression, a part of the concrete is crushed, developing a vertical failure surface, and the specimen completely loses its supporting weight. Ability to immediately contact the barren ground after impact. Due to the decrease of stirrups, the section between the impact point and the damaged surface cannot bear greater force, and the undissipated energy is further supported to the right end via the steel bars. In YH4, the crack extension is wider than YH2 and reaches into the interior of the right end support due to the stirrup transmission. The stirrups in the concrete collapse area have collapsed. Increasing the hoop ratio increases the specimen's impact resistance.

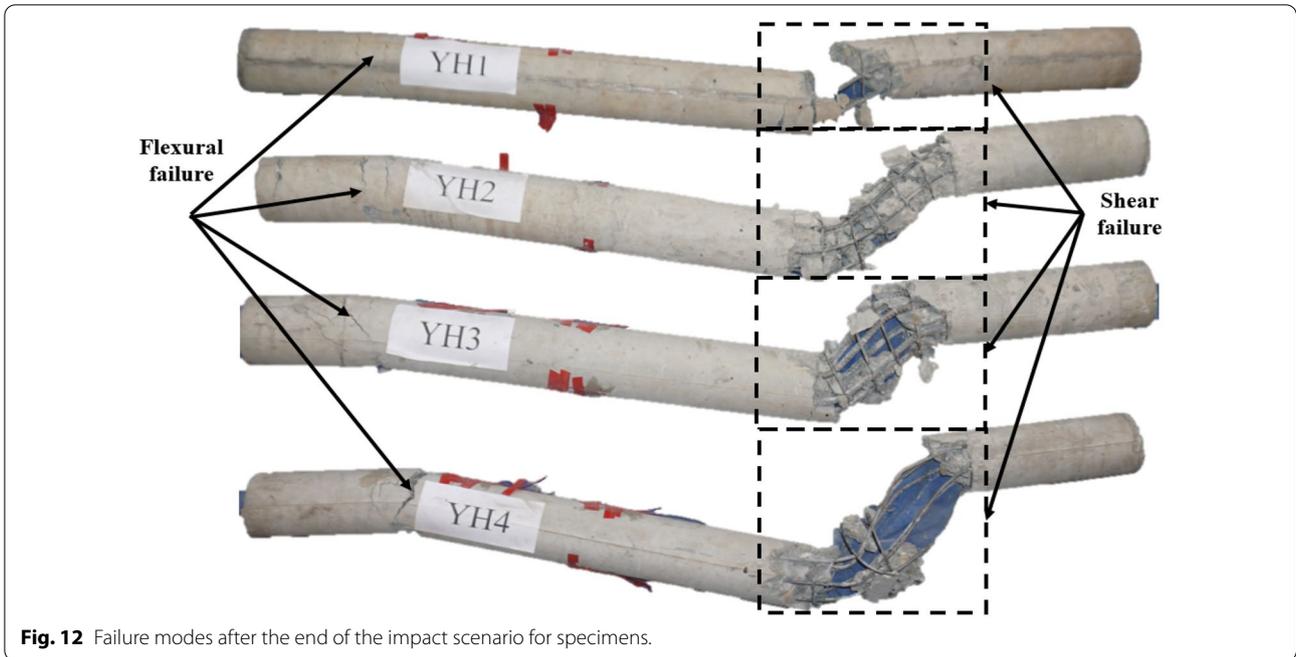
Fig. 12 Failure modes after the end of the impact scenario for specimens.

Fig. 12 shows the overall damage of specimens after impact load. It seems that all RC specimens have undergone devastating shear failure. The specimen is crashed to eliminate the concrete fragments' form. On the end of the specimen near the support, obvious shear oblique cracks penetrated and developed an oblique crack failure surface. Although vertical cracks appeared at the impact point's bottom and the support's left and right end, the impact point's bottom vertical crack did not expand. Due to the concrete failure between the impact point and the failure surface, the steel bar is stretched, and the specimen becomes a cantilever beam with force at both ends. A vertical crack appears on the support. The specimen's damaged areas are the left top of end support, the impact point to the failure surface, and the right top end support.

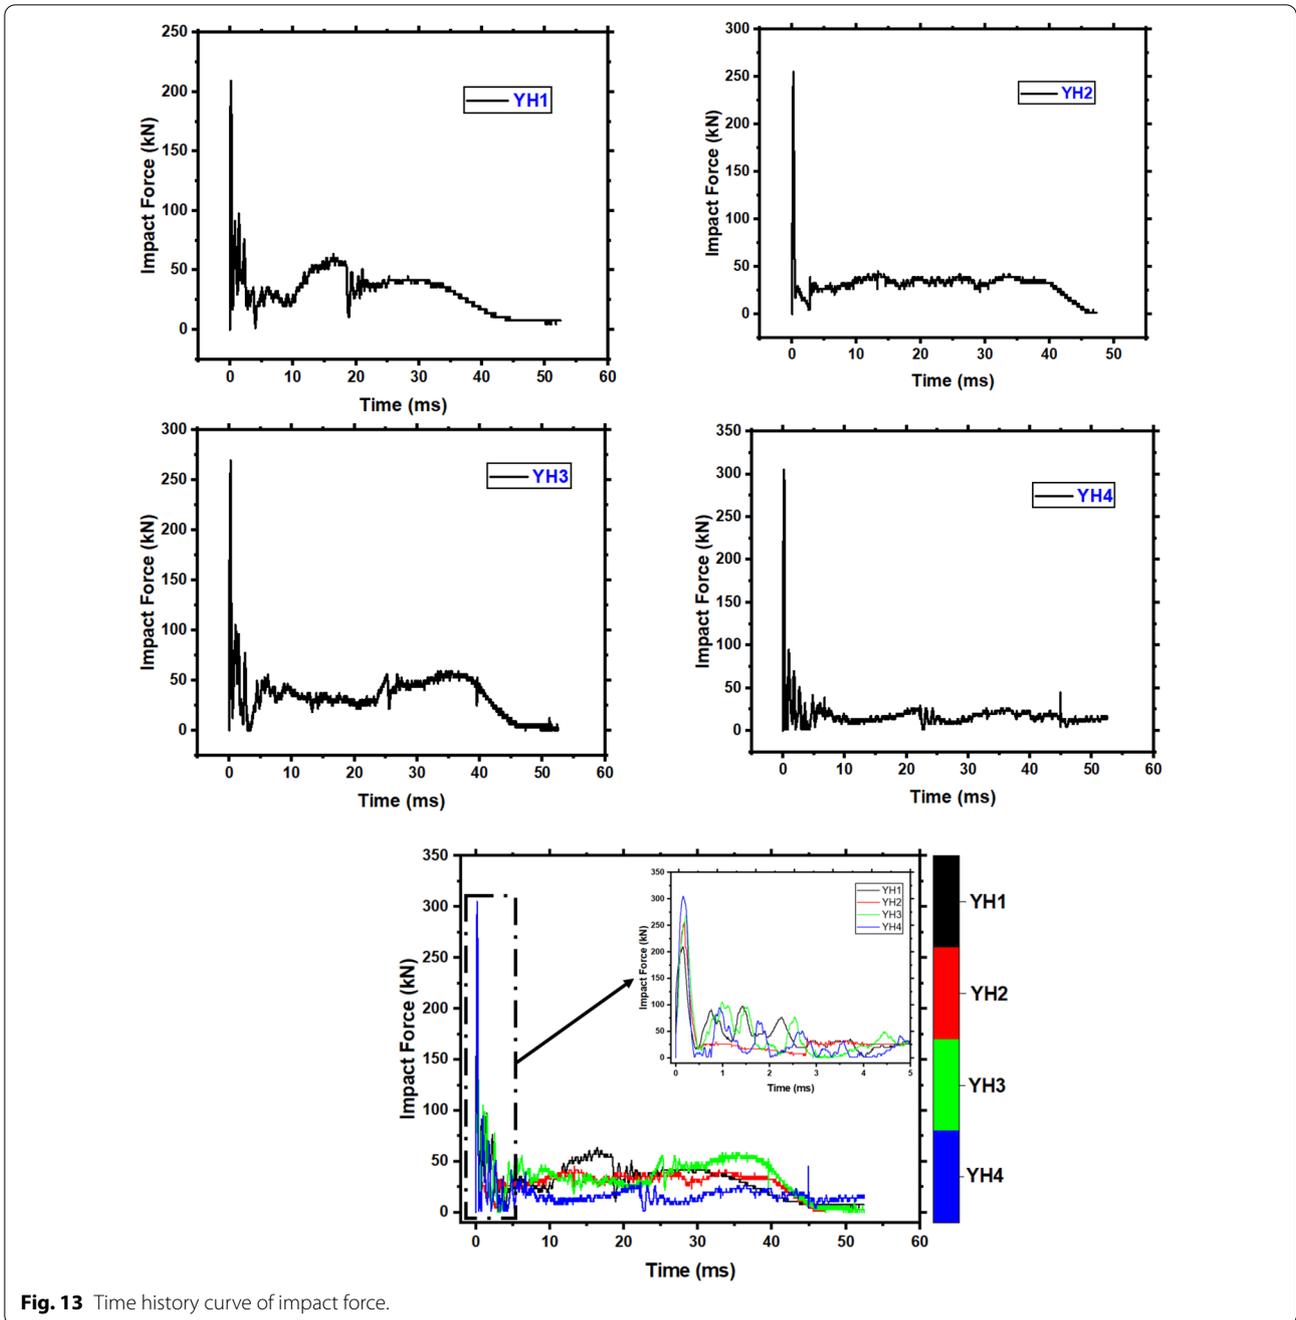
Fig. 13 Time history curve of impact force.

Impact force–time history curve is shown in Fig. 13 and can be roughly separated into three stages, as shown in the chart: (1) oscillation stage: at zero time, the impact body is in contact with the specimen, and the impact force rapidly achieves its highest value and then rapidly decays, resulting in a triangular pulse. (2) Stable stage: after the first peak value, the impact force varies within a particular range and lasts for a long time; this is the stage when most work is done. (3) Attenuation stage: after a steady stage, the impact force starts to attenuate and eventually drops to zero. Table 4 records the impact force’s specific peak value, the impact force plateau value (the average value of the impact force once it enters the stable phase), and time duration for specimens. It is the number of independent coordinates necessary to describe the masses’ displacement relative to their origin. SDOF systems have just one degree of freedom (degree of rigidity) in comparison to the affected members. The hammer’s equation of motion is:

In Eq. (2), v_0 is the hammer’s initial impact velocity. All specimens reach their maximal impact force in less than a second (5 ms). Although YH2 has double impact height, the peak impact force is 46kN higher than YH1. However, the impact force plateau was reduced by 5.37 kN, increasing the length (7 ms). Peak impact force increased by 14.47 kN, and plateau value increased by 5.98kN with increasing reinforcement ratio, but duration remained the same; YH2 was only 2 ms longer than YH3. Increasing the stirrups ratio reduces the impact force of YH2 by 50.13 kN, which is why the local stiffness of YH4 is greater than YH2. The specimen can bear more impact during hits. YH4’s platform value is 17.98 kN less than YH2, yet it lasts 5 ms longer. With the exception of YH2 and YH4, the impact force of YH1 and YH3 changes significantly in the platform stage and then rebounds strongly. The impact point and failure surface of the concrete collapsed parts of YH1 and YH3. However, the longitudinal bars of YH2 and YH4 has been revealed and increased. It seems that YH1 and YH3 steel bars are now yielding. For YH2 and YH4, when the failure surface is formed, the reinforcement provides the main resistance and enters the strengthening stage.

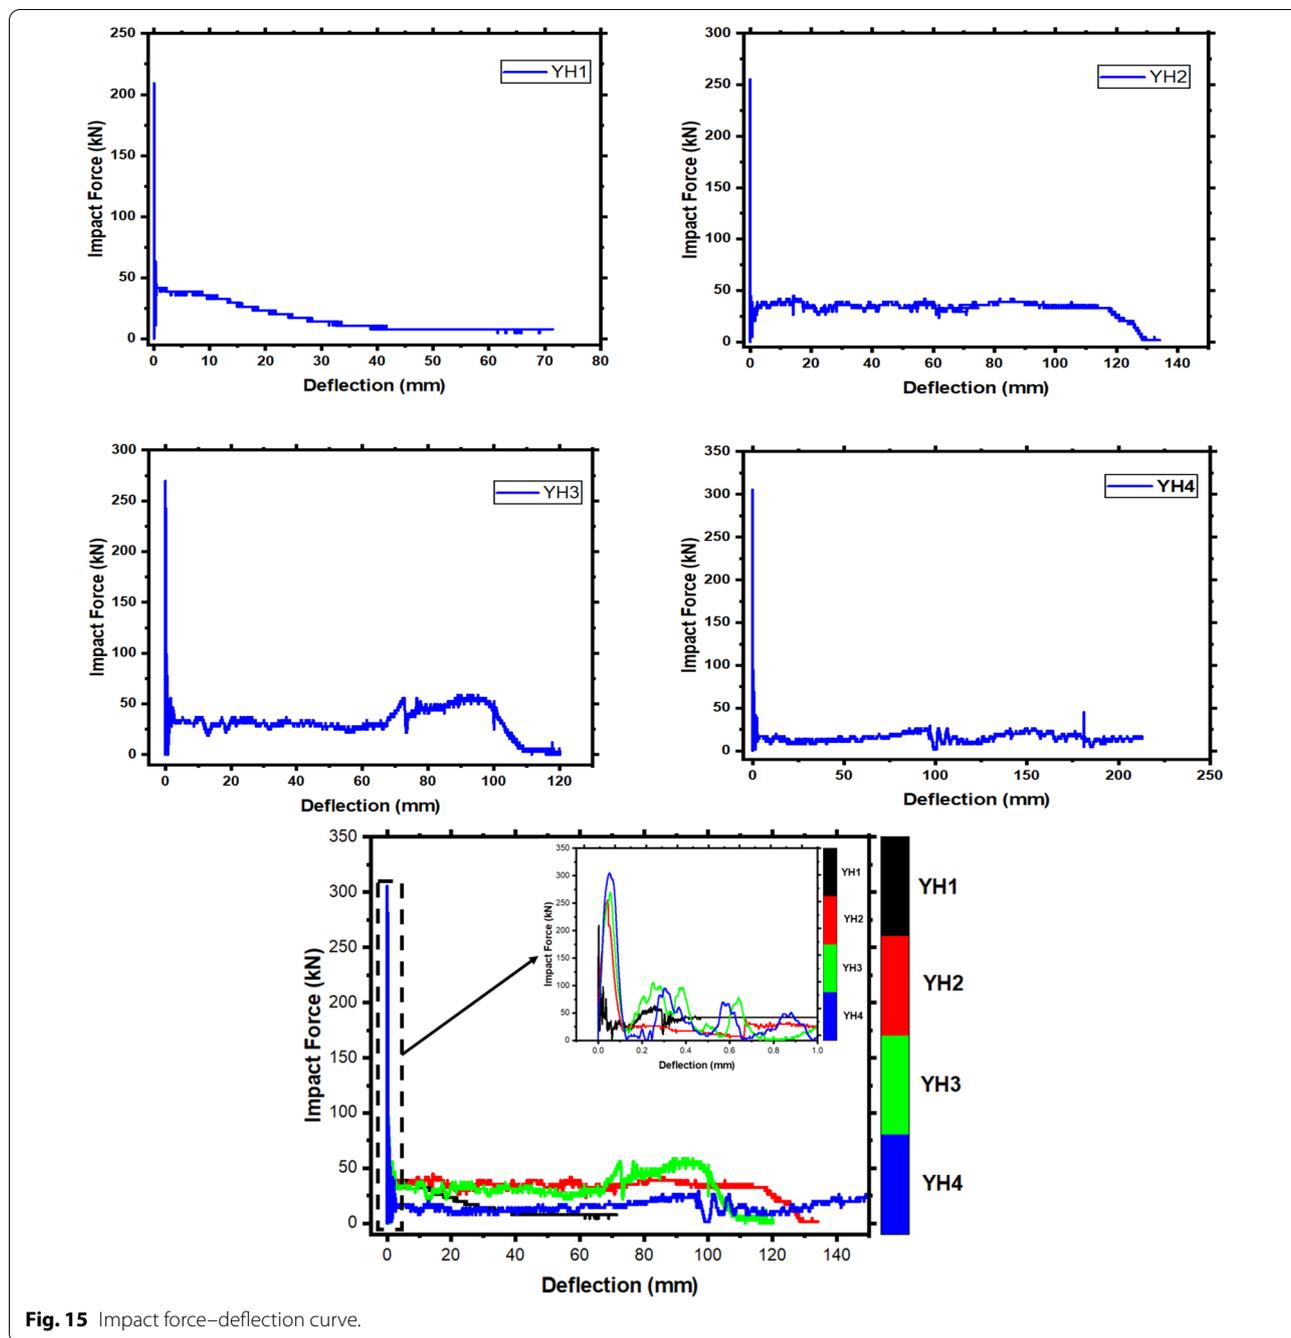
Fig. 15 Impact force–deflection curve.

To produce the impact–deflection curves, the impact force and deflection time histories were combined. The area under the curve represents the total energy consumed by the member during impact. Load–deflection

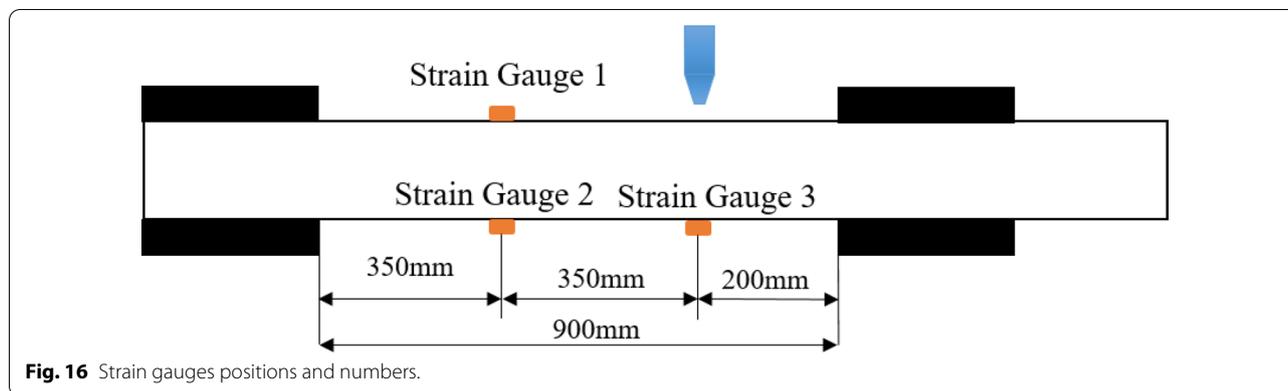
Fig. 16 Strain gauges positions and numbers.

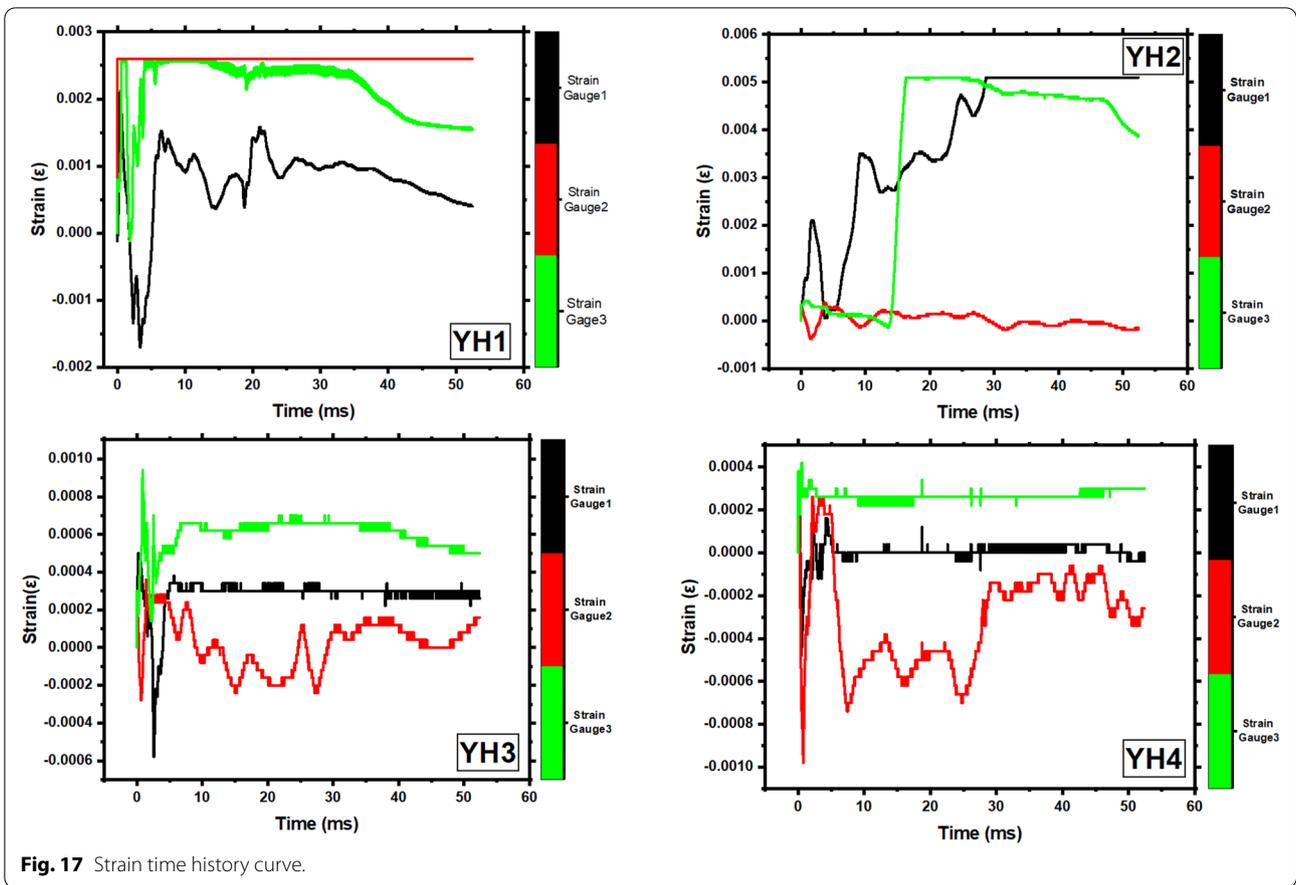
Fig. 17 Strain time history curve.

Since YH2 has a higher drop hammer than YH1, it is evident that this specimen has the maximum strain curve as measured by gauges 3 and 1. Due to the specimen fracture, strain gauge 2 records a minimum value, and no resistance seems to be recorded on strain gauge 2's position. The capacity of the YH3 specimen to record decrease and increase values between (0.00067 and 0.0005) over the period (7 ms to 55 ms) is explained by the high longitudinal reinforcement ratio at the impact point gauge strain value.

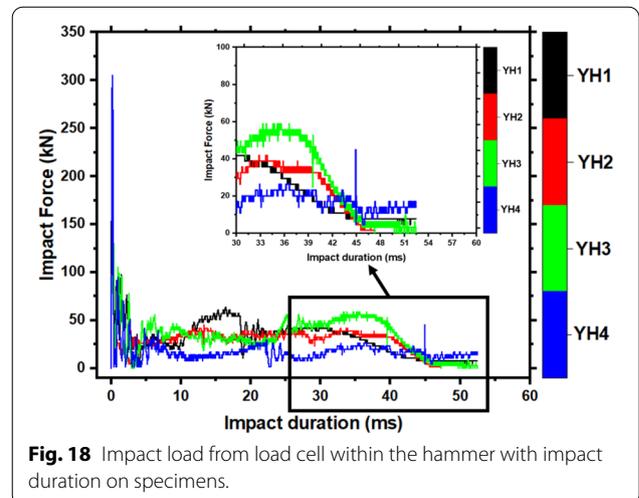
Fig. 18 Impact load from load cell within the hammer with impact duration on specimens.

A striker's entire period of contact (impact duration) is measured from first contact until separation. Fig. 18 reveals that the impact lasted much longer than the specimen's main natural period. The overall mass of

the specimen, including the striker mass, determines the total impact duration. During impact, the specimen deforms plastically. Plastic deformation extends the impact time. In a situation when the structure is subjected to a lateral force, the duration of the impact is determined exclusively by the damaged area (Zeinoddini et al., 2002).
