Effect of Mixing and Placing in Hot Weather on Hardened Concrete Properties

Abstract: Portland cement concrete exposed to high temperatures during mixing, transporting, casting, finishing, and curing can develop undesirable characteristics. Applicable requirements for such the hot weather concrete differ from country to country and government agencies. The current study is an attempt at evaluating the hardened properties of the concrete exposed to hot weather in fresh state. First of all, this study reviews the current state of understanding and practice for hot weather concrete placement in US and then roadway sites with suspected hot weather concrete problems were investigated. Core samples were obtained from the field locations and were analyzed by standard resonance frequency analysis and the boil test. Based on the results, there does not appear to be systematic evidence of frequent cracking problems related to high temperature placement. Thus, the suspicious deteriorations which are referable to hot weather concreting would be due to other factors.

Keywords: hot mix concrete, frequency resonance test, boil test, temperature limit, dynamic modulus, permeable pore space.

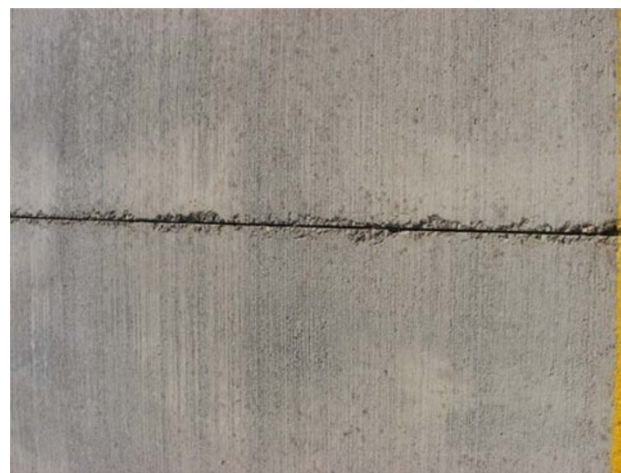
Fig. 3 Excessive joint spalling on the eastbound direction of Cruger Road, as well as poor surface texture.

Even though the concrete temperatures were lower during the pour of eastbound Cruger Road, it shows more deterioration than the westbound lane. The eastbound lane shows overworking of the surface, crazing, poor tining and surface texture, and very poor contraction joint quality. Whether related to warm weather or not, the joints were sawed too

early, and the edge of the joint was badly spalled. A poorly sawn joint and the poorly broomed texture can be seen in Fig. 3. Figure 4 shows a poor finished surface, and Fig. 5 shows an adequately finished surface for Cruger Road.

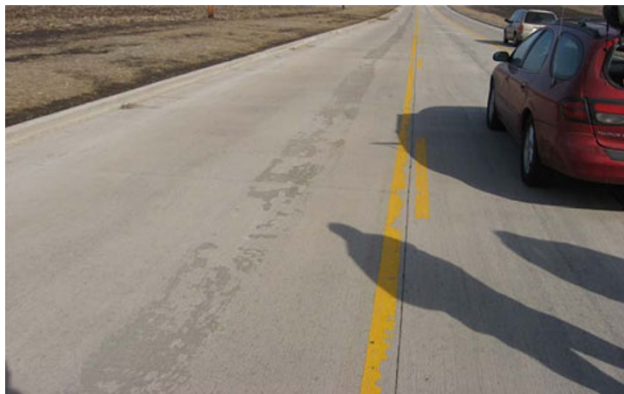
Fig. 5 Westbound Cruger Road with proper surface texture (*left lanes*). The discoloration in the westbound lane is merely a cosmetic flaw.

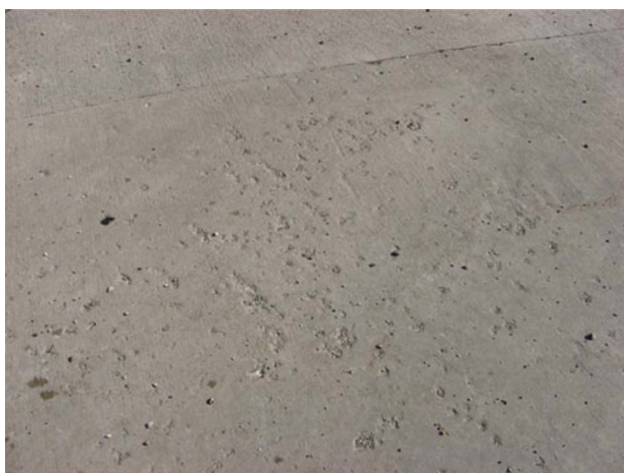
Fig. 6 No surface texture and significant pop-out distress.

These concrete slabs have almost no surface texture and significant pop-out distress across the entire surface. A petrographic examination was not done, but this could be the result of very poor air void structure at the surface, leading to

freezing damage during the winter. This damage can be seen in Fig. 6.

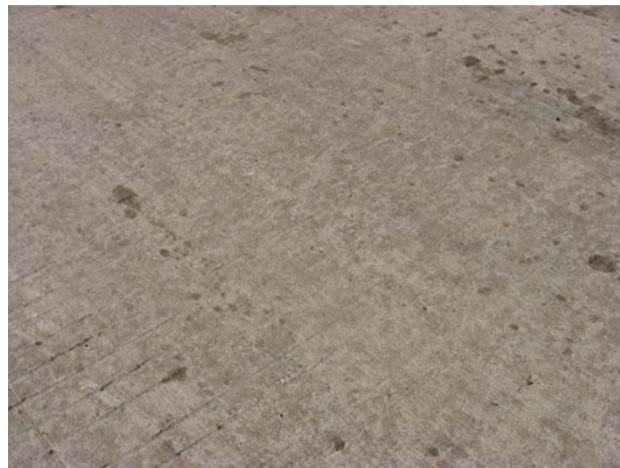
Fig. 7 Crazing and poor tining on exit ramp jointed concrete pavement.

As previously mentioned, the contractor was unable to put the proper texture into the concrete, so the surface is very smooth which is undesirable for proper skid resistance. This is especially problematic for a highway exit ramp where traffic needs to decelerate rapidly. In addition to the lack of proper tining, the concrete is starting to show some fine crazing.

Though this is not a problem yet, it could be worsened into surface scaling. This crazing is most likely due to the overworking of the surface by the finishers. This could have included addition of water to the surface to aid in finishing which ultimately weakens the surface concrete. The surface of the exit ramp concrete is shown below in Fig. 7.

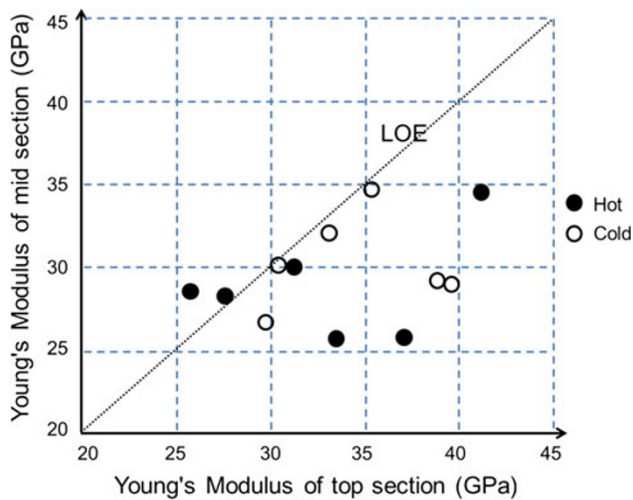
Fig. 8 Comparison of dynamic Young's modulus from top and mid sections of same cores: comparison with regard to plastic temperature across all aggregate types.

Table 6 shows the results for the 5 cm core samples. The data from the halved core samples were statistically analyzed, using the T test, in order to determine if there is a difference in E values between the upper section of the core sample (near the pavement surface) and the mid-section of the same core sample for different plastic concrete temperatures. The statistical data are shown in Table 6. Although relatively small sample population size and relatively high variance do limit the statistical analysis, some statistical inferences can be made using the T test as a basis. The data suggest that the top sections of the core samples have significantly higher E values, regardless of the plastic concrete temperature condition or aggregate type of the sample. The T test analysis confirms this, with over a 95 % confidence level: top sections of the samples show higher E , regardless of other attributes. This outcome of the test was not expected since high temperatures at the surface would create more near surface problems than towards the middle of the concrete slab. The higher dynamic modulus could be due to uneven aggregate distribution throughout the core sample depth (more aggregate at the top), less air voids near the surface, or enhanced concrete compaction near the pavement surface where vibrators are located. This statistical distinction at the 95 % confidence level between top section and mid-section E values is also seen when only the “cold” samples are analyzed. All other sample sets, when comparing aggregate types and temperature conditions, show too much variability to draw any meaningful statistical conclusion about the differences between top and midsection sections of the same core. Figure 8 shows these findings, where the E values from the top section of each core are plotted against those of the mid-section for all the samples. Most of the data points lie to the right of the line of equality (LOE), which confirms the conclusion that the top sections show higher modulus, regardless of other parameters, to a high degree of statistical confidence. However, no clear distinction between hot and cold plastic temperatures is seen. As

both hot and cold samples show about the same level of scatter about the LOE.

Based on the provided concrete samples, the data suggest that the observed differences in dynamic E at top and mid sections of the core samples are not caused by plastic concrete temperature conditions. The distributed microscopic damage state caused by high concrete plastic temperatures, within those samples, is not notably different at the top and bottom sections.
