Effect of Anchorage Number on Behavior of Reinforced Concrete Beams Strengthened with Glass Fiber Plates

Abstract: Reinforced concrete beams with insufficient shear reinforcement were strengthened using glass fiber reinforced polymer (GFRP) plates. In the study, the effect of the number of bolts on the load capacity, energy dissipation, and stiffness of reinforced concrete beams were investigated by using anchor bolt of different numbers. Three strengthened with GFRP specimens, one flexural reference specimen designed in accordance to Regulation on Buildings Constructed in Disaster Areas rules, and one shear reinforcement insufficient reference specimen was tested. Anchorage was made on the surfaces of the beams in strengthened specimens using 2, 3 and 4 bolts respectively. All beams were tested under monotonic loads. Results obtained from the tests of strengthened concrete beams were compared with the result of good flexural reference specimen. The beam in which 4 bolts were used in adhering GFRP plates on beam surfaces carried approximately equal loads with the beam named as a flexural reference. The amount of energy dissipated by strengthened DE5 specimen was 96 % of the amount

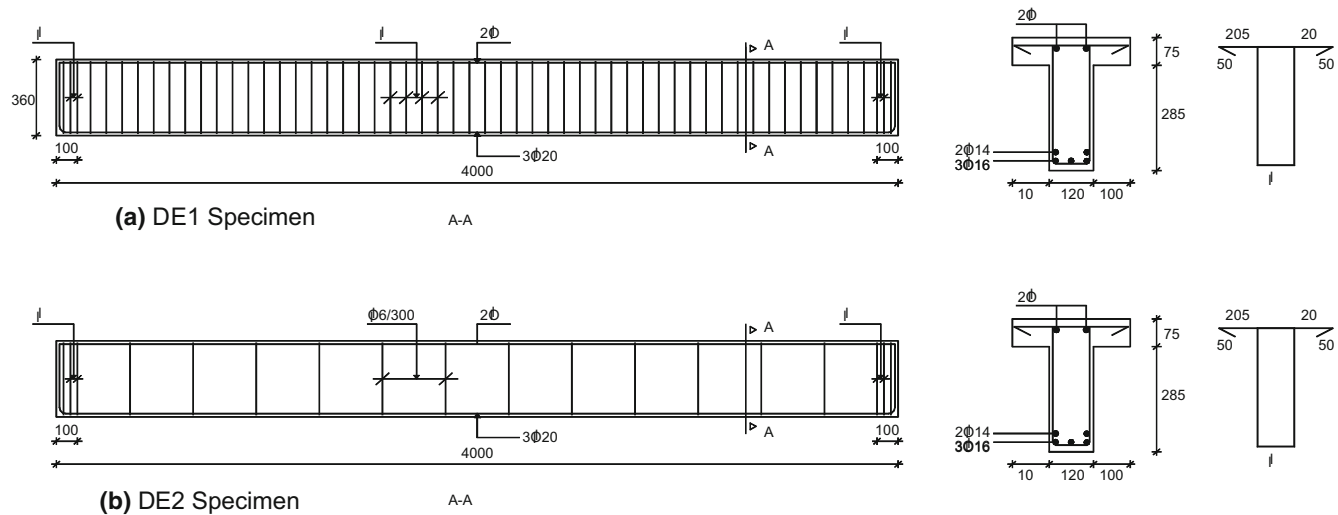
Fig. 1 DE1 and DE2 reference test specimens.

The test specimens were detailed in 1/2 scale. Five beams were tested in the experimental program. The test specimens were designed as a T cross-section beam with a length of 4000 mm. In the beam cross-section web width was designed as 120 mm, beam height was designed as 360 mm, topping concrete width was designed as 320 mm and topping concrete depth was designed as 75 mm. 3Ø16, and 2Ø14 longitudinal reinforcement was used in all specimens as tensile reinforcement. The percentage of tensile reinforcement in the beams is $\rho = 0.0230$. Since this ratio is smaller than the balanced reinforcement ratio $\rho_b = 0.0305$ specified in TS 500 (2000). 2Ø8 longitudinal reinforcement was used as compressive reinforcement. Transverse reinforcements (stirrup) produced with Ø6 straight reinforcements were used in the beams. Stirrups were placed with a span of 75 mm in reference test specimens with sufficient shear reinforcement, shear transverse reinforcements were placed with a span of 300 mm in reference test specimens with insufficient shear reinforcement. The stirrup ratio in beams with insufficient shear reinforcement is $\rho_w = 0.00157$. With this stirrup ratio, it was aimed to keep shear strength at the low level. The geometric form and reinforcement plan test specimens are given in Fig. 1.

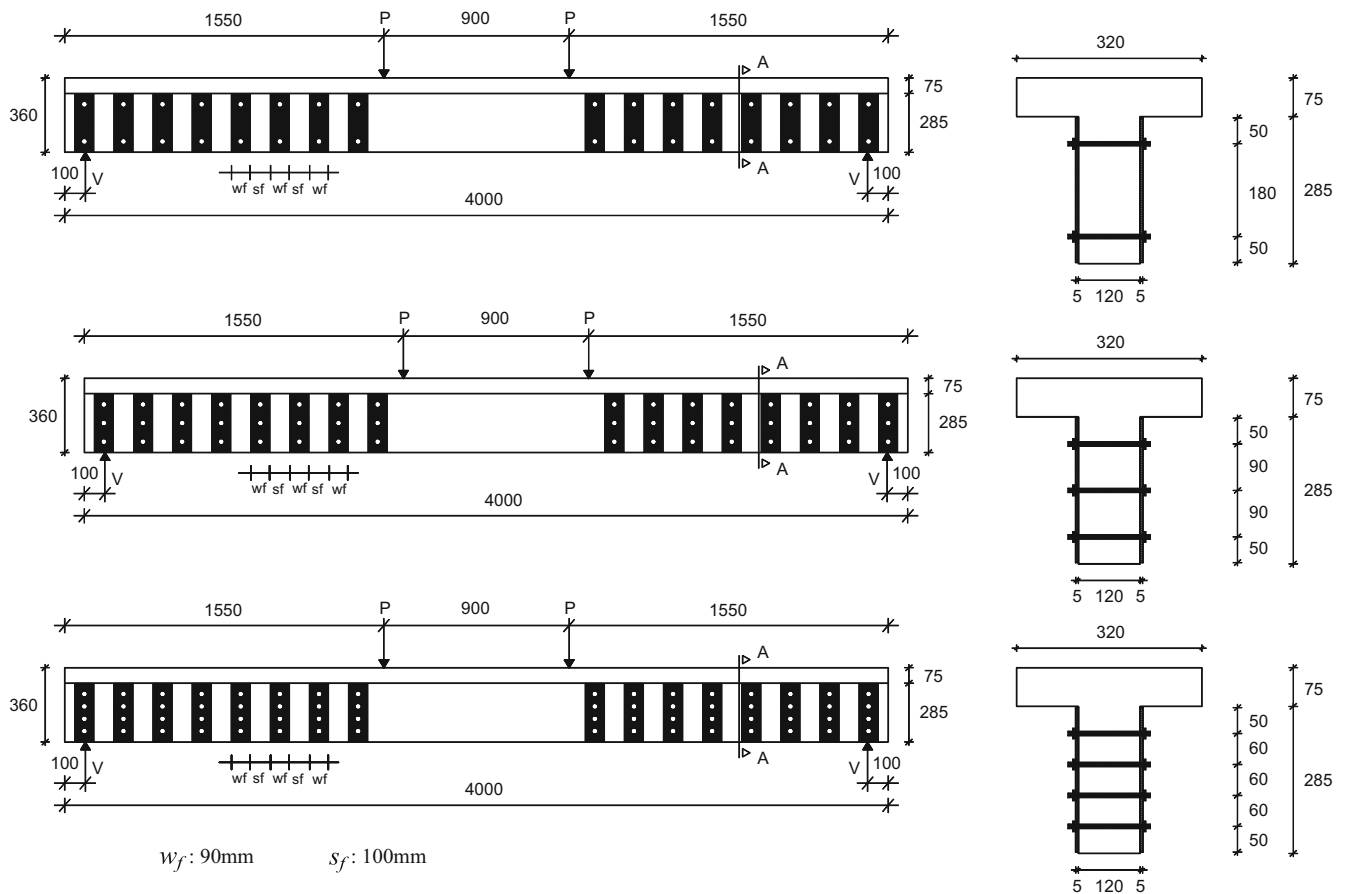
Fig. 2 DE3, DE4 and DE5 reinforced test specimens.

between the effective anchorage depth to anchorage diameter was considered as 5. The anchorage diameter was applied at approximately 8 mm in the experimental study mild steel bolt was used as an anchorage. Consequently, the ratio between the anchorage depth to anchorage diameter was provided. Anchorage status of test specimens was given in Table 3. GFRP plate placement used on the specimens and anchorage details was given in Fig. 2.

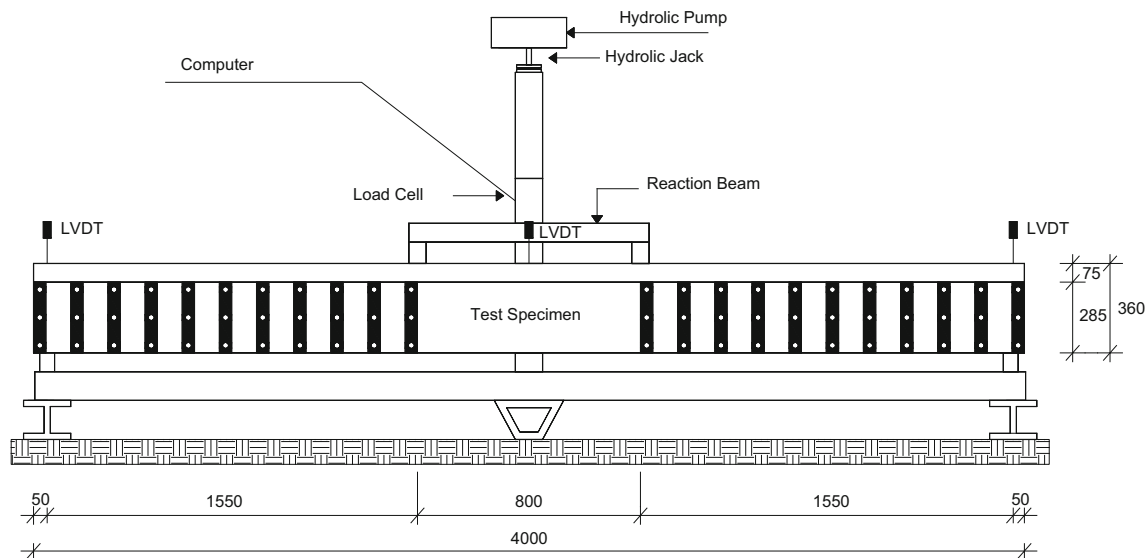
Fig. 3 Test setup and measurement system.

The load was applied to test specimens with 50 kN capacity mechanic pump connected to a hydraulic jack and the applied load was measured with 40 kN capacity load cell. The reaction was placed on the test specimens as simple support. The single load with P size transmitted to the reaction beam from the hydraulic jack was transmitted to the test specimens in the form of two equal single loads with $P/2$ sizes. The loading was started from zero and continued till collapse. Test setup and measurement system in the test specimens were given in Fig. 3.

Electronic measurement devices (LVDT) were placed on the midpoint of the beam on the sports in order to determine midpoint displacement of test specimens. To determine the midpoint displacement 200 mm capacity LVDT was used. To determine right, and left supports displacements 100 mm capacity LVDTs were used. The load, and displacement values were used to draw load-displacement curves of test specimens.

The net displacement at the end of the beams measured from the LVDT (D0) were equal to the difference of the average vertical displacements of the D1 and D2 LVDTs.

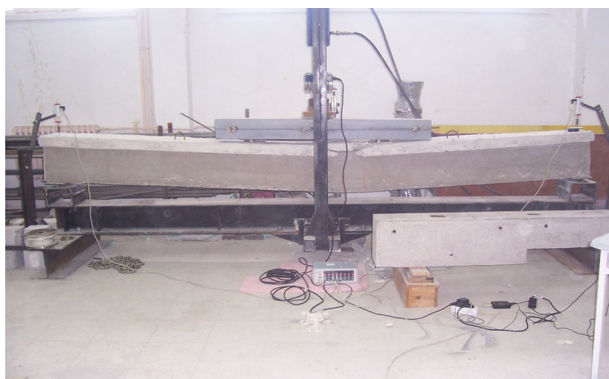
Fig. 4 View of the DE1 specimen after test finished.

The first bending crack in this specimen was occurred in the fixed moment region at the load of 45.4 kN. The midpoint displacement measured when the first crack occurred is 3.80 mm. Bending cracks at a load of 170.0 kN reached a width up to 1 mm. At the load of 180.24 kN tensile reinforcement started to yield. At that load, midpoint displacement was measured as 25.42 mm. While there was no definite increase in the load capacity of the specimen after that load, the midpoint displacement continued to increase. The highest load value in the test specimen was measured as 187.38 kN. The midpoint displacement at that value became 51.95 mm. At the load value of 185.96 kN, the test specimen collapsed as a result of the crash of concrete in the concrete compressive region. The midpoint displacement measured in the test specimen during the collapse is 56.08 mm. The collapse of this test specimen happened in the form of bending fracture. The view of the test specimen after a collapse is shown in Fig. 4.

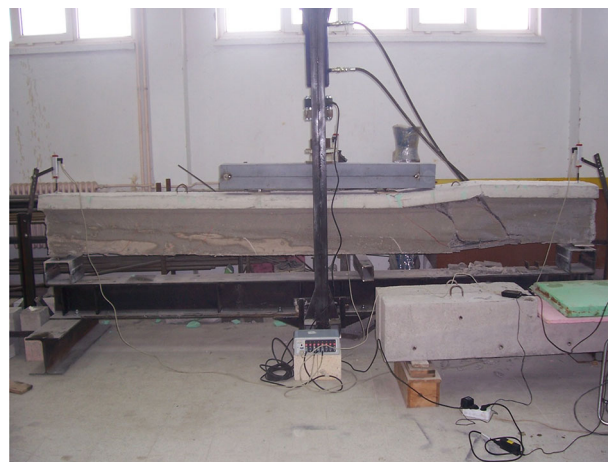
Fig. 5 View of the DE2 specimen after test finished.

The DE2 test specimen was a reference specimen with insufficient shear reinforcement prepared to be compared to strengthened test specimen. The first crack in DE2 was occurred in the fixed moment region in the form of bending crack at the load of 39.2 kN and at 3.98 mm midpoint displacement value. In parallel with the increase of loading, shear cracks arose. Two shear cracks became at the load of 130.0 kN in the right shear span. The test specimen collapsed as a result of the main shear crack at a load of 138.76 kN in the right shear span and reaching the topping concrete. When the specimen collapsed, midpoint displacement of 22.07 mm was measured in the test specimen. The collapse of this test specimen happened in the form of shear fracture. The view of DE2 after the collapse is shown in Fig. 5.

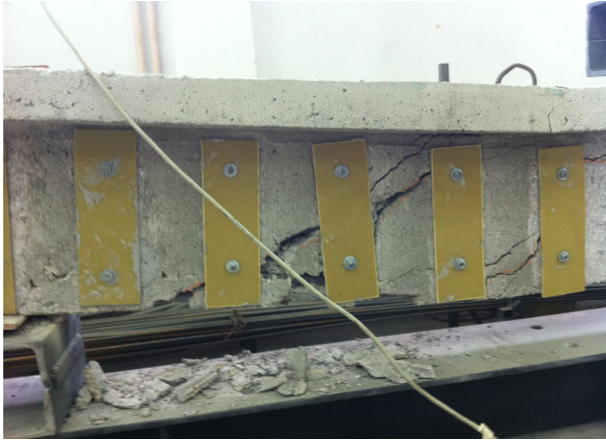
Fig. 6 View of the DE3 specimen after test finished.

crack in DE3 occurred at the of 41.0 kN load and midpoint displacement of 3.64 mm. The first shear crack occurred at a load of 130.0 kN in the right shear span. The crack occurred in the plate numbered 5 and passed under the plate, and reached a thickness of 1 mm. Two main shear cracks became at the load of 168.0 kN in left shear span the plates numbered 3 and 6 passed and passed under the plates plates numbered 4 and 5. As a result of the arrival of this main crack to the topping concrete, the Specimen collapsed at a load of 169.08 kN. The midpoint displacement of the specimen measured at the load of collapse is 28.23 mm. The view of DE3 after a collapse is shown in Fig. 6. The collapse of this specimen happened in the form of shear failure.

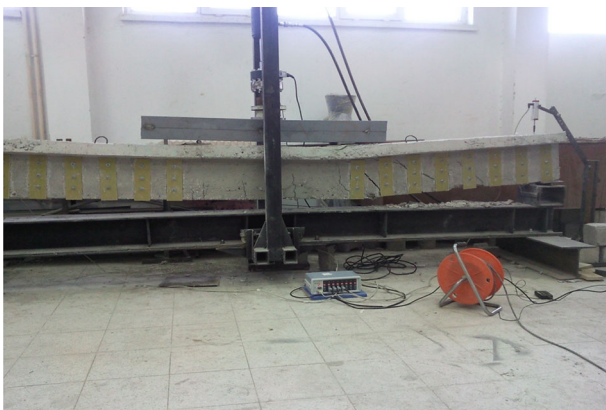
Fig. 7 View of the DE4 specimen after test finished.

The DE4 test specimen was a strengthened with GFRP plates of which 3 anchorages were used. The first bending crack in this specimen occurred at 43.8 kN load. At that load in the same specimen, midpoint displacement was measured as 3.79 mm. When it reached to a load level of 100.0 kN, the first shear crack occurred in the right shear span. The first shear crack that occurred in the right shear span passed under the plate numbered 12 reached to the plate numbered 13. The specimen collapsed at a load of 174.94 kN with sudden and brittle as a result of shear crack that occurred under the plates numbered 11 and 12 reaching to the topping concrete. The midpoint displacement of the specimen measured at the moment of collapse is 28.45 mm. The collapse of this specimen happened in the form of shear failure. The view of after a collapse is shown in Fig. 7.

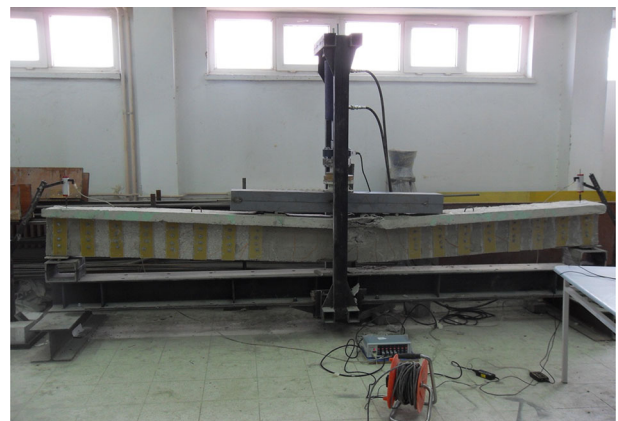
Fig. 8 View of the DE5 specimen after test finished.

the compressive region at a load of 185.30 kN. The midpoint displacement of 44.98 mm was measured at the load of collapse. The test specimen's collapse mechanism is in the mode of bending fracture. Tensile reinforcement in the specimen yielded and a ductile behavior was observed. The view of DE5 after a collapse is shown in Fig. 8.

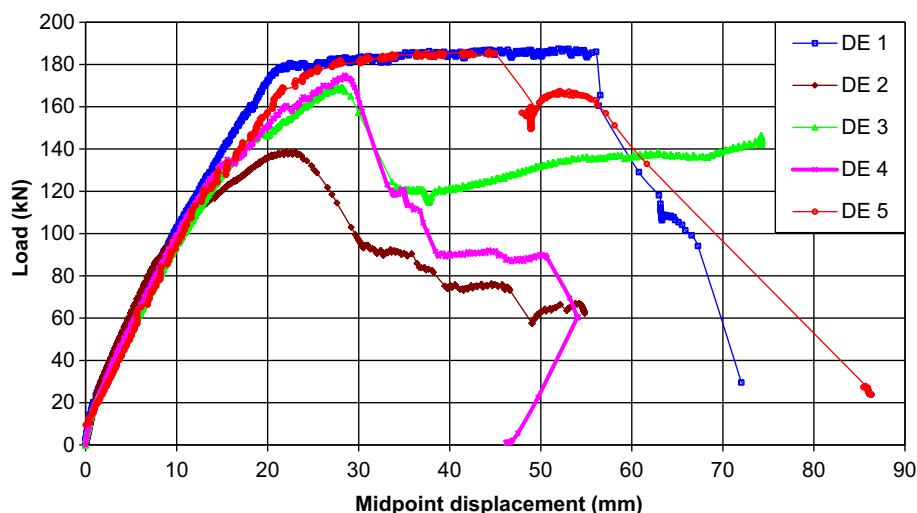
Fig. 9 Superpose load–displacement curves of the test specimens.

The results obtained from the experiments were compared. In the comparison, response envelopes of test specimens were used (Fig. 9). Furthermore, test specimens' yield load, collapse load, yield and collapse displacements, stiffness, and energy dissipation capacities were compared (Table 8).

The load displacement curves of the reference test specimen DE1 with sufficient shear reinforcement, DE2 the reference test specimens with insufficient shear reinforcement, and strengthened with different numbers of anchorages DE3, DE4 and DE5 test specimens were compared in Fig. 9. The reference test specimen with sufficient shear reinforcement (DE1) is the flexural reference specimen to which strengthening was not applied. This test specimen carried 34 % more load compared to the insufficient shear reinforcement (DE2). DE1 shear reinforcement sufficient specimen carried 10 %
