Structural Performance of RC and R-ECC Dapped-End Beams Based on the Role of Hanger or Diagonal Reinforcements Combined by ECC

Abstract

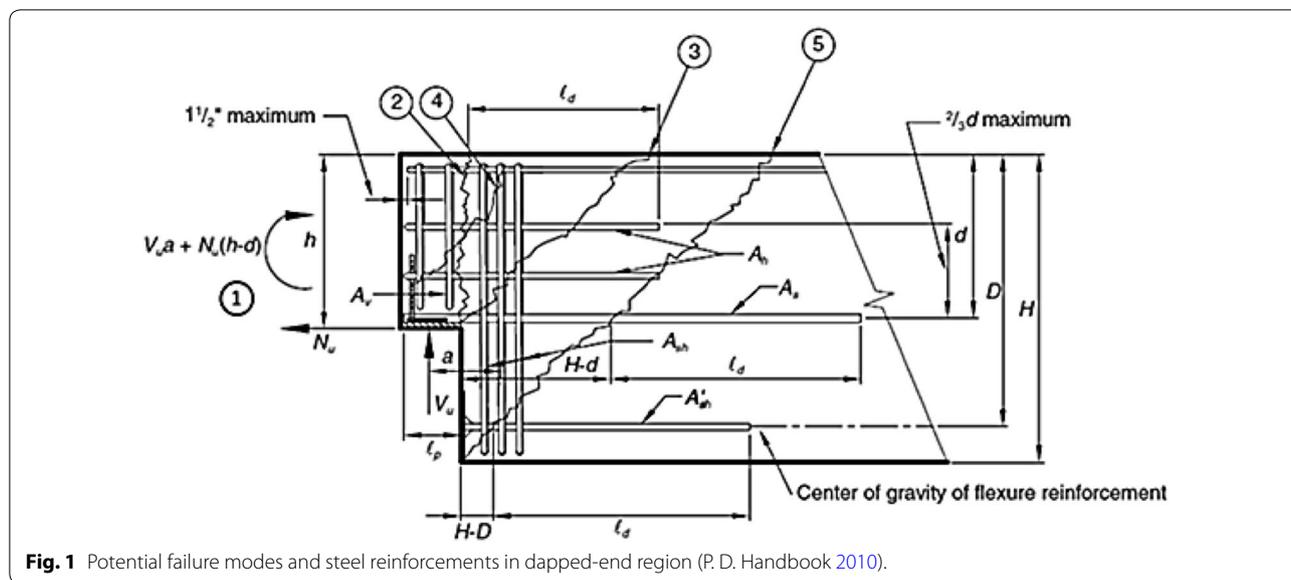
Fig. 1 Potential failure modes and steel reinforcements in dapped-end region (P. D. Handbook 2010).

One control beam has been designed in accordance with the requirements of PCI code (P. D. Handbook 2010). Five potential failure modes of RC-DEB have been specified as shown in Fig. 1. These failure modes are: (1) flexure and axial tension in extended end, (2) direct vertical shear between nib and un-dapped portion, (3) diagonal tension initiating from re-entrant corner, (4) diagonal tension in the nib area, and (5) diagonal tension in un-dapped portion.

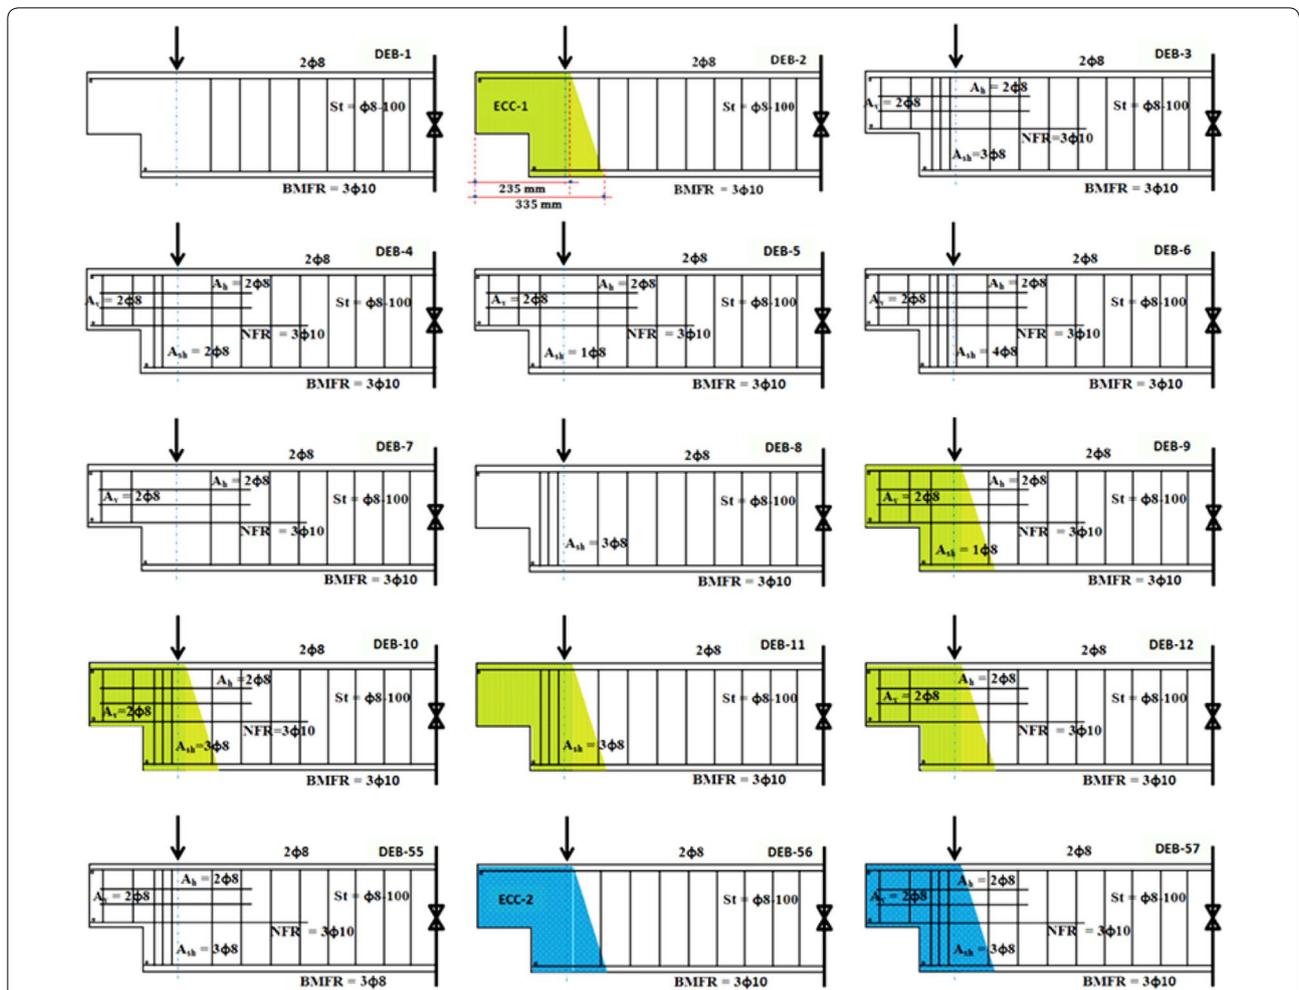
Fig. 2 The steel reinforcement configuration of DEBs in the first group.

investigated beams in this study consist of two groups. The first group includes 15 DEB specimens which involves different HR scheme and combined by using ECC. The second group contains of 12 DEB specimens with different DR configuration that combined by utilizing HR and ECC. The ECC placement and the steel reinforcement configuration of all DEB specimens can be seen in Figs. 2 and 3, while the steel reinforcement details are presented in Table 1.

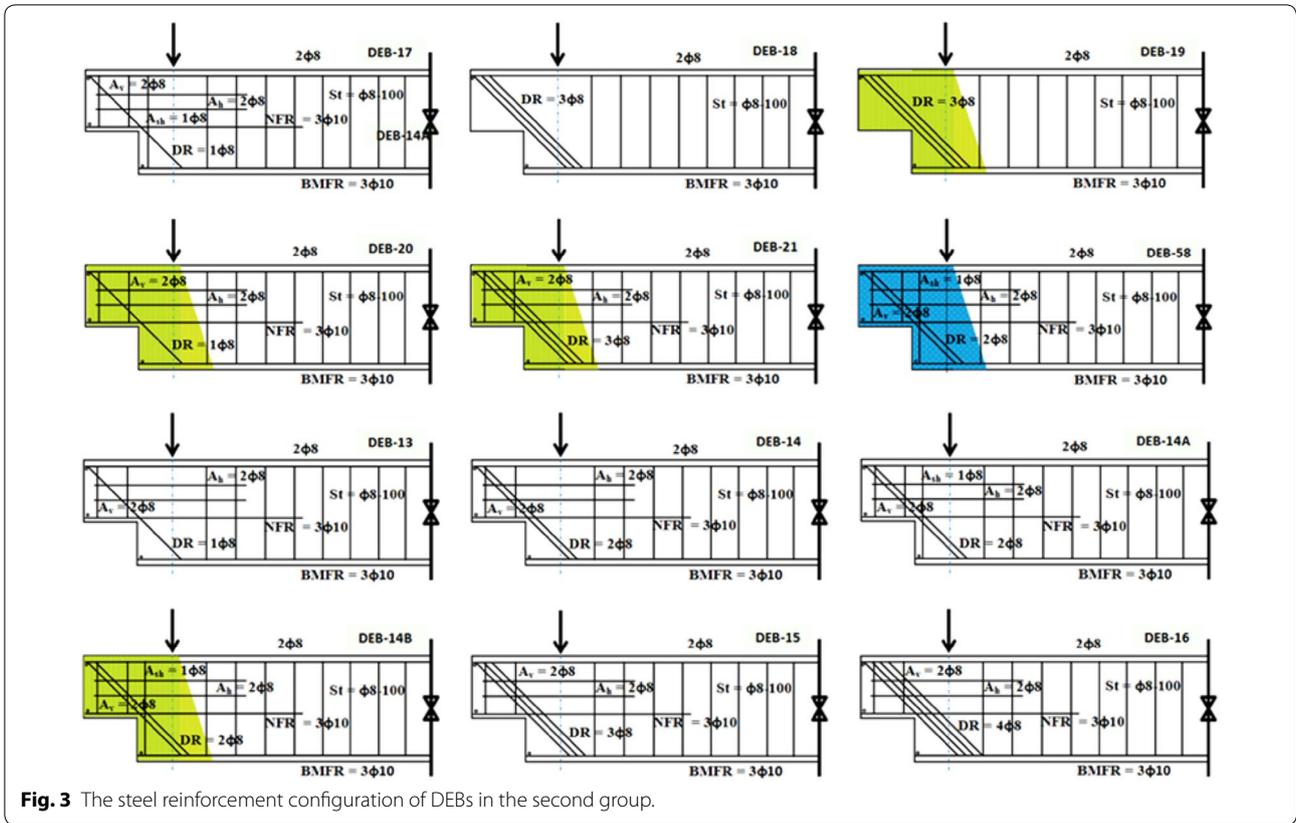
Fig. 3 The steel reinforcement configuration of DEBs in the second group.

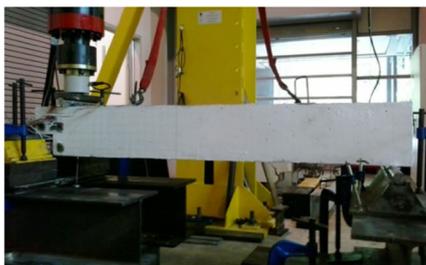
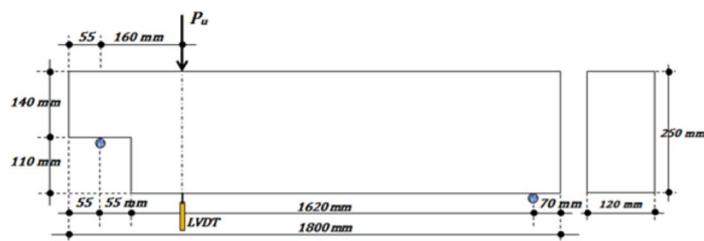
(a) Beam setting at loading frame

(b) Load position, beam and nib size

Fig. 4 Experimental setup of DEB specimen.

The typical experimental setup for the DEBs testing was shown in Fig. 4. To measure the vertical deflection of beams, Linear Variable Differential Transducer (LVDT) has been located at soffit of DEB specimen. All beams are subjected to the three point loading up to failure with loading rate of 0.15 kN/s. No axial tension force was applied.

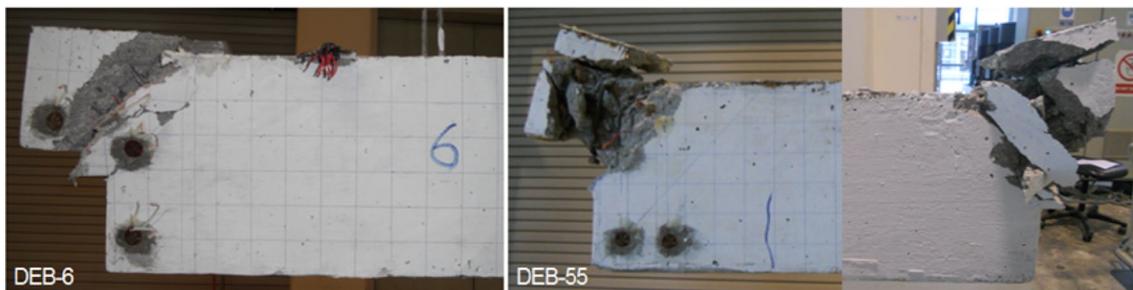
Fig. 10 The beams condition after testing (For DEB-6 and DEB-55).

The load–deflection relationships of the DEB-6 and DEB-55 in the first group are given in Fig. 10. The DEB-55 exhibited a similar behavior to DEB-3 in the pre-peak and post-peak ranges, but the behavior of the DEB-6 exhibited a decline after reaching the post-peak, as if it had no capability to withstand the applied load. The DEB-6 still had the ability to conduct more plastic deformation up to the failure. The variations of the HR caused the changes of the behavior of the DEB specimens.

Basically, the DEB-6, DEB-55, and DEB-3 had similar crack patterns and failure modes. The first cracking of the beams emerged from the re-entrant corner. Initially, the crack propagated diagonally, but the HR of all these beams was able to inhibit and resist the diagonal crack from the re-entrant corner. Accordingly, other cracks also appeared at the support during the beam loading. The cracks at the support developed when the applied load increased and the cracks propagated toward the load point up to the rupture. The failure condition of these beams was characterized by the dominant diagonal crack at the support, as well as the diagonal crack at the re-entrant corner. The DEB-6 and DEB-55 failed in the shear failure mode.

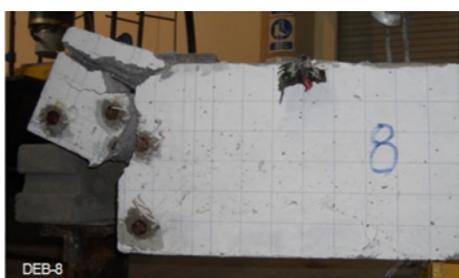
Fig. 11 The beam condition after testing (For DEB-8).

There was a significant difference in the beam behavior between the DEB-7 and DEB-8 as shown in Figs. 9 and 11. During the beam loading, the first cracking of both beams appeared at the re-entrant corner. Basically, the HR was able to resist the diagonal crack emanating from the re-entrant corner, but in fact, the absence of the HR in the DEB-7 did not provide a large effect in reducing the capacity of the beam. The NFR or NHR also has the ability to resist the diagonal crack or shear force. Therefore, the DEB-8 that only used the HR (without other dapped-end reinforcements) exhibited a lower capacity compared to the DEB-7. The DEB-8 did not have the NFR to resist the flexural moment caused by the vertical shear force at the support. Accordingly, the DEB-8 only improved a little on the capacity compared to the DEB-1. According to Fig. 11, for the DEB-8, initially, the diagonal crack emerged from the re-entrant corner, but this crack could not propagate diagonally because it was resisted by the HR. Due to the absence of the NFR and NHR, this crack propagated in a vertical direction parallel to the direct shear plane. The failure process of the beam took place in a short time and failed in the shear failure mode. The HR could not work alone to improve the performance of the DEB. This condition has proved that the existence of the HR should be supported by the NFR or NHR to achieve better performance of the DEB.

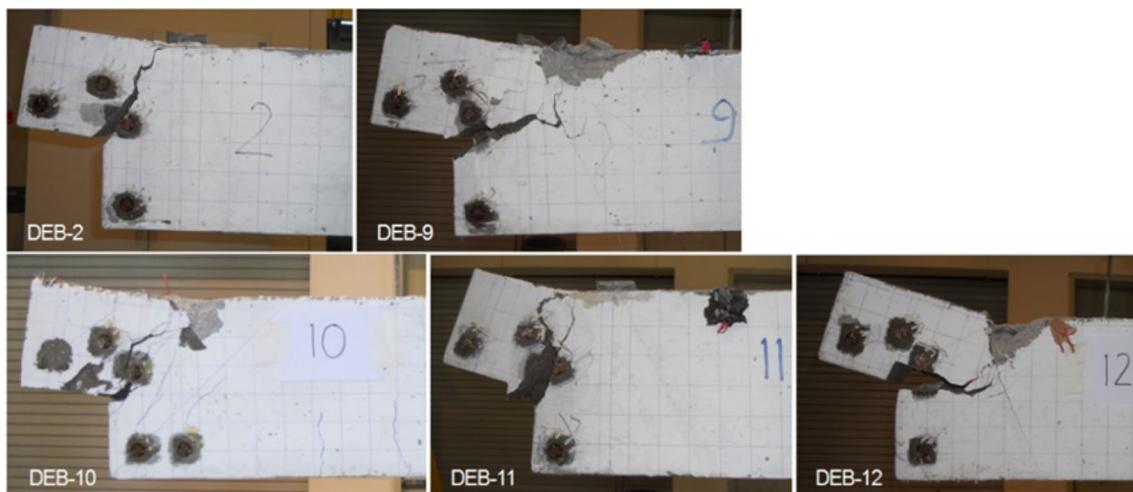
Fig. 12 The beam condition after testing (For DEB-2,-9,-10,11 and DEB-12).

DEB-8 were shown. As shown in Fig. 12, the failure condition of the DEB-2 was similar to the DEB-1, and the DEB-11 was similar to the DEB-8. Due to the use of the ECC-1, for the DEB-9 and DEB-10, the bonding strength between the ECC-1 with the NFR was stronger than the HR so the weak point moved to the HR. The flexural moment caused a dominant crack to occur at the re-entrant corner. However, for the DEB-12, the strong bonding between the ECC-1 and NFR was able to resist the diagonal crack from the support and the re-entrant corner, but due to the flexural moment, de-bonding occurred along the NFR measured from the center of the flexural moment. The first cracking of all of the above beams occurred at the re-entrant corner. In comparison with the RC-DEBs, for the R-ECC-DEBs, there was no spalling occurring but the cracks were wider. The crack propagation was longer and clearer. Some fine cracks always accompany the dominant cracks. All these beams failed in the shear failure mode, but on the DEB-10, some flexural cracks appeared at the soffit of the main beam. It

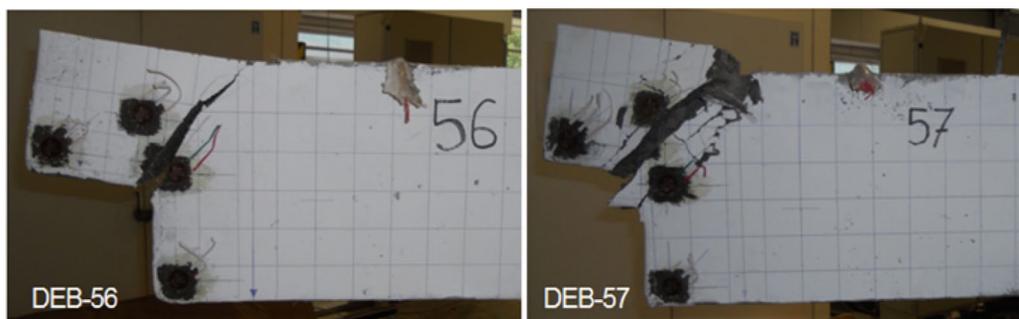
Fig. 13 The beam condition after testing (For DEB-56 and DEB-57).

Figure 13 shows the superiority of the ECC-2 that was used for the DEB specimens compared to the ECC-1 which involved a comparison between the DEB-56 and DEB-2, as well as the DEB-57 and DEB-10. Due to the use of the ECC-2, there were some improvements generated which covered the failure load and final deflection capacity. Basically, their behaviors were quite similar, either in the pre-peak or post-peak range. Likewise, with the crack pattern and failure condition of these two R-ECC-DEBs, there was a slight difference between them. For the DEB-57, at the failure condition, Aside from at the re-entrant corner, the dominant diagonal crack also occurred at the support. Due to the use of the ECC-2, the center point of the flexural moment was stronger than the region in between this point and the support. The flexural effect at this region caused the dominant diagonal crack to occur at the support. The first cracking of the DEB-56 and

DEB-57 was initiated from the re-entrant corner. Both the R-ECC-DEBs failed in the shear failure mode. During testing of the DEB-57, it was observed that some fine flexural cracks appeared at the soffit of the main beam, but after the loading stopped, these cracks were not visible. All of the above evidences have exhibited that the performance of the R-ECC-DEBs was better than the RC-DEBs.

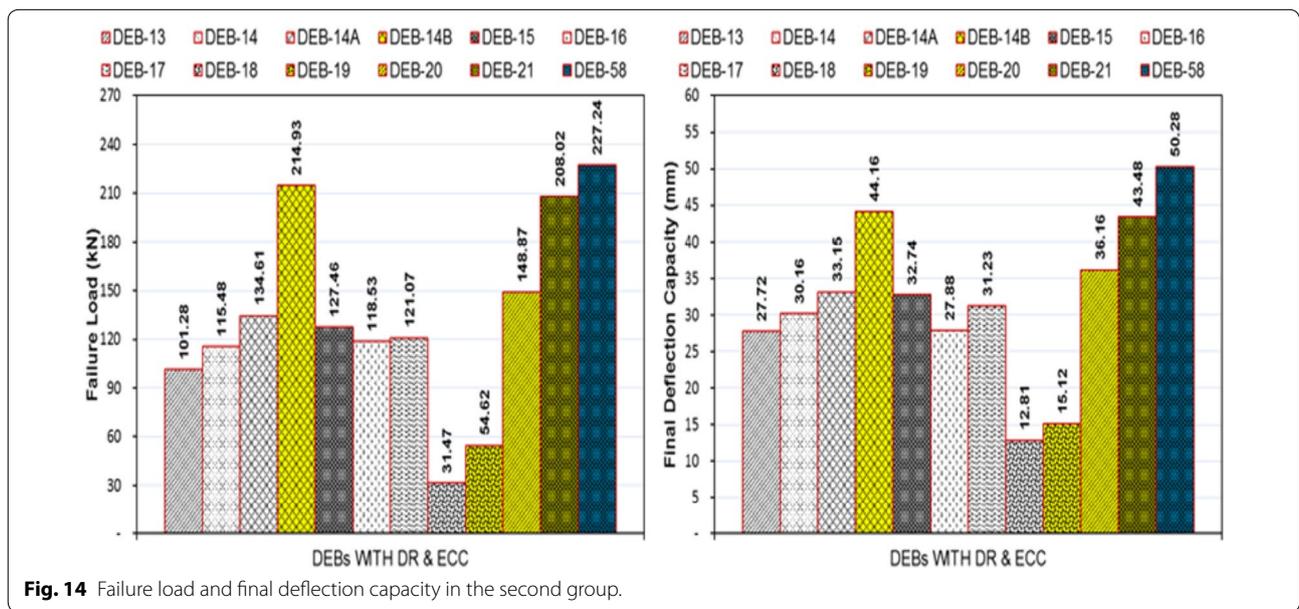
Fig. 14 Failure load and final deflection capacity in the second group.

Figure 14 shows the test results of all the DEB specimens in the second group. The variation of the DR provided the changes of the failure load and final deflection capacity of the DEB specimens.

By using the ECC-1 placed in the dapped-end region, it has been proved that the increment of the DEB capacity occurred for both the failure load and final deflection, as shown in Fig. 14. The enhancement of the failure load and final deflection capacity can be described as follows: 73.56% and 18.03% for the DEB-19 compared to the DEB-18, 46.99% and 30.45% for the DEB-20 compared to the DEB-13, 59.67% and 33.21% for the DEB-14B compared to the DEB-14A, as well as 63.20% and 32.80% for the DEB-21 compared to the DEB-15. The ECC-1 improved the capacity of the DEB on the failure load and final deflection. It was attributed to the strong bonding between the steel bars and the ECC-1. In addition to that, the ECC-1 performed the plastic strain up to 2.93% even though the steel bars had passed their yield strain phase, where the yield strain of the steel bars was around 0.226%.

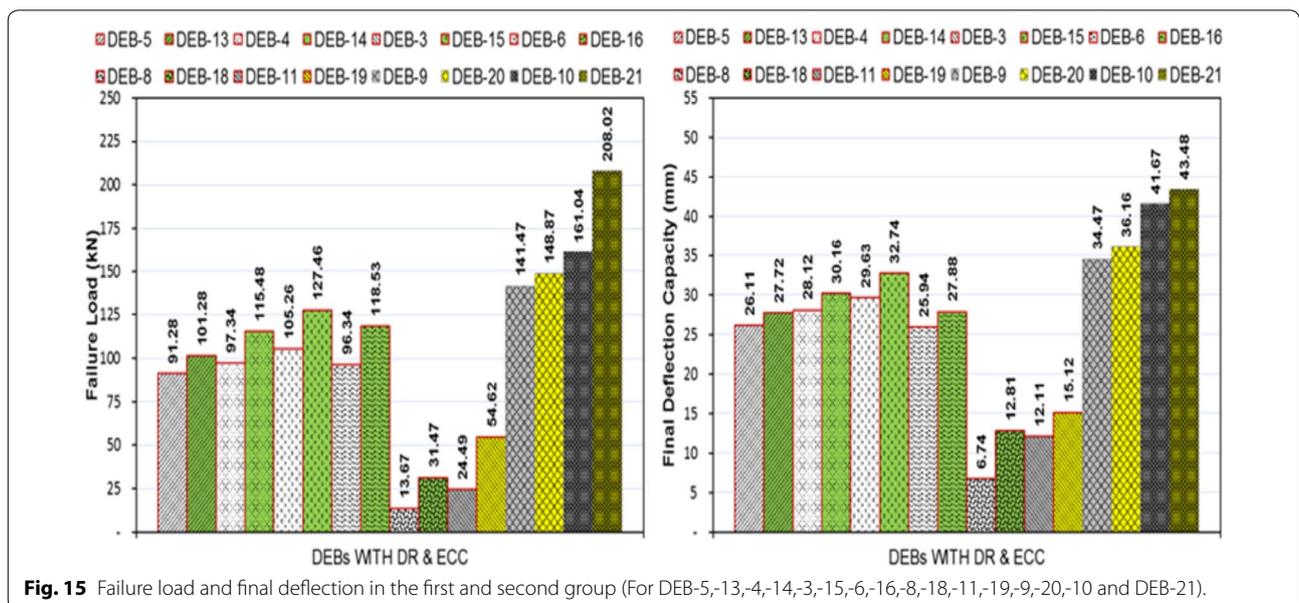
Fig. 15 Failure load and final deflection in the first and second group (For DEB-5,-13,-4,-14,-3,-15,-6,-8,-18,-11,-19,-9,-20,-10 and DEB-21).

There was a different capacity between the DEBs using the HR and the DR as shown in Fig. 15. Based on the charts, all of the DEBs with the DR had a higher capacity compared to the DEBs with the HR. The increment on the failure load and final deflection capacity can be reported as follows: 10.96% and 6.17% for the DEB-13 compared to the DEB-5, 18.64% and 7.25% for the DEB-14 compared to the DEB-4, 21.09% and 10.50% for the DEB-15 compared to the DEB-3, 23.03% and 7.48% for the DEB-16 compared to the DEB-6, 130.21% and 90.06% for the DEB-18 compared to the DEB-8, 123.03% and 24.86% for the DEB-19 compared to the DEB-11, 5.23% and 4.90% for the DEB-20 compared to the DEB-9, as well as 29.17% and 4.34% for the DEB-21 compared to the DEB-10.

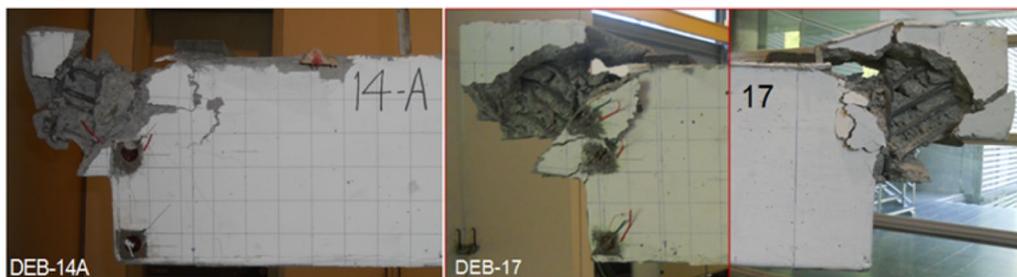
Fig. 18 The beams condition after testing (For DEB-14A and DEB-17).

The existence the HR of 1Ø8 mm in the dapped-end region of the DEB specimen with the DR improved the behavior of the DEB both in pre-peak and post-peak ranges. The DEB-17 reached the ultimate load and final deflection with a higher load than the DEB-13, likewise for the DEB-14A compared to the DEB-14 as shown in Fig. 18.

By adding 1Ø8 mm of the HR in the DEB-14A and DEB-17, the HR in these beams was able to contribute to the confinement strength at the end face of the beam so that the HR was able to, adequately, resist the diagonal crack from the corner of the un-dapped portion. During the testing, it was observed that the first cracking emerged from the re-entrant corner. The existence of the HR and the DR inhibited or helped to avoid the propagation of this crack, therefore, other cracks appeared at the support and its vicinity. These cracks developed and propagated to the load point up to failure. The failure condition of these beams was characterized with a dominant diagonal crack at the support and severe damage.

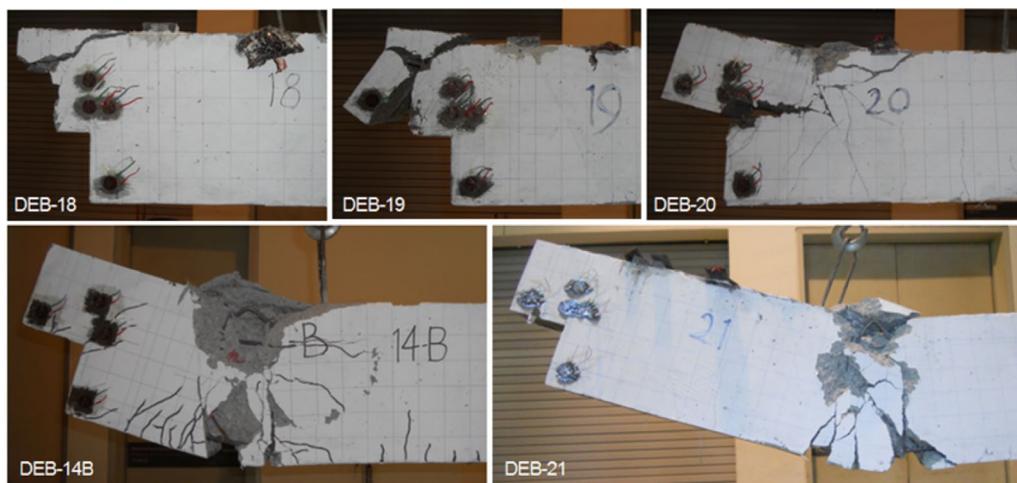
Fig. 19 The beams condition after testing (For DEB-18,-19,-20,-14B and DEB-21).

In the previous section, the crack pattern and failure condition of the DEB-18, DEB-13, DEB-14A, and DEB-15 were shown. Figure 19 can be utilized to compare the failure condition between the DEB-19 and DEB-18, the DEB-20 and DEB-13, the DEB-14B and DEB-14A, as well as the DEB-21 and DEB-15. The first crack of all the above beams was always initiated from the re-entrant corner. Even though using different concrete types, the DEB-19 and DEB-18 exhibited similar crack patterns and failure modes. The DR had the ability to resist the diagonal crack from the re-entrant corner, but then the crack emerged at the support. The vertical shear force at the support acted dominantly causing cracks to develop and propagate vertically up to failure. With the DEB-20, the ECC-1 provided strong bonding on the dapped-end reinforcements. Initially, the cracks propagated diagonally. Due to the bonding strength between the ECC-1

The DEB-14B was the R-ECC-DEB derived from the DEB-14A. As shown in Fig. 19, the ECC-1 provided a significant increment on the failure load and final deflection capacity of the DEB-14B. The combination between the ECC, DR, HR, and other dapped-end reinforcements generated adequate performance on the DEB-14B. This beam had a high failure load capacity and also performed large plastic deformations. The dapped-end region of the DEB-14B was very strong. The dapped-end section was able to resist the shear force and diagonal cracks that occurred. Finally, the DEB-14B failed in the flexural mode. Many flexural cracks occurred at the soffit of the main beam. In addition, the DEB-21 had a similar case to the DEB-14B. The DEB-21 also failed in the flexural mode as shown in Fig. 19 but the failure location was close to mid-span. The DEB-21 was derived from the DEB-15. Even though only using the NSC, the DEB-15 showed sufficient performance. This was due to the use of the DR in the dapped-end region of the DEB-15. Its failure had also been indicated by some flexural cracks. Based on this fact, the DEB-21 was created, where the ECC-1 was placed in the dapped-end region of the DEB-15. The ECC-1 was superior compared to the NSC. However, the R-ECC-DEBs exhibited better structural performance than the RC-DEBs.

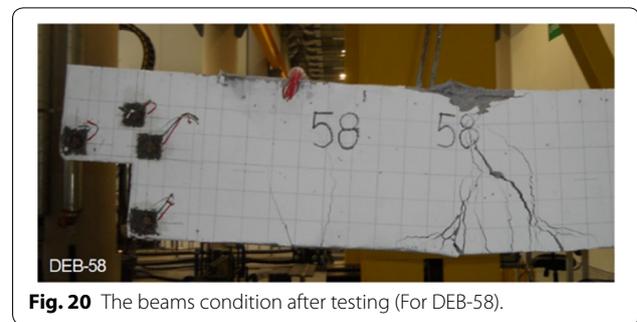
Fig. 20 The beams condition after testing (For DEB-58).

Figure 20 shows the behavior of the DEB-58 that used the ECC-2, as well as the DEB-14B and DEB-21 which utilized the ECC-1 as shown in Fig. 19. There were no improvements generated covering the failure load and final deflection capacity. Basically, their behaviors were quite similar, either at the pre-peak or post-peak ranges. Likewise, with the crack pattern and failure condition of these two R-ECC-DEBs, there was a slight difference in between as shown in Figs. 19 and 20.

For the DEB-58, the failure location was close to mid-span. The ECC-2 was superior compared to the ECC-1 as explained, aforementioned. It caused the DEB-58 to support a higher failure load and final deflection capacity than the DEB-14B or the DEB-21. The DEB-58 also performed larger plastic deformations compared to the DEB-14B or the DEB-21. Nevertheless, all three of these beams failed in the flexural mode. Even though the failures were in the flexural mode, the first crack of these
