Rapid Repair of Severely Damaged RC Columns with Different Damage Conditions: An Experimental Study

Abstract: Rapid and effective repair methods are desired to enable quick reopening of damaged bridges after an earthquake occurs, especially for those bridges that are critical for emergency response and other essential functions. This paper presents results of tests conducted as a proof-of-concept in the effectiveness of a proposed method using externally bonded carbon fiber reinforced polymer (CFRP) composites to rapidly repair severely damaged RC columns with different damage conditions. The experimental work included five large-scale severely damaged square RC columns with the same geometry and material properties but with different damage conditions due to different loading combinations of bending, shear, and torsion in the previous tests. Over a three-day period, each column was repaired and retested under the same loading combination as the corresponding original column. Quickset repair mortar was used to replace the removed loose concrete. Without any treatment to damaged reinforcing bars, longitudinal and transverse CFRP sheets were externally bonded to the prepared surface

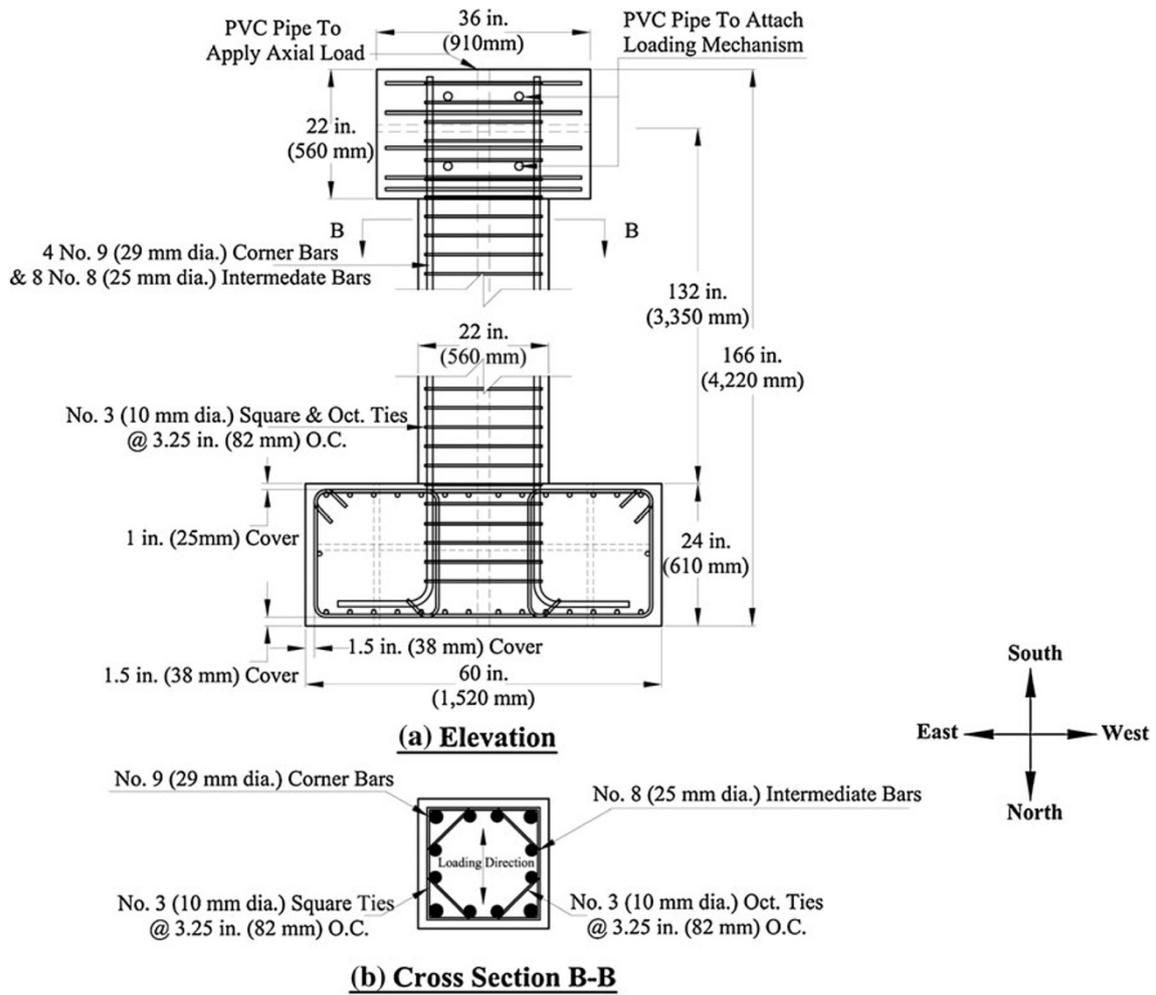
Fig. 1 Geometry and reinforcement details of original columns.

Five square RC columns were tested in a previous study, each with the same nominal geometry and material properties. The columns were 1/2 scale bridge columns designed based on CALTRANS (2004) and ACI 318 (2008) seismic provisions. The column specimen was simulated as a cantilever, and the aspect ratio (H/B) was 6, where H and B are the height of the column and the cross-section dimension, respectively. Figure 1 shows the column geometry and reinforcement details. The column was 22 in. (560 mm) square reinforced with four No. 9 (29 mm dia.) deformed bars in the corners and eight No. 8 (25 mm dia.) intermediate bars, with a longitudinal reinforcement ratio of 2.13 %. Tie reinforcement consisted of square and octagonal No. 3 (10 mm dia.) deformed bars spaced at 3.25 in. (82 mm), with a transverse reinforcement ratio of 1.32 %. The measured yield strength of the longitudinal bars was 76 ksi (524 MPa) for No. 8 (25 mm dia.) bars and 67 ksi (462 MPa) for No. 9 (29 mm dia.) bars. For the ties, the measured yield strength was 74 ksi (510 MPa). Yield strength of the reinforcing bars was determined in accordance with ASTM A 370 (2012). The target 28-day cylinder compressive strength of the concrete was 5,000 psi (34 MPa). Additional information including measured concrete properties is provided in Prakash et al. (2012).

A detailed description of the damage to the original columns is summarized in Table 1. Damage to each column included concrete cracking, cover concrete spalling, and core concrete crushing, as well as longitudinal reinforcement yielding. Damaged ties failed by yielding and, in some cases, subsequent straightening of the end hooks. Additionally, longitudinal bars buckled in Columns 1–4, and two longitudinal reinforcing bars fractured in Column 1 near the base of the column at the northwest and southeast corners of the cross-section (see Fig. 1).

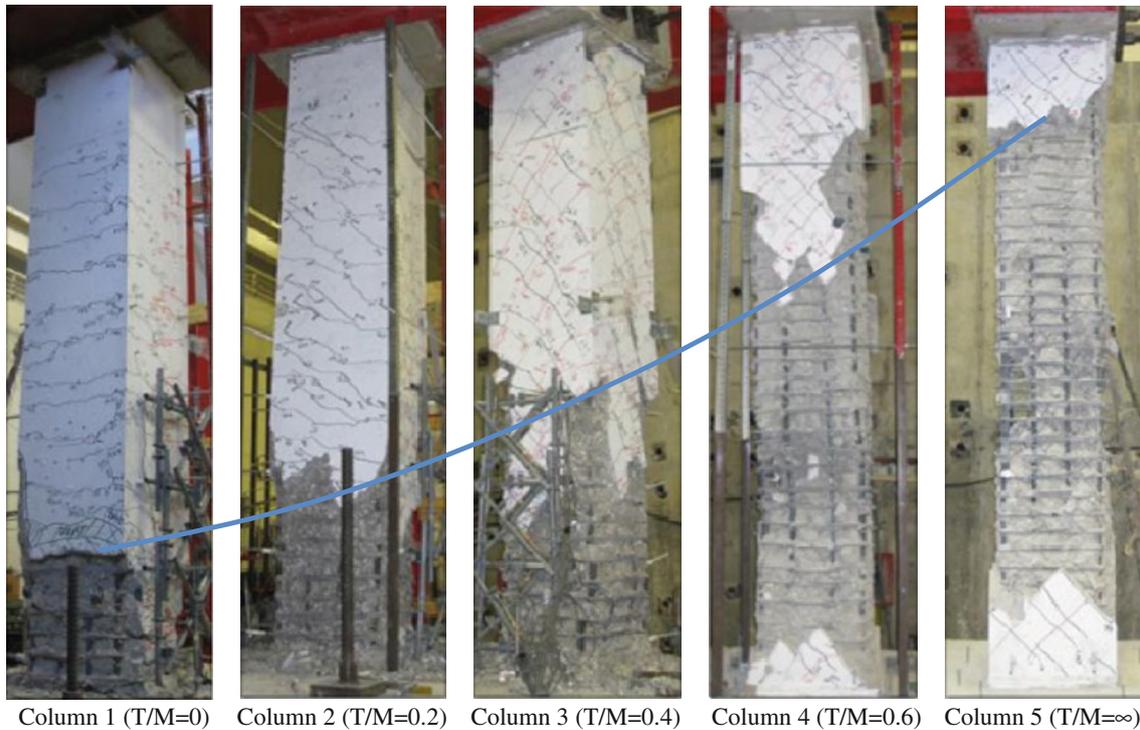
Fig. 2 Damage conditions of the original columns after previous tests.

The damaged columns after the original tests are shown in Fig. 2, which illustrates the difference in the visible damage extent and the plastic hinge location. Generally, the damage region extended farther along the column height and the plastic hinge location shifted away from the base with increasing torque-to-moment ratio. For instance Column 1, which was tested under cyclic shear and bending, sustained cover concrete spalling 25 in. (635 mm) above the column base, and the plastic hinge was located approximately 10 in. (260 mm) above the base. Column 5, which was subject to cyclic torque moment, exhibited concrete damage that extended almost the entire column length, and the core concrete crushed through the cross section 64 in. (1,620 mm) above the column base. The damage to Columns 1, 2, and 3 was concentrated near the base of the column at the location of maximum moment due to flexure-dominant behavior in columns with low T/M ratios ($T/M < 0.5$). Columns 4 and 5 were torsion-dominant with high T/M ratios ($T/M > 0.5$), which resulted in higher plastic hinge location and larger damage extent as illustrated in Fig. 2.

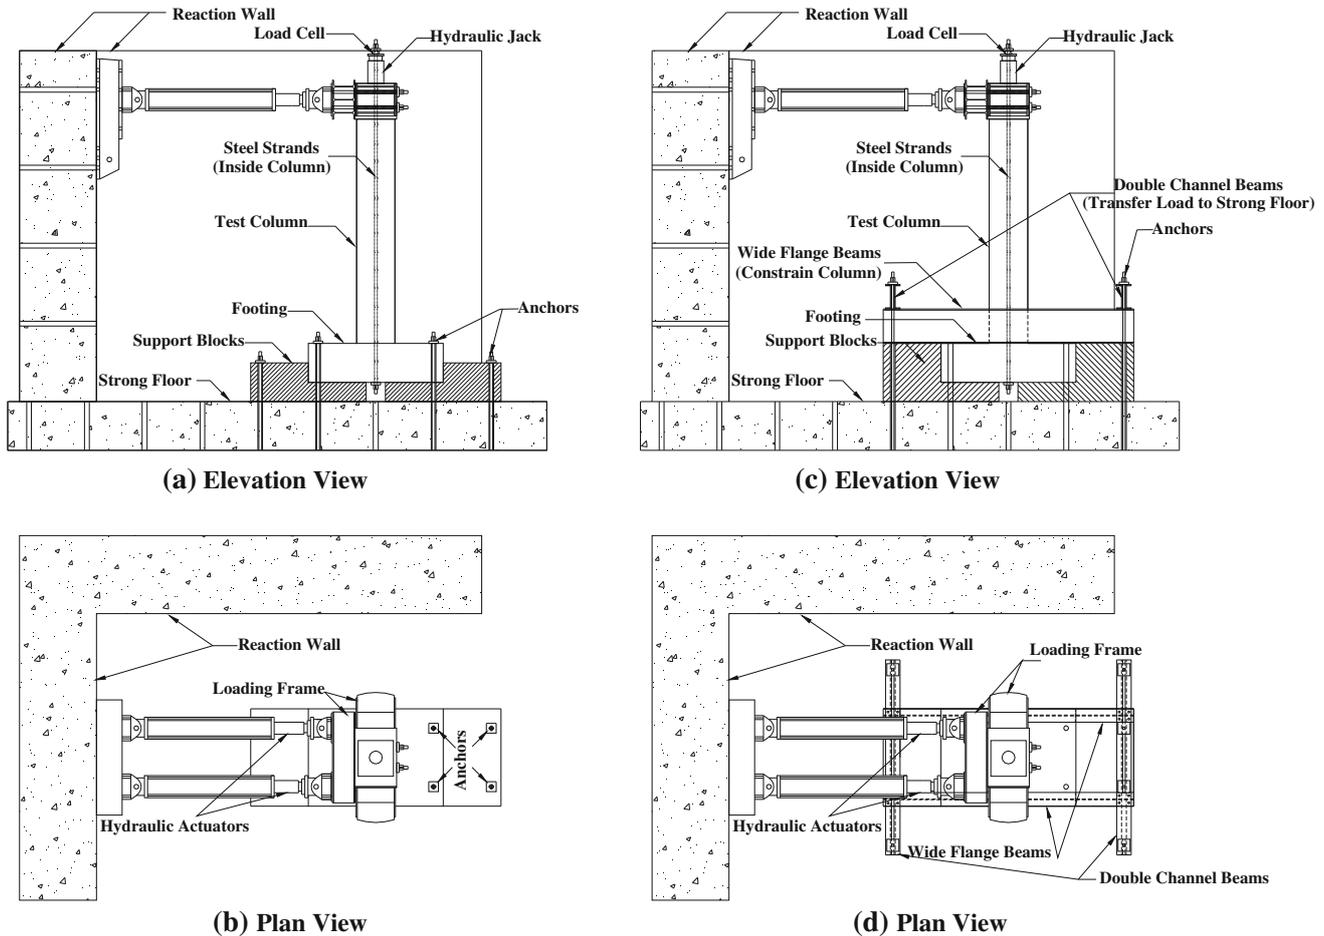
Fig. 3 Test setup for original and repaired columns.

The experimental setup is shown in Fig. 3. In the original tests, the columns were anchored to the strong floor with four DYWIDAG bars with 50 kips (222 kN) prestressing force in each bar (Fig. 3a, b), which is discussed in Prakash et al. (2012). The system used to anchor the repaired

columns to the strong floor was modified due to damage to the anchors. Two steel wide flange beams were used with two steel double channel beams to anchor the repaired column specimens (Fig. 3c, d). Because of the position of the wide flange beams and resulting space limitations, some of the instrumentation used in the original tests was not used in the repaired column tests.

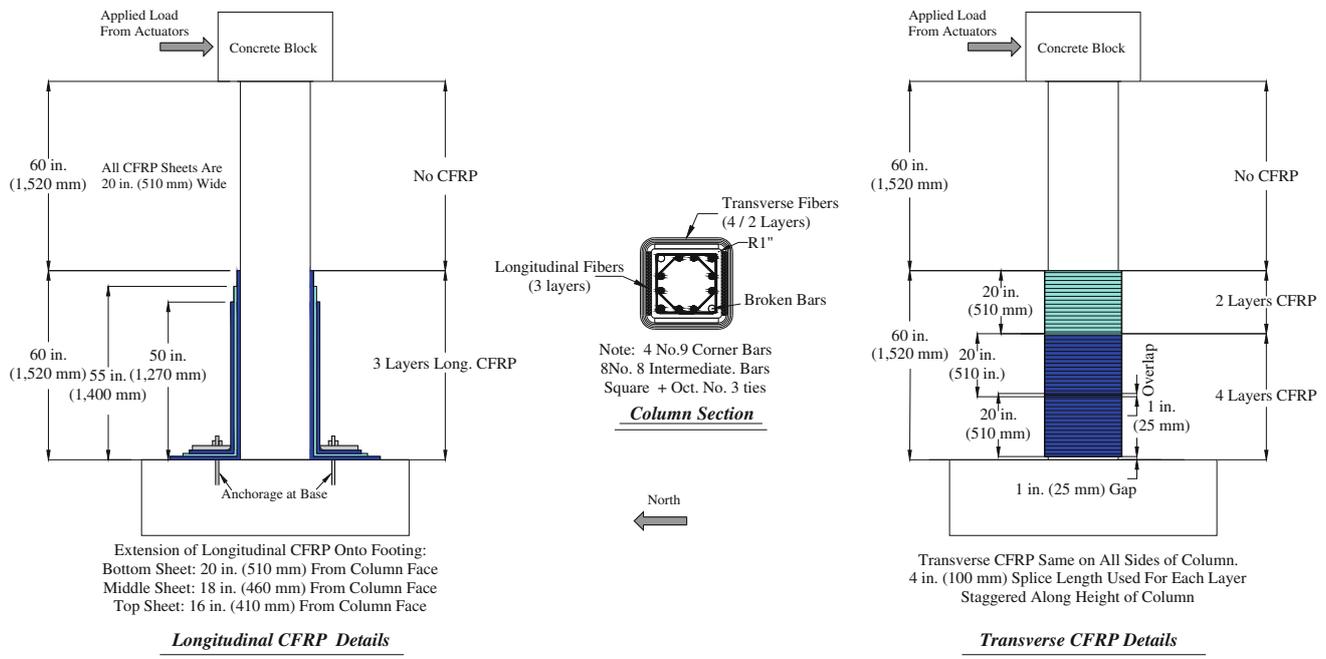
Fig. 4 CFRP layout for Column 1-R.

The CFRP layout for each repaired column is shown in Figs. 4 to 8. Repaired columns are denoted in this paper with the extension “-R”. The CFRP layout for each column was designed and detailed considering the nature of damage to the column, the damage location, and the peak applied loading. As a result, each column had a different repair region and CFRP layout. To maximize the time efficiency, only the regions of the column at and adjacent to the plastic hinge were repaired. Adjustments were made to the designs based on lessons learned during testing of previous repaired columns within the series as discussed below. (Repaired columns were repaired and tested in sequential order from Column 1-R to 5-R).

was concentrated near the base of the columns. This was the case because Columns 1, 2, and 3 were flexure dominant. The increasing number of transverse CFRP sheets at the bottom level of Column 3-R compared to Column 2-R, and Column 2-R compared to Column 1-R, is due to the fact that the damage in Columns 1-R and 2-R was concentrated near the base of the column, and damage did not spread to the adjacent region. Longitudinal CFRP was installed only on the north and south sides of Column 1-R because the column was subjected to uniaxial bending and no torsion, and because space limitations did not allow for installation of an appropriate anchorage system to anchor longitudinal sheets on the east and west faces. However, transverse CFRP splitting observed on the east and west sides at early stages of testing Column 1-R prompted the use of longitudinal CFRP sheets on all four sides of Columns 2-R and 3-R. Thus one longitudinal sheet was provided on the east and west sides that was anchored at the base by U-anchors, which required minimal space for installation. The longitudinal CFRP sheets on the north and south faces were anchored with an anchorage system consisting of a steel plate welded to a quarter-section of steel pipe reinforced with stiffeners and fastened to the concrete with threaded steel anchor rods that were embedded using a chemical adhesive. The anchorage system is sketched at the base of the columns in Figs. 4, 5

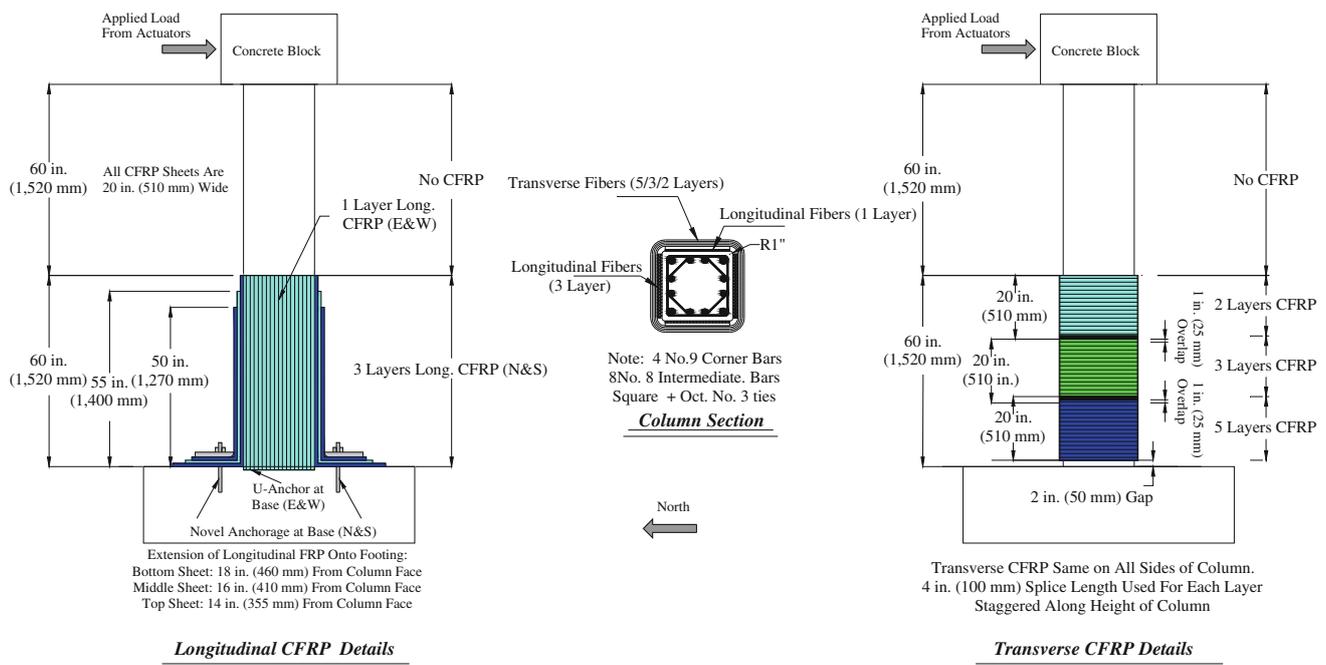
Fig. 5 CFRP layout for Column 2-R.

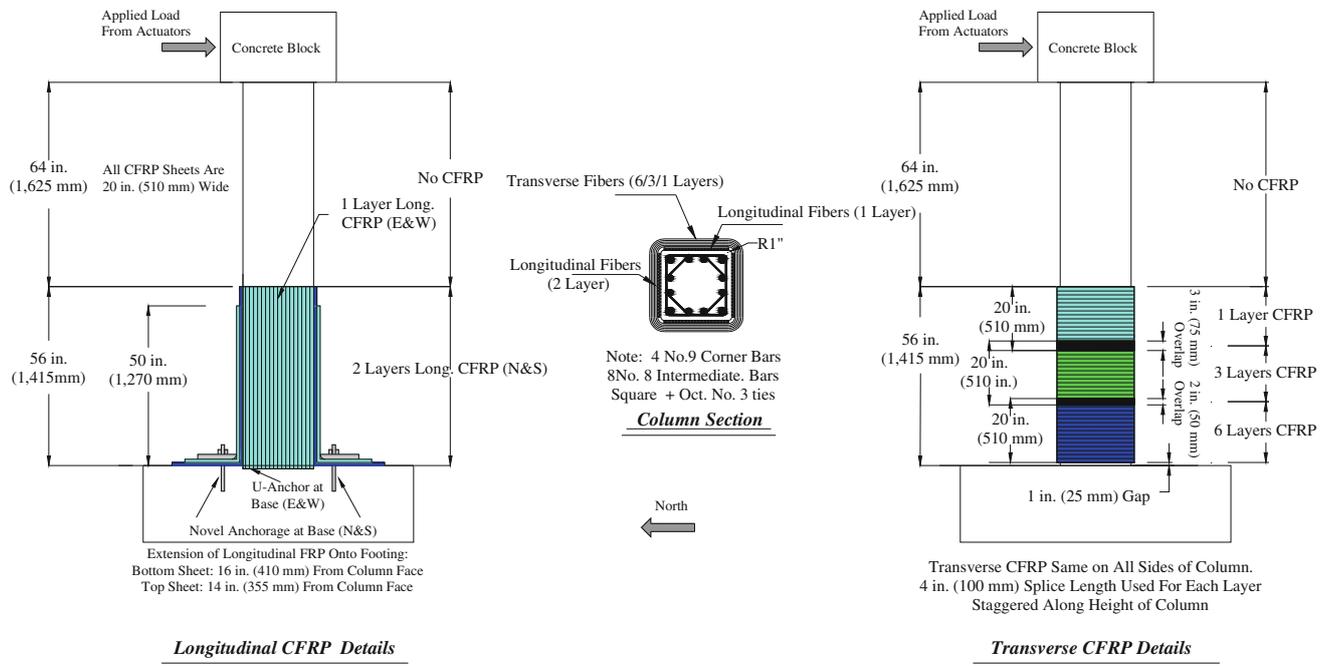
Fig. 6 CFRP layout for Column 3-R.

and 6. A photo of the anchorage system is shown in Fig. 9, and details of the anchorage system design are described by Grelle (2011).

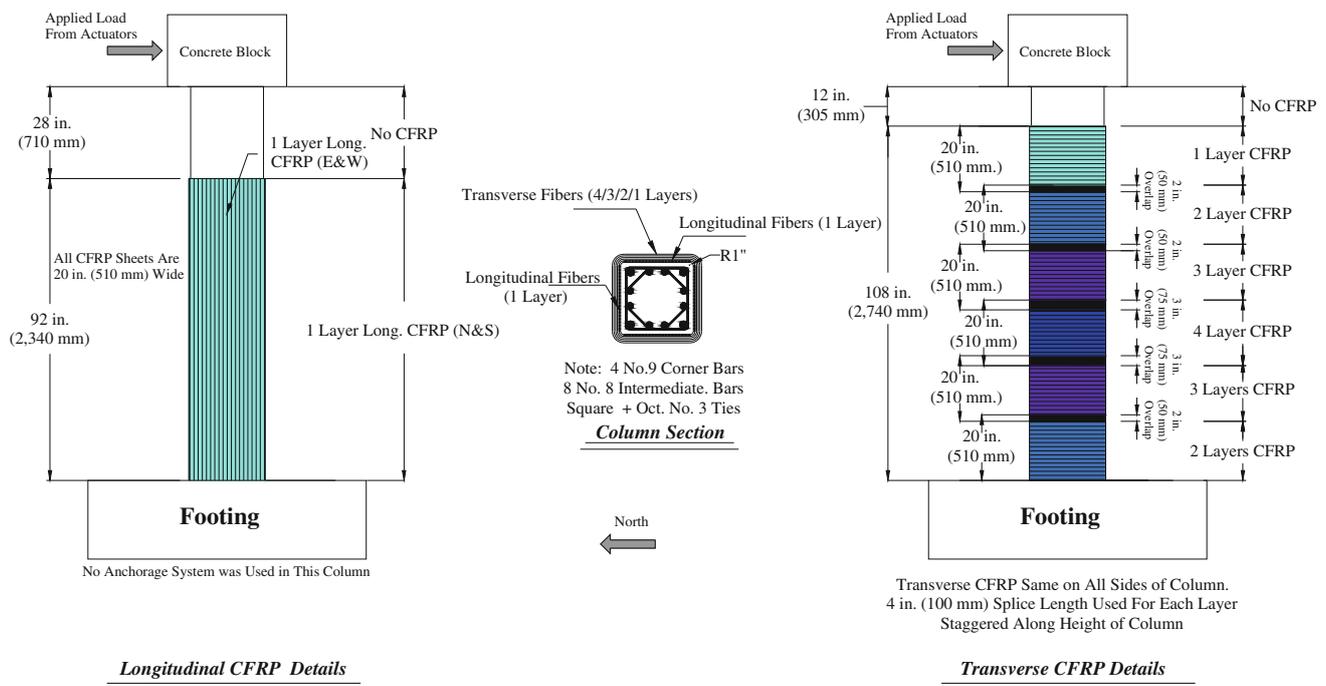
Fig. 7 CFRP layout for Column 4-R.

For Columns 4-R and 5-R, the repair regions extended along most of the column length. Column 4 was repaired along most of its height except for the top 12 in. (305 mm) because of lack of damage in the top region as well as difficulty of applying formwork and placing the repair mortar along the full height of the column. However, shifting of the plastic hinge location of Column 4-R prompted the full height repair of Column 5-R.

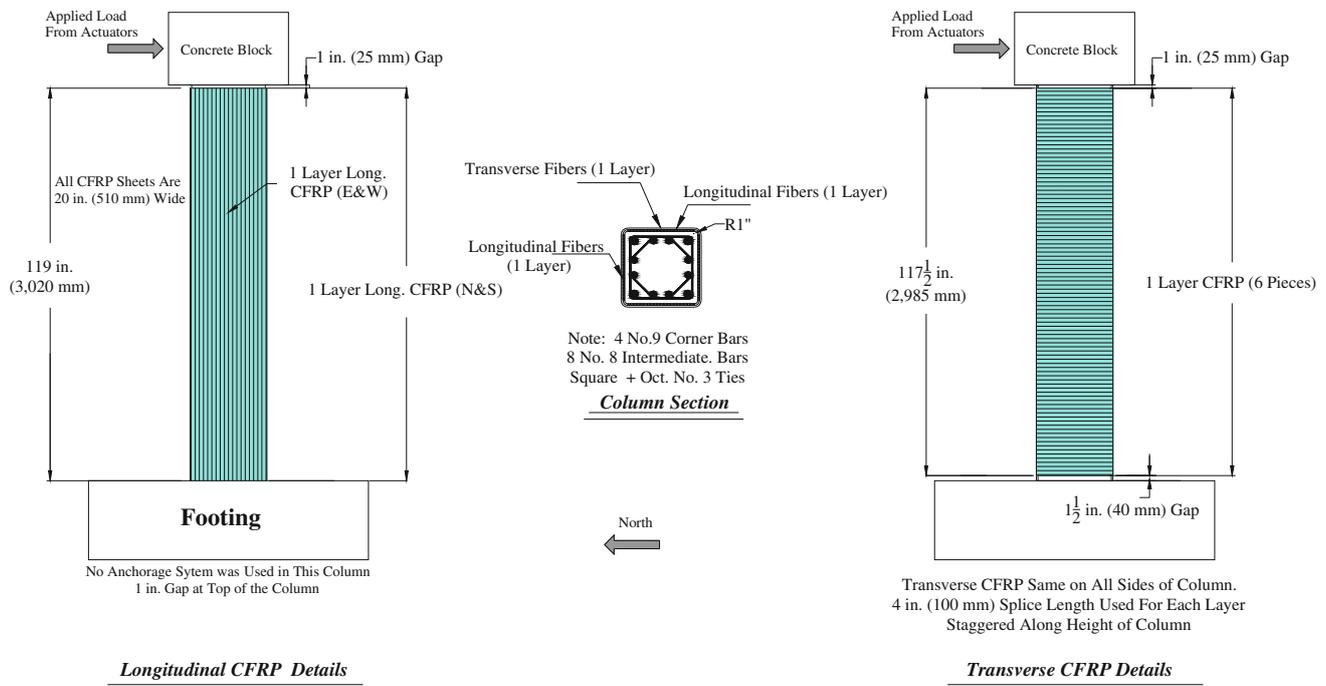
Fig. 8 CFRP layout for Column 5-R.

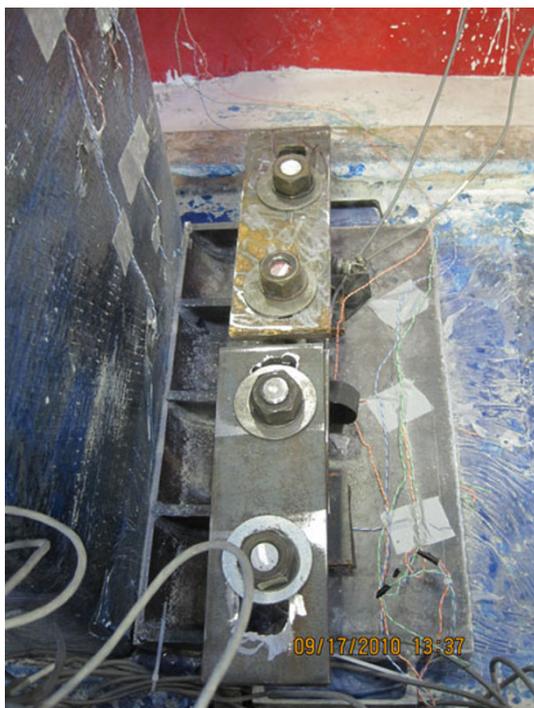
Fig. 9 Novel anchorage system.

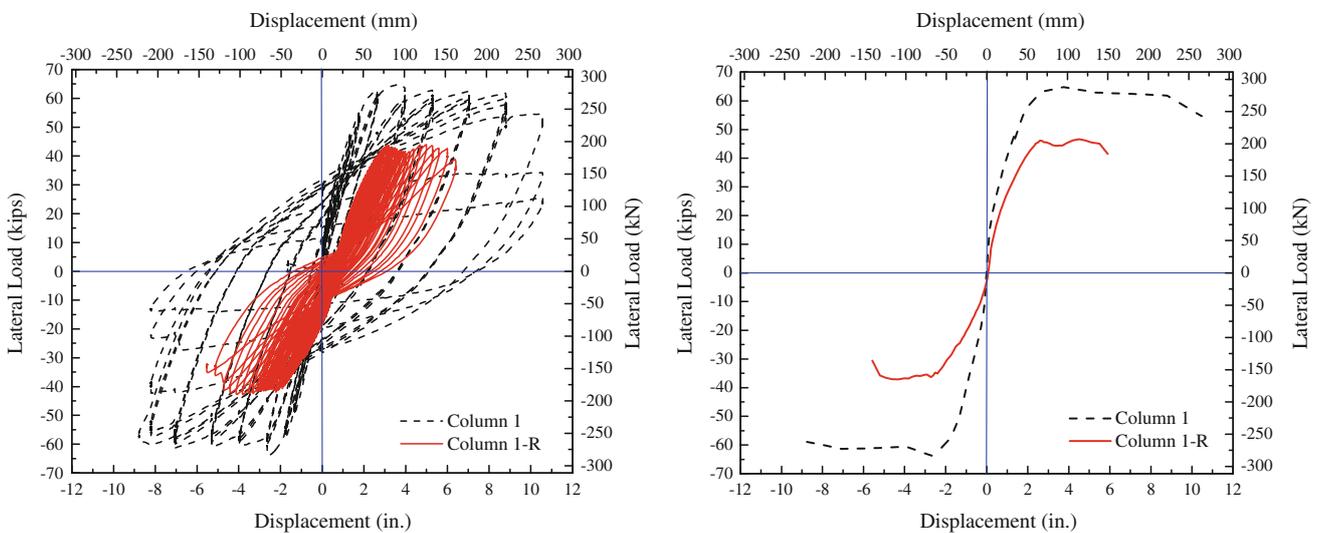
Fig. 10 General behavior of Column 1-R compared to Column 1

The general response of each repaired column relative to the corresponding original column is described in this section. The measured load–displacement and torque–twist relationships of the repaired columns compared to the corresponding original columns are shown in Figs. 10 to 14, in which both the hysteresis and envelope responses are provided. As illustrated in the figures, the repaired columns behaved asymmetrically in the positive and negative cycles. This response can be attributed to the unsymmetrical damage in the original column, the unsymmetrical removal and replacement of loose concrete during the repair procedure, and possibly some original displacement at the beginning of testing the repaired columns, which was due to the fact that the repaired column was not perfectly straightened.

The measured lateral load and displacement in Column 1-R did not reach that of Column 1, which is due to premature failure associated with longitudinal CFRP anchorage as discussed in the previous section. A moment–curvature analysis of the repaired cross-section confirms that the lateral load associated with the predicted moment capacity after failure of the longitudinal CFRP was close to the peak lateral load measured during the test. It must be noted that anchorage of externally bonded longitudinal CFRP sheets is a crucial issue to ensure that the tensile force can be developed at the critical section. When the plastic hinge is located near a joint, the situation is even more complicated by the interaction between the column and the anchorage system, which was the situation of Column 1-R. Therefore careful attention must be paid to detailing of both the FRP and its anchorage system.

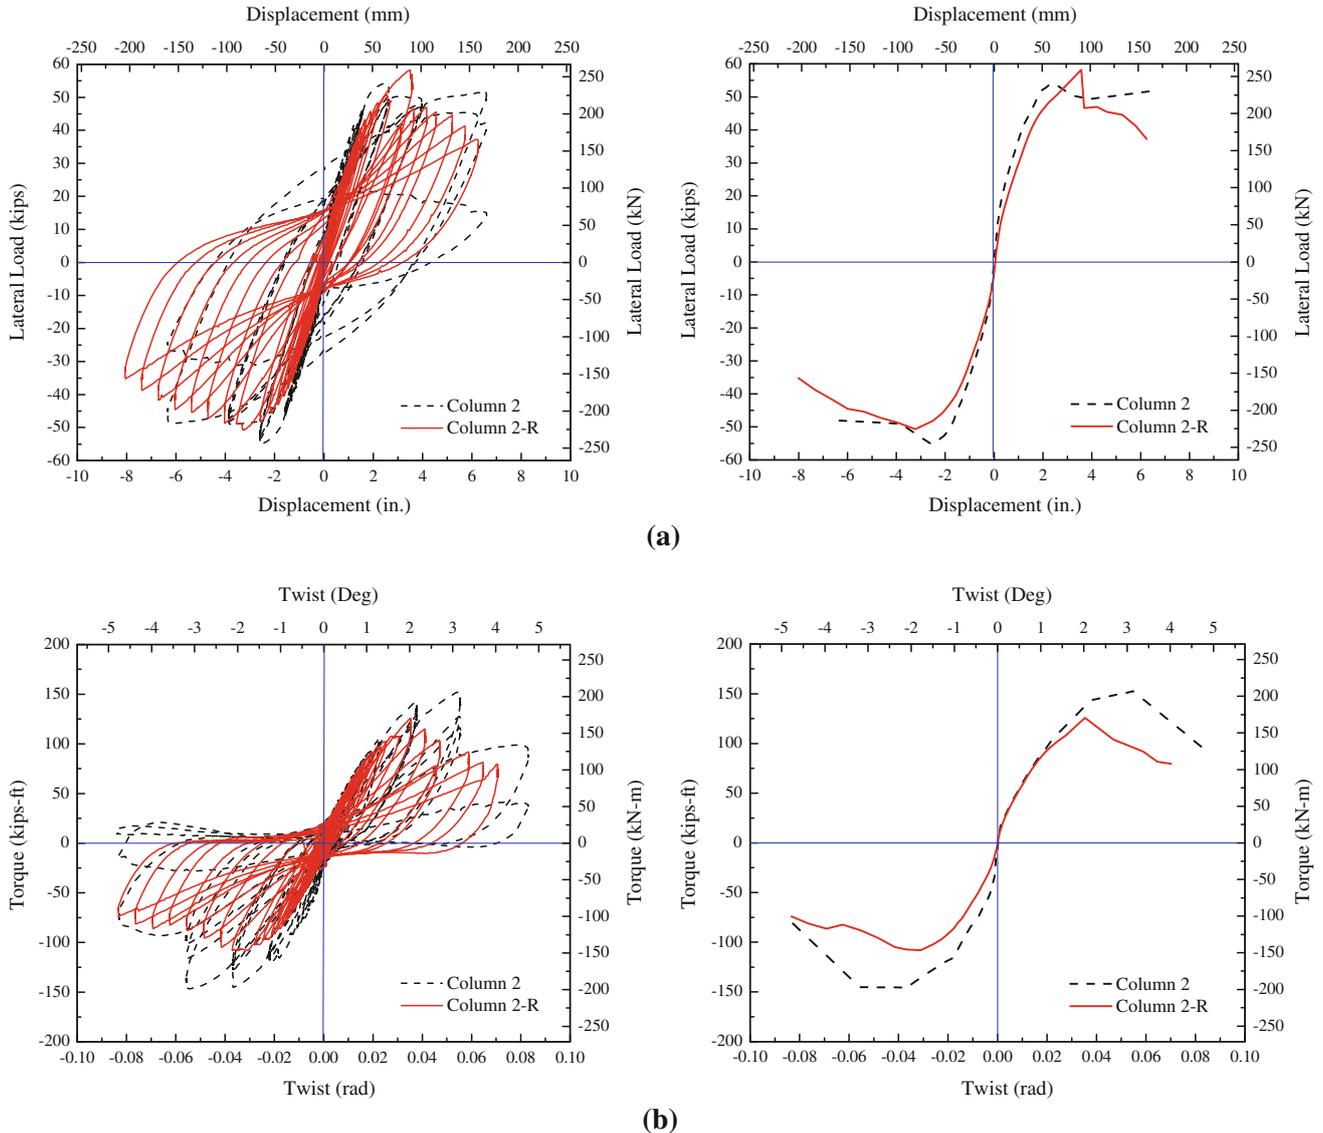
Fig. 11 General behavior of Column 2-R compared to Column 2. a Bending behavior. b Torsional behavior.

Figures 11 and 12 show that both the flexural strength and ductility of Columns 2-R and 3-R were mainly restored to

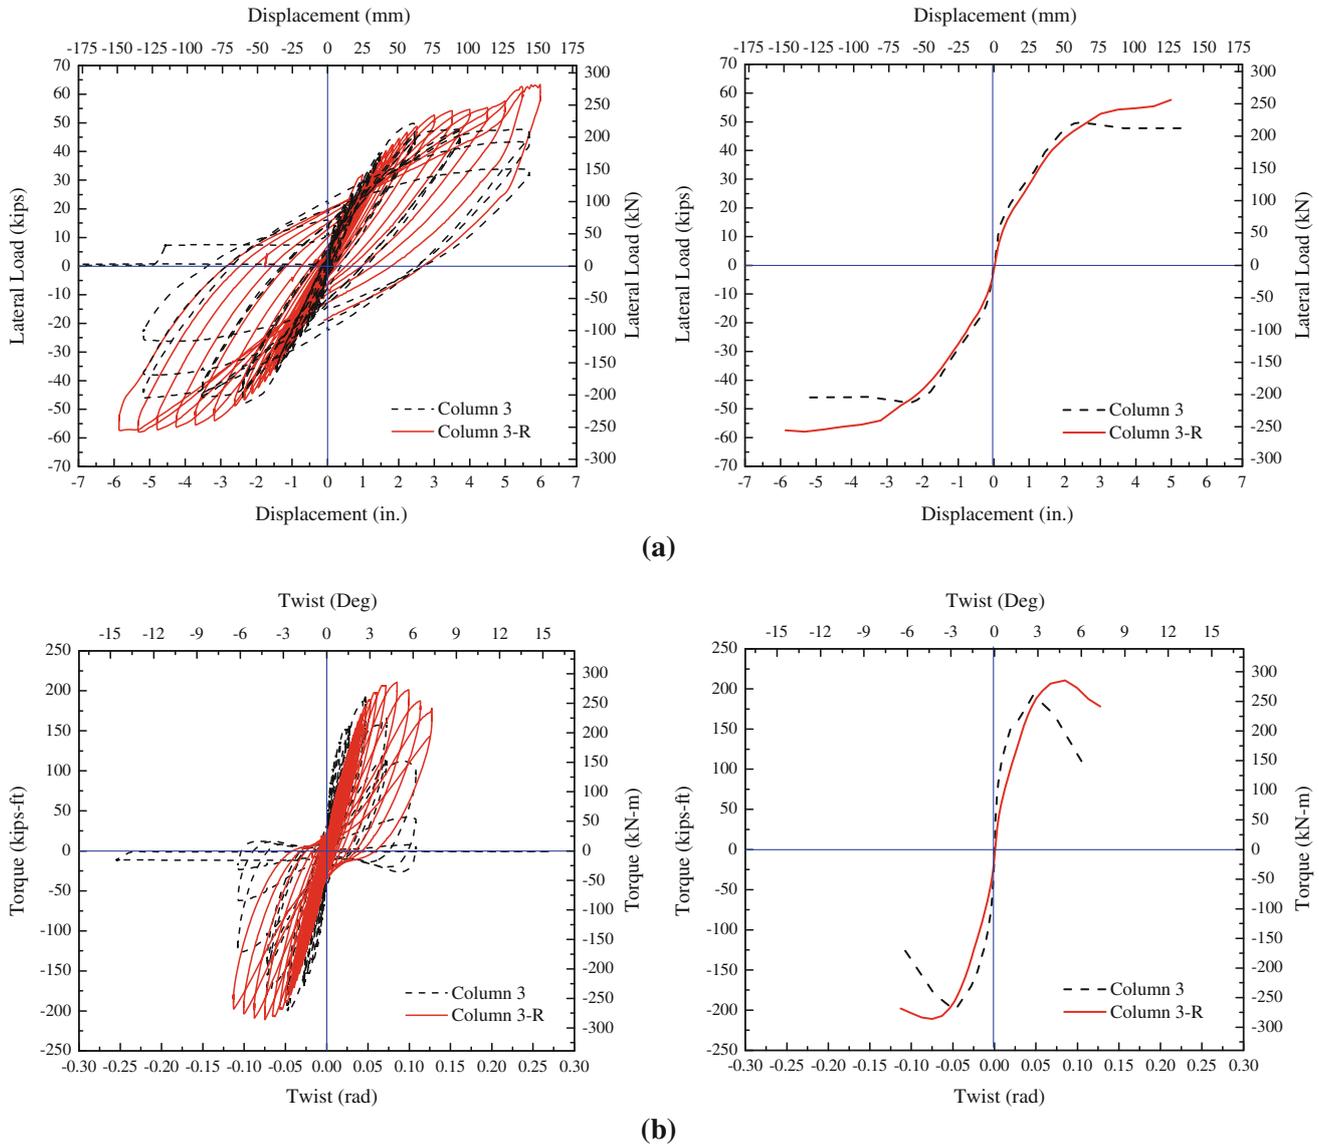
Fig. 12 General behavior of Column 3-R compared to Column 3. **a** Bending behavior. **b** Torsional behavior.

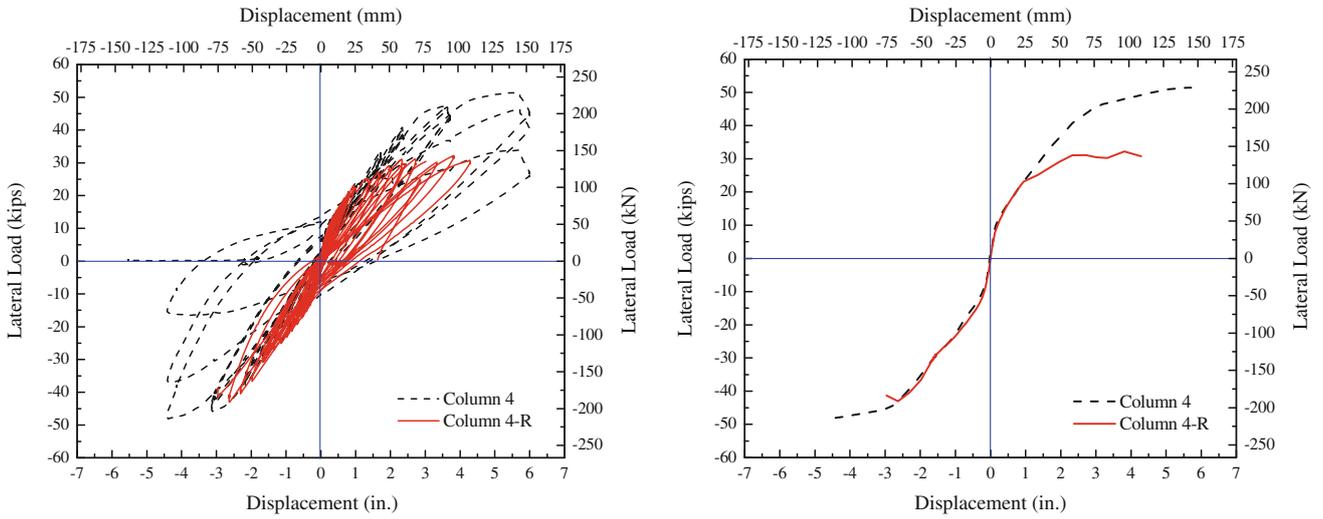
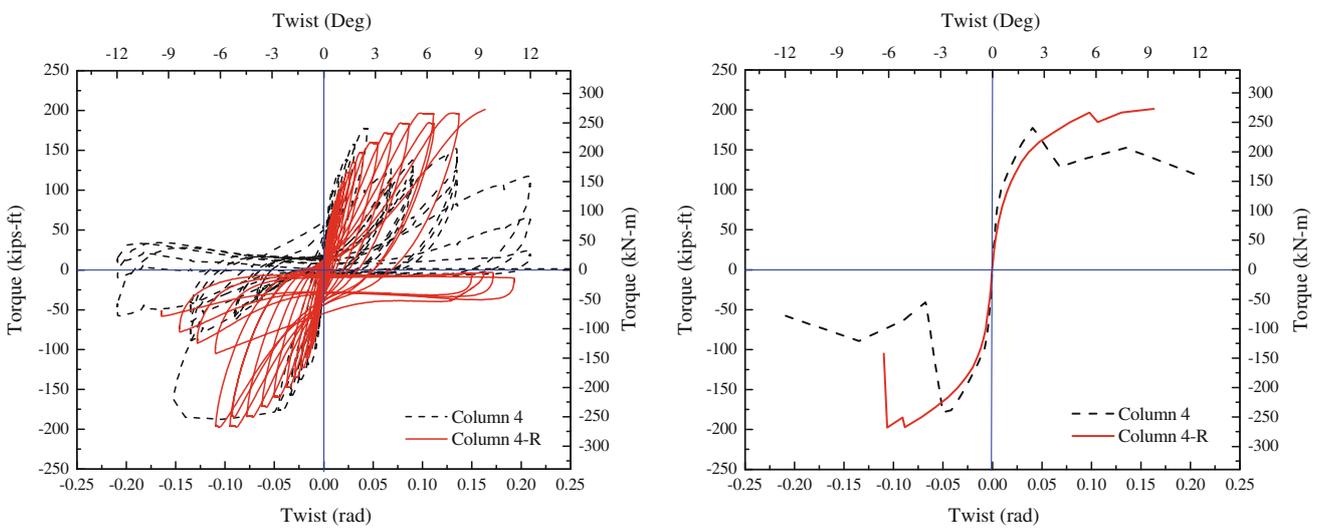
Fig. 13 General behavior of Column 4-R compared to Column 4. **a** Bending behavior. **b** Torsional behavior.

Columns 2 and 3, although the maximum torque of Column 2-R did not reach that of original column. Similarly for Column 4-R, Fig. 13 shows that the torsional strength was improved compared to Column 4, but the measured lateral load and displacement did not reach the original state. To explain the differences in bending and torsional strength restoration for each repaired column, the difference in the loading protocol details between the repaired column and corresponding original column must be noted. As discussed previously, it was difficult to maintain the torque-to-moment ratio after shifting to displacement control, which resulted in the applied load with different torque-to-moment ratios for the repaired and original columns. For instance Fig. 15 shows the torque-to-moment ratios (T/M) for the applied load on Column 4-R and Column 4. The torque-to-moment ratio of Column 4 reduced significantly after shifting from load control to displacement control at a lower load level compared to Column 4-R. This resulted in higher bending moment in Column 4 compared to Column 4-R, since this bending moment was reached at a lower torque compared to

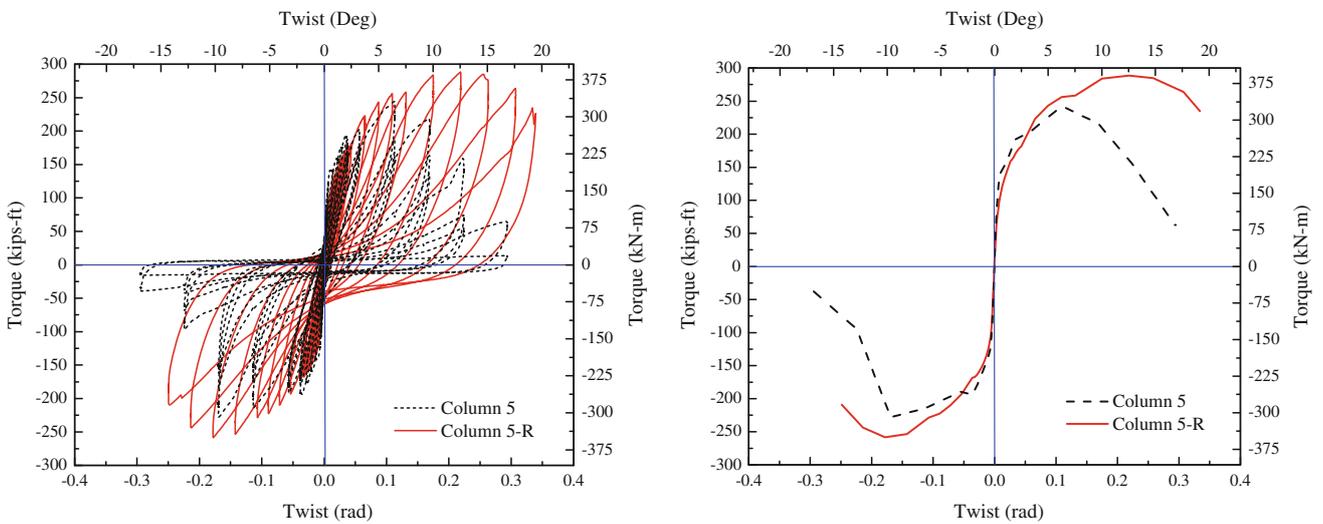
Fig. 14 General behavior of Column 5-R compared to Column 5.

Comparison of the applied torque-twist envelopes of Column 5 and Column 5-R in Fig. 14 indicates that the torsional strength and twist at maximum torque were enhanced by the repair. For Column 5, the torsional strength reduced rapidly after the maximum torque was achieved because the core concrete crushed and thus could not provide further torsional resistance. The post-peak response of Column 5-R was characterized by a reduction in torsional strength with increasing applied torque, but not as rapidly as that of Column 5. This phenomenon can be explained in part by the confinement provided by the transverse CFRP wrap.

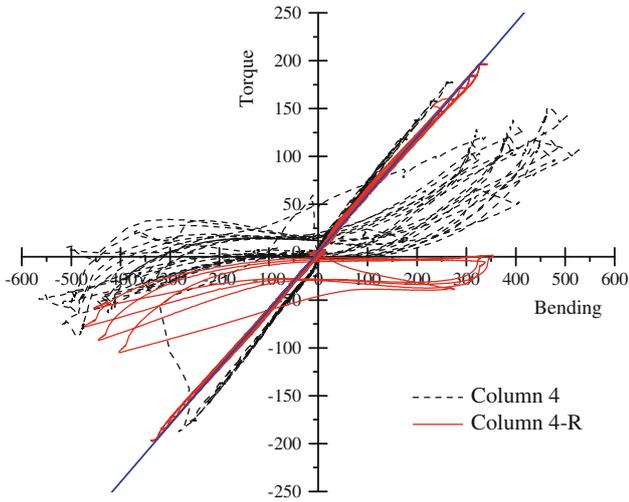
Fig. 15 Torque-to-moment ratios for Column 4 and Column 4-R.

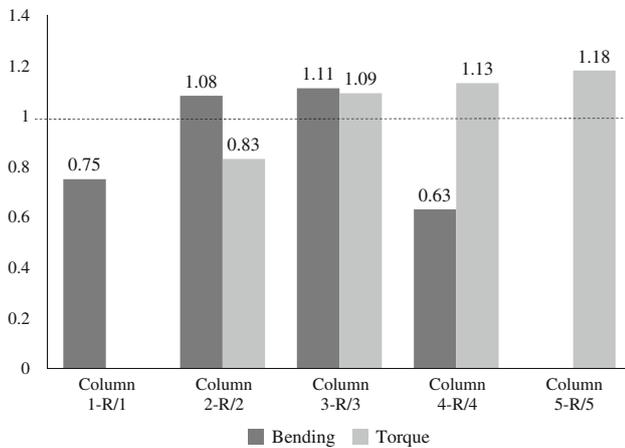
Fig. 16 Strength indices for repaired columns.

The strength indices for the columns are provided in Fig. 16, which illustrates that the repair method is effective in restoring the bending and/or torsional strength. The flexural strength restoration ranged from 63 to 111 %, and torsional strength restoration ranged from 83 to 118 %. Although Column 1-R was restored to 75 % of its original flexural strength, the results can be misleading since the strength restoration was limited by the flexural capacity of the repaired cross-section section with fractured bars, because the longitudinal CFRP failed prematurely. For Columns 2-R, 3-R, and 4-R, which were subjected to combined bending and torsion, either the flexural strength, the torsional strength, or both, were fully restored. Bending-torque interactions played a role in the level of bending and torsional strength restored as discussed in the previous sections. For Column 5-R subjected to pure torsion, the torsional strength was fully restored.

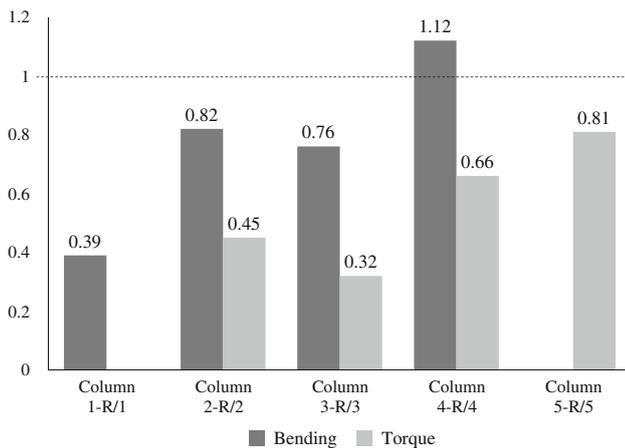
Fig. 17 Stiffness indices of initial state for repaired columns.

The initial stiffness indices for the repaired columns are illustrated in Fig. 17. The initial bending stiffness indices ranged from 39 to 112 %, and initial torsional stiffness indices ranged from 32 to 81 %. With the exception of the bending stiffness of Column 4-R/4, the initial stiffness of the repaired columns was lower than that of the corresponding original columns. This reduction in initial stiffness is due to the unrepaired cracked portions of the repaired columns and material degradation during the original tests.

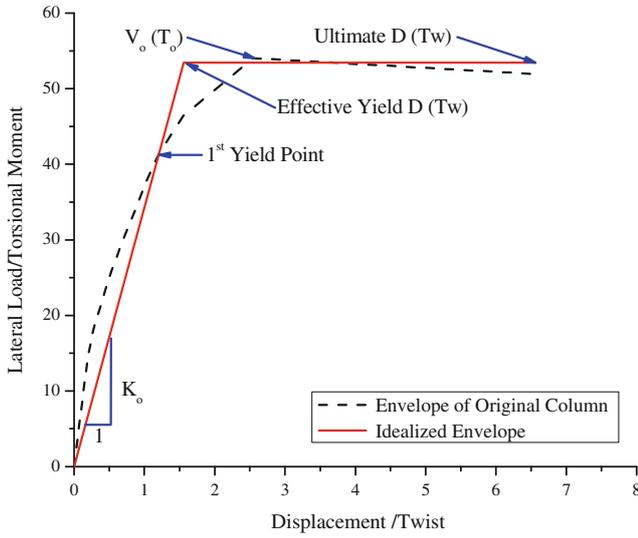
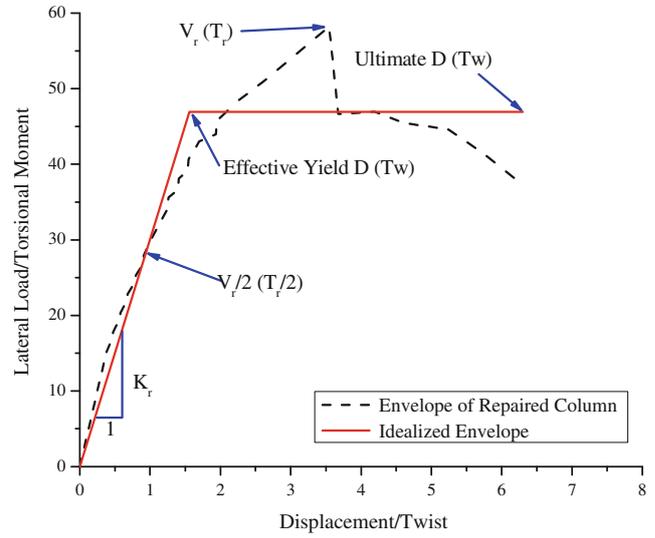
Fig. 18 Idealized envelopes for original and repaired columns.

point on the measured envelope at which the applied load (torsional moment) was one-half of the peak measured value. The yield level was established by equalizing the area between the measured and idealized curves. The idealizations of the envelopes of the original and repaired columns are illustrated in Fig. 18.

The general service stiffness index $STFI_2$ is defined as the ratio of the service stiffness of the repaired column K_r to that of the original column K_o as shown in Eq. (4). The service stiffnesses K_r and K_o are determined from the ratio of the plastic base shear (torque) to the effective yield displacement (twist), which were obtained from the idealized curves (see Fig. 18).

The ductility index DI is defined as the ratio of the ductility capacity of the repaired column D_r to that of the original column D_o (see Eq. (5)). The ductility capacity is defined as the ratio of the ultimate displacement (twist) to the effective yield displacement (twist), which can be obtained from the idealized curves in Fig. 18.

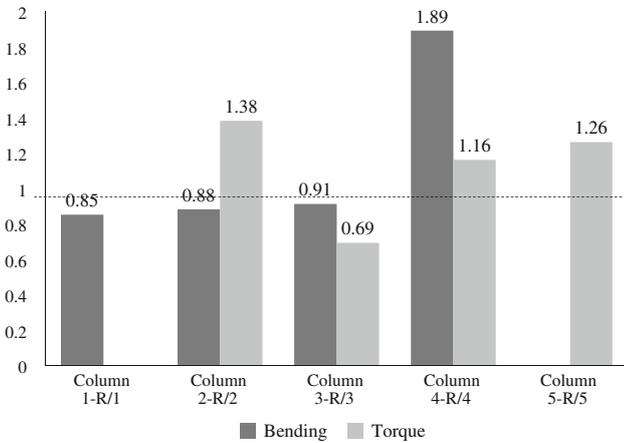
Fig. 19 General service stiffness indices for repaired columns.

The general service stiffness indices of the repaired columns are summarized in Fig. 19. The general service stiffness indices for bending ranged from 85 to 189 %, and general service stiffness indices for torsion ranged from 69 to 138 %.

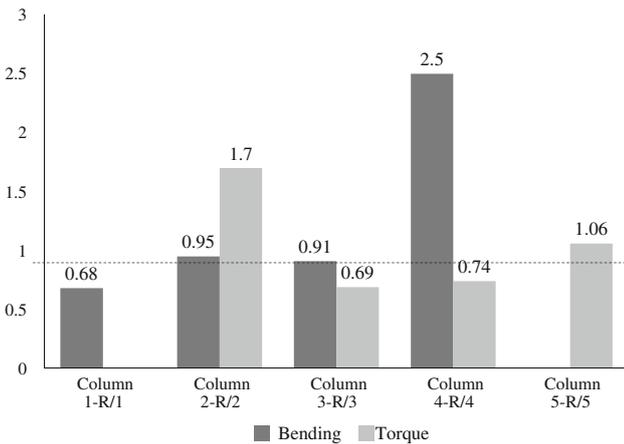
Fig. 20 Ductility indices for repaired columns.

The ductility indices in terms of both bending and torsion are illustrated in Fig. 20. The ductility indices for bending ranged from 68 to 250 %, and for torsion ranged from 69 to 170 %.
